## **Conditions Assessment, Historical Analysis, and Adaptive Reuse**

### **Town Hall Campus Study Mendon Center Historic District Town of Mendon, Massachusetts**

PROJ.: Mendon Town Hall Campus Study  
RE: Building Conditions Assessment, Historical Analysis, and Adaptive Reuse

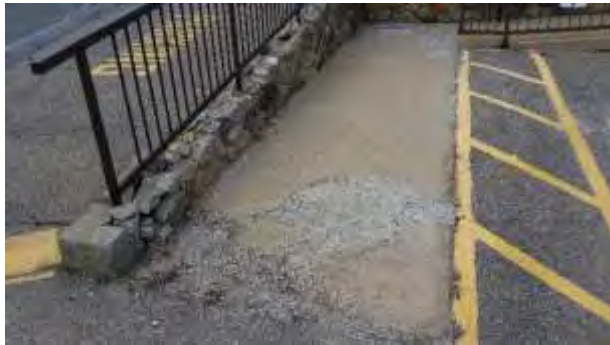
Deteriorated concrete slab and stone wall at base of exterior ramp.

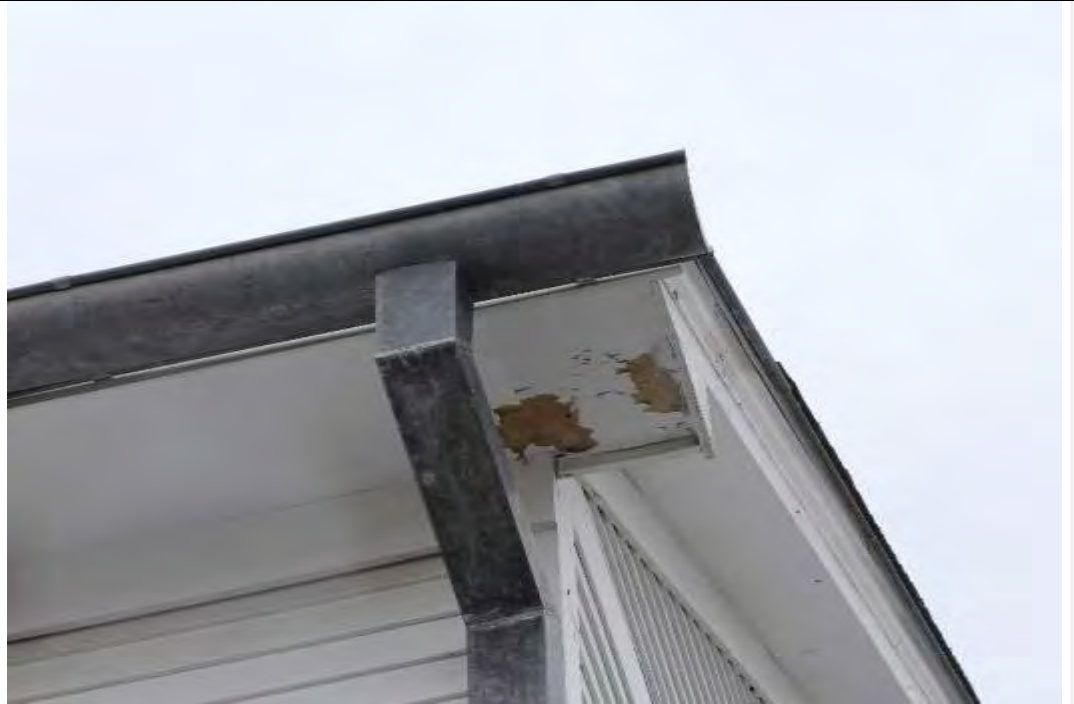
11

The roof was recently replaced, including new L.C.C. gutters and downspouts. The soffit, fascia and rake appear to be replacements. Paint failures are not throughout, but significant in areas.

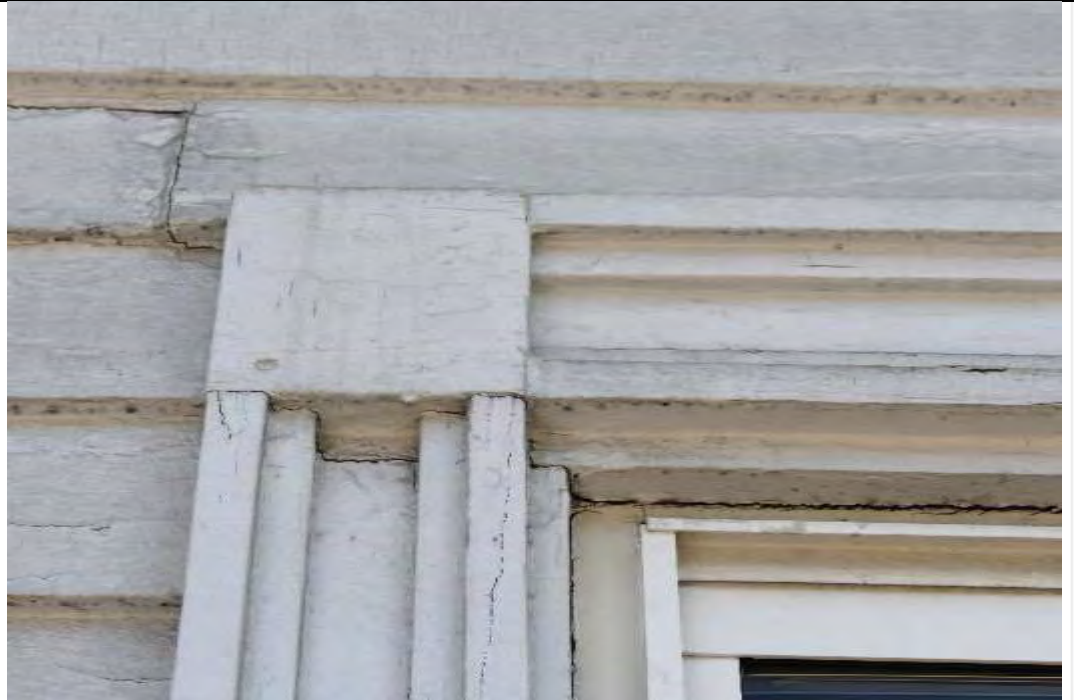
12

The window casing on the side elevations are original, while windows are vinyl replacements.

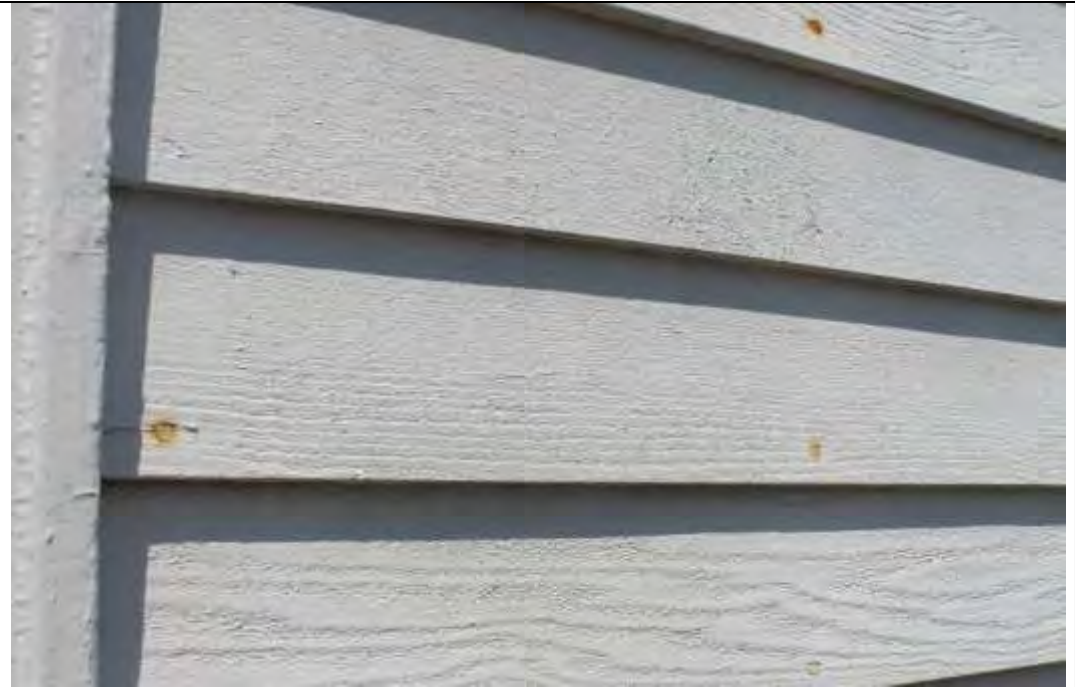
13

Replacement siding appears to have been installed in various areas, new and old. The siding was installed using steel nails, which are now beginning to show rust through the paint. This will eventually lead to premature failure of the paint around the nail.

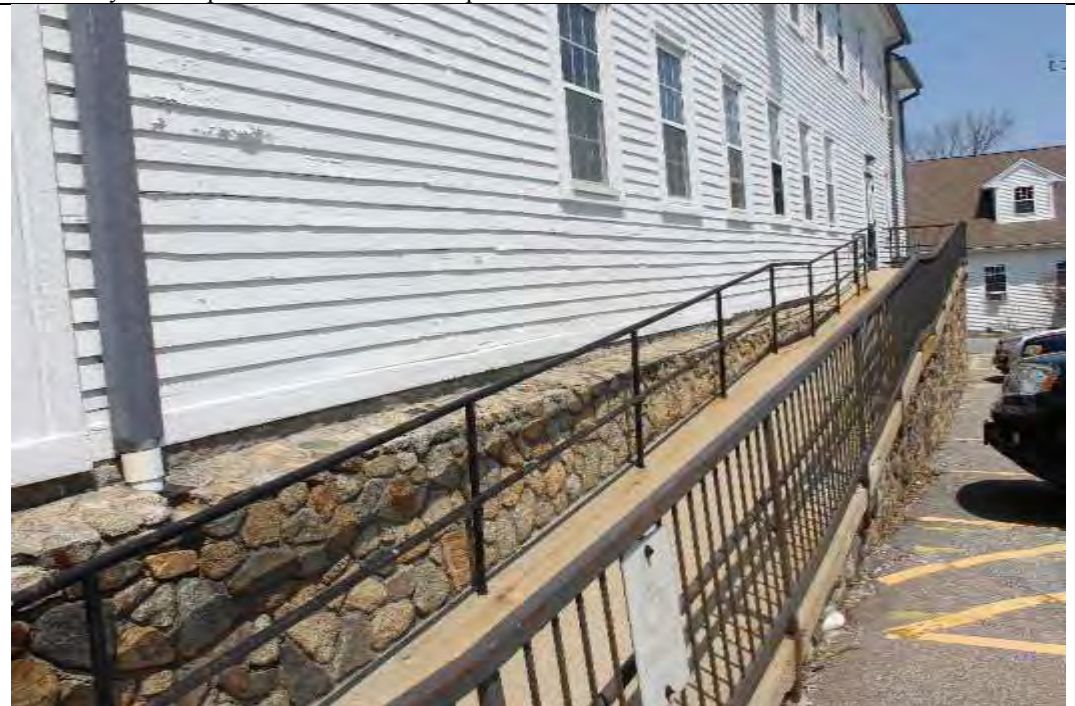
14

The exterior ramp with side walls of fieldstone. The original granite foundation can still be seen.

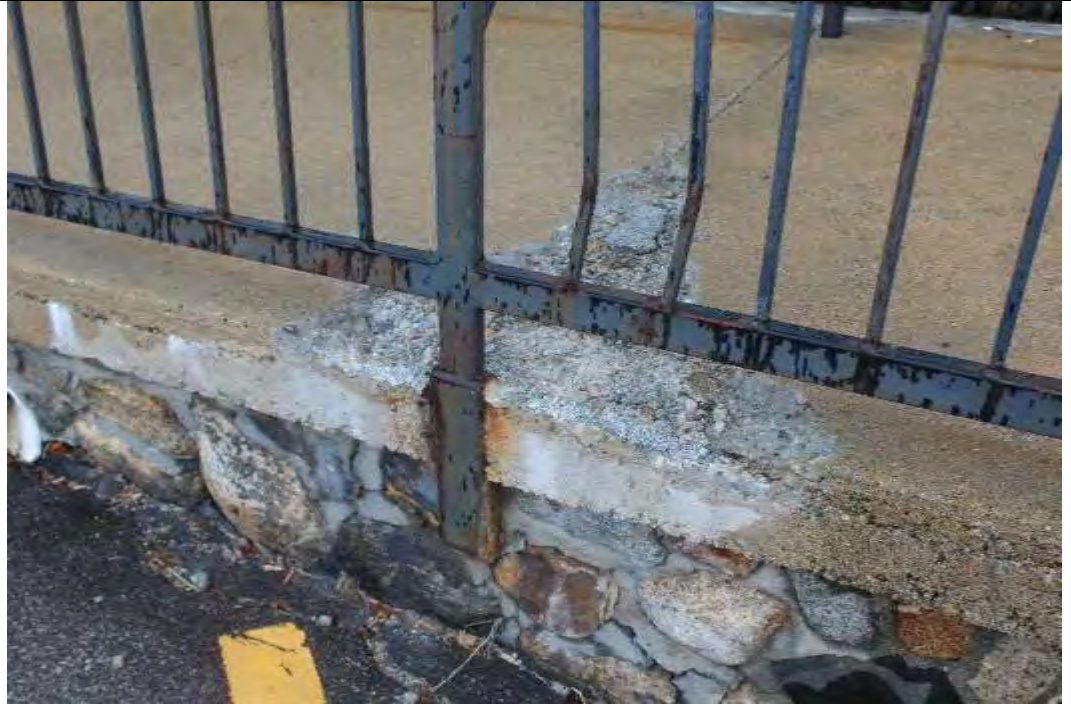
- Historical Integrity: Fieldstone may be local. Ramp was installed in 1980's or 1990's
- Material: Fieldstone walls and concrete surface with steel railings and posts.
- Condition: Poor, with open / failing joints and loose stones at walls, damaged and rusting railing components, and spalled areas of concrete.
- Recommendations:

The ramp is in poor condition and should be repaired, including the fieldstone walls, the railings and guardrails, and the concrete slab.

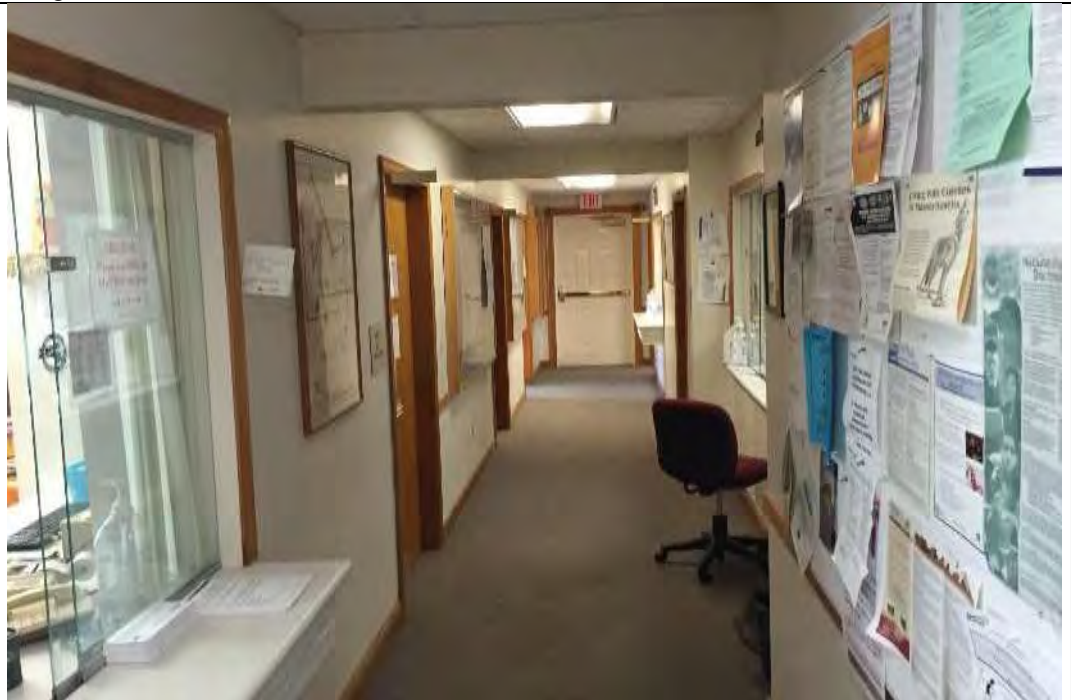
16

The First Floor Corridor is narrow, dark, un-inviting, and not reminiscent of the building's history.

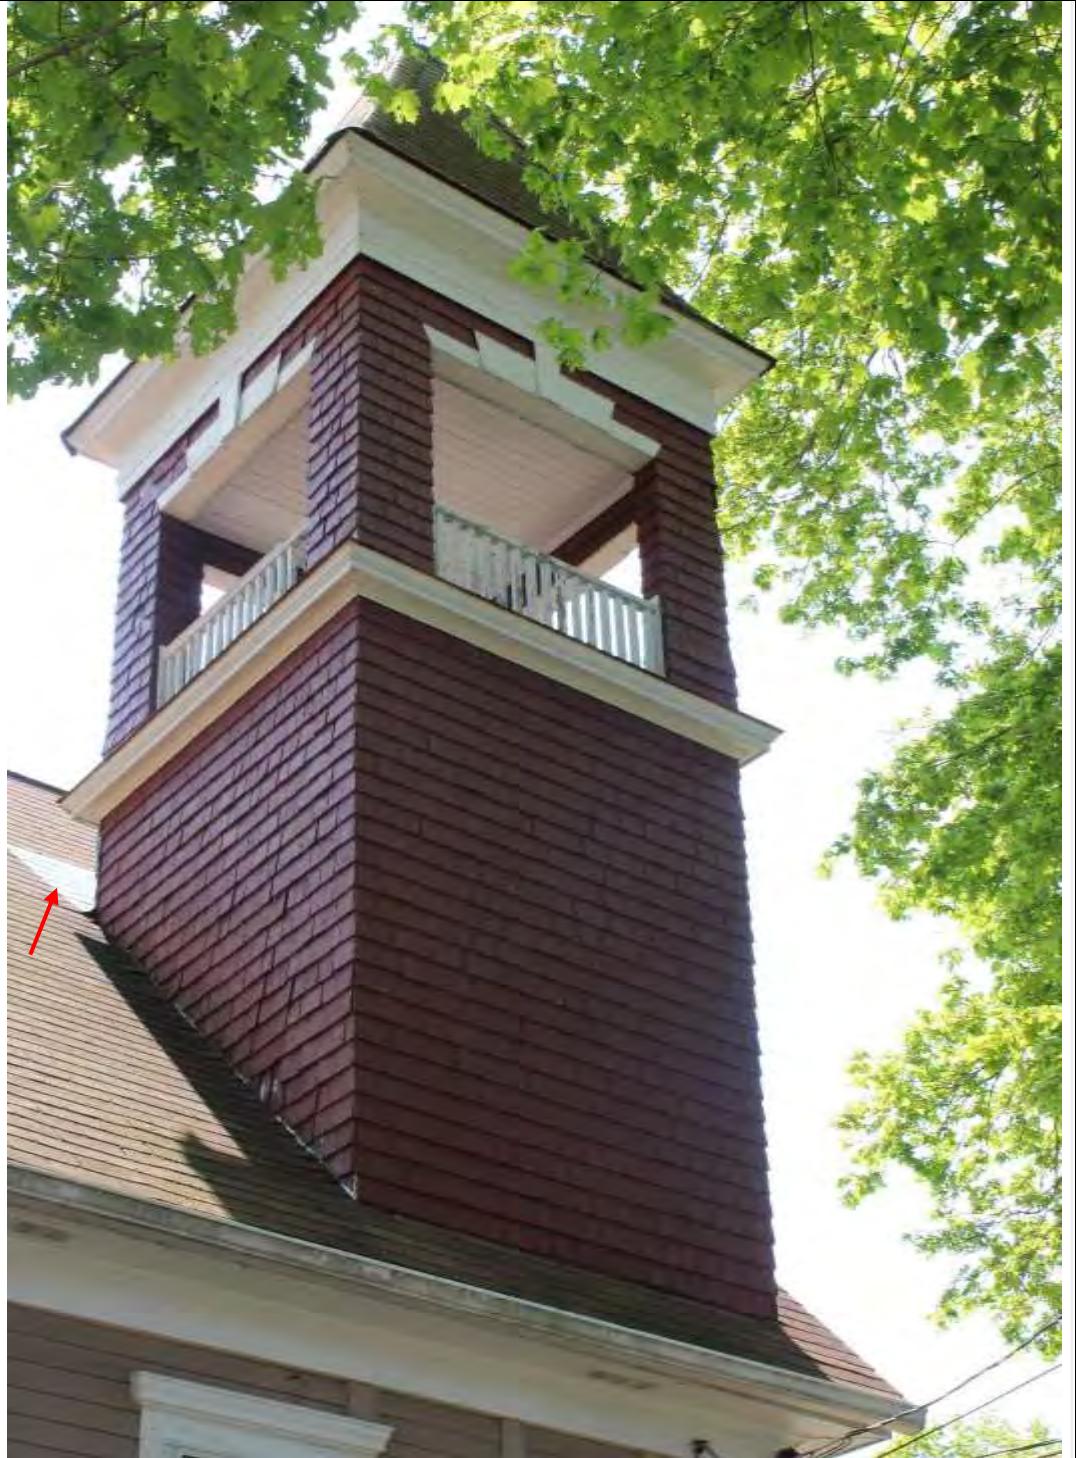
8

The belfry. A leak was patched with ice & water shield on the roof and cheek wall where the roof meets the belfry wall.

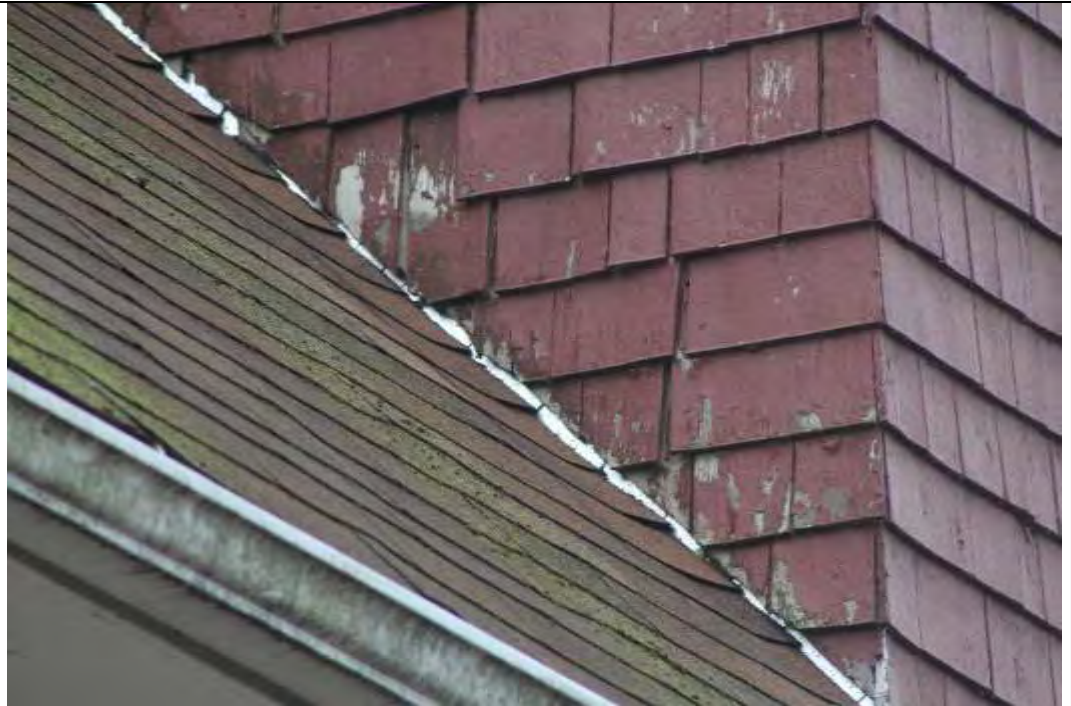
9

The roof is in need of being replaced. All flashing should be replaced as well.

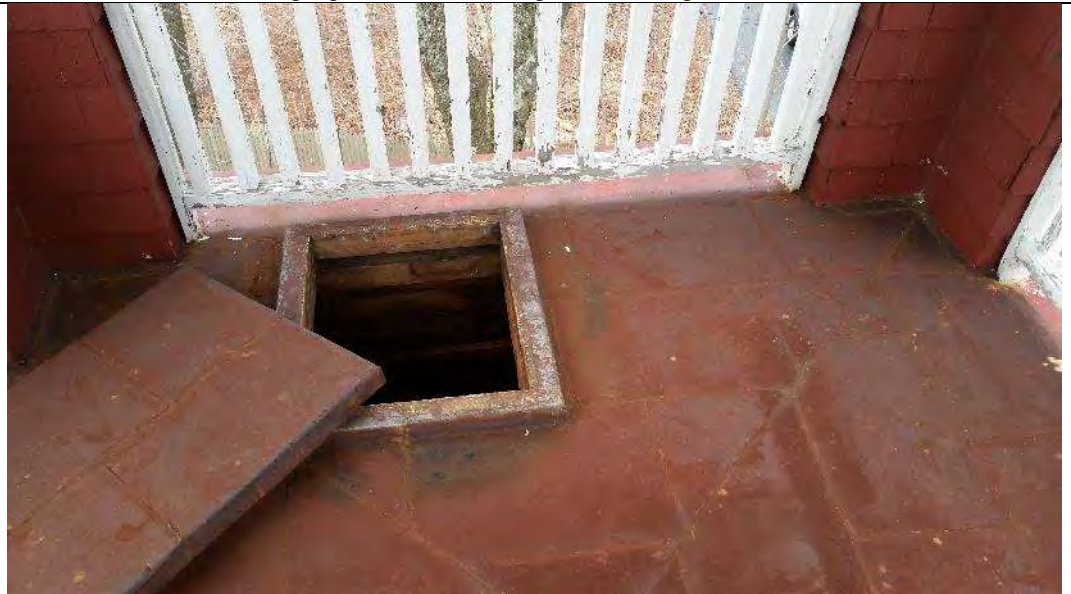
10

The belfry railings and walls are in poor condition. The access hatch should be made watertight.

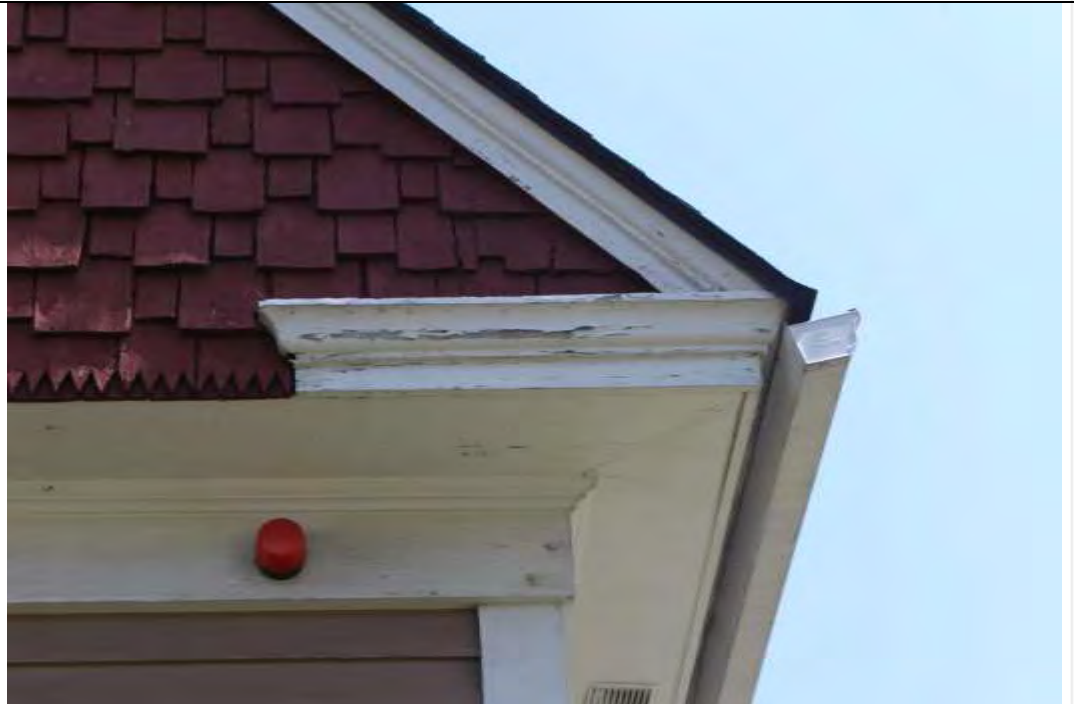
11

Aluminum gutters should be replaced along with the roof. The wood trim should be repaired and painted.

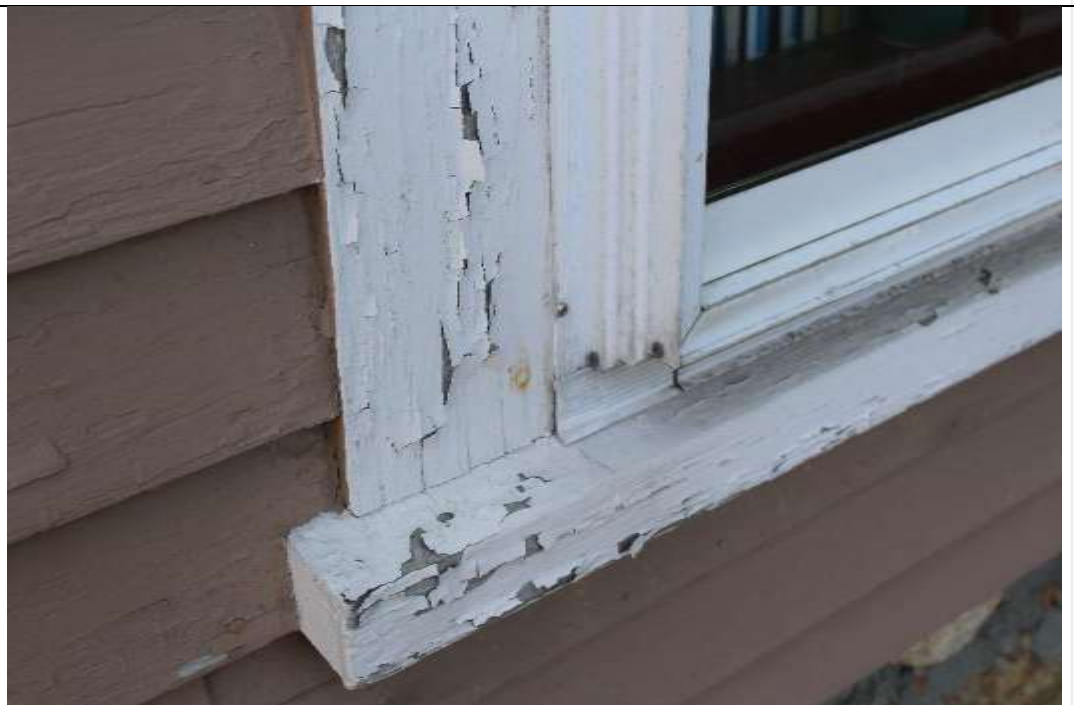
12

The siding is in good condition but the trim and window casing should be repaired and painted.

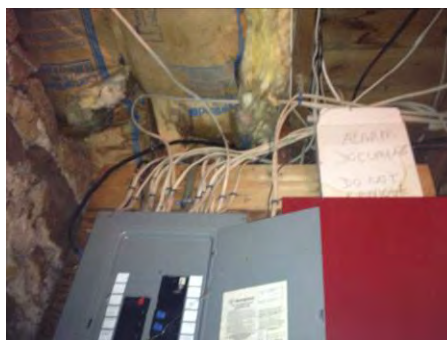
The wiring method is generally nonmetallic-sheathed cable (Romex) and in some instances runs exposed in finished spaces where it may be subject to damage and become a safety hazard. Exposed Romex needs to be replaced with concealed wiring.

*Wiring*

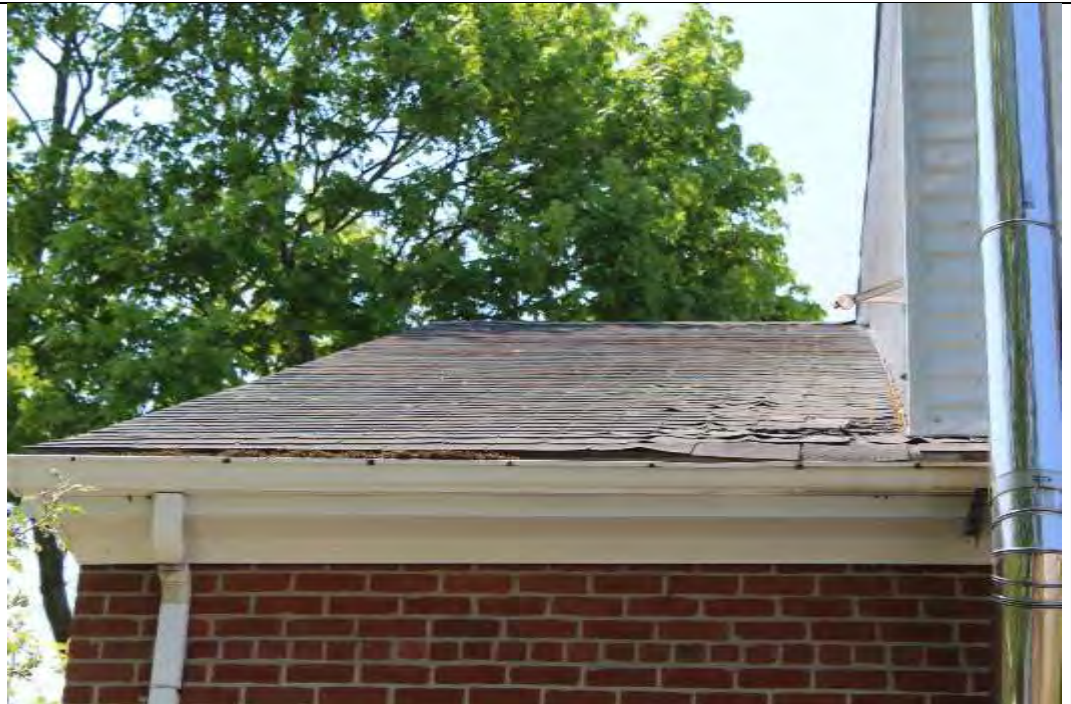
6

The asphalt shingle roof has failed and should be replaced.

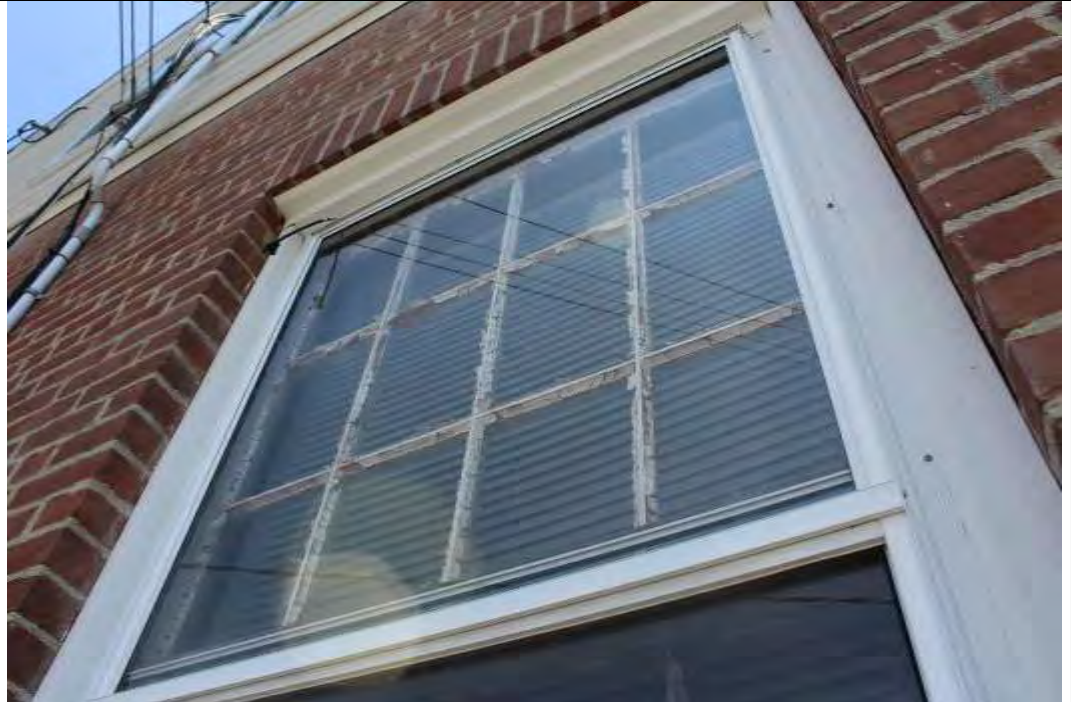
7

The existing wood double-hung windows remain and can be repaired and painted. The masonry appears to be in good condition.

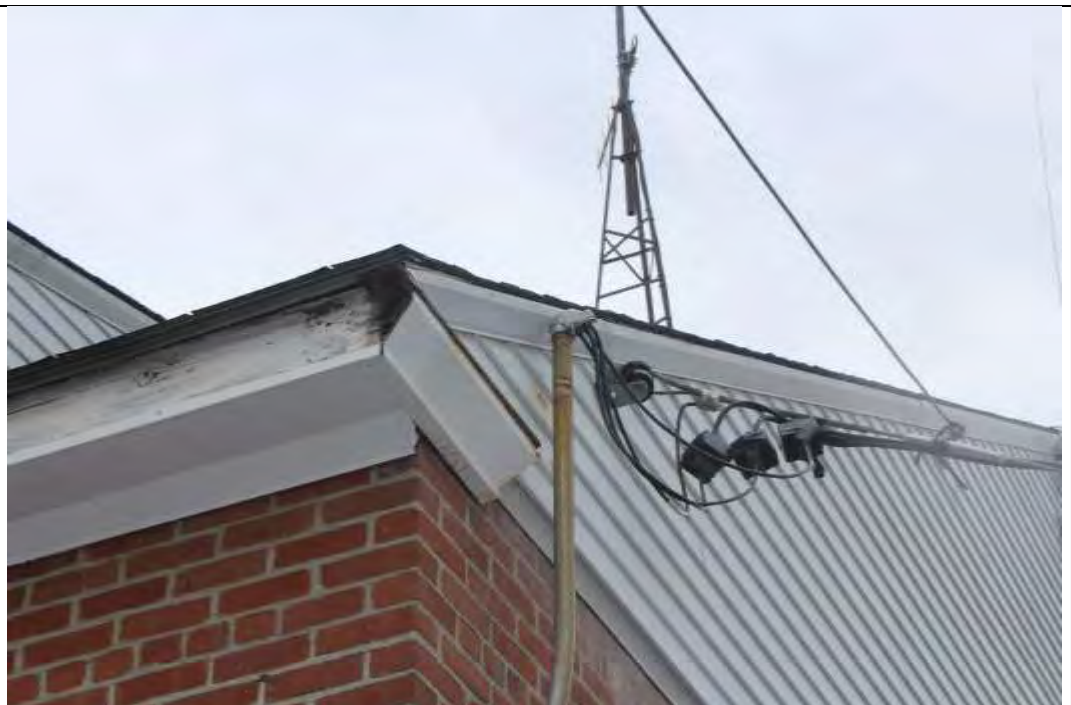
8

The gable ends and dormer walls have aluminum siding. Several trim pieces are missing.

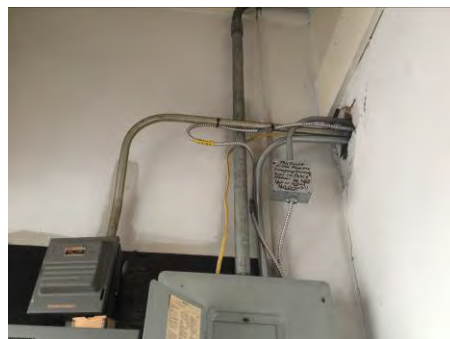
Branch circuit wiring has been added on over the years. The installation varies in quality and type. Both MC cable and NM sheathed cable “Romex” have been used. Romex is not code compliant in commercial installations. Lack of receptacles results in the use of extension cords and plug strips. Most wiring has been installed exposed and some MC and Romex are subject to physical damage.

*Wiring*

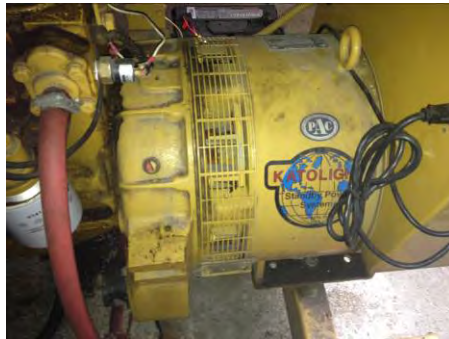
The facility is equipped with a Katolight natural gas fired interior pad mounted generator. The generator is in poor condition, and is undersized. It feeds an ASCO automatic transfer switch that serves an emergency panel. No exterior emergency egress lighting was noted during the field visit.

*Generator*

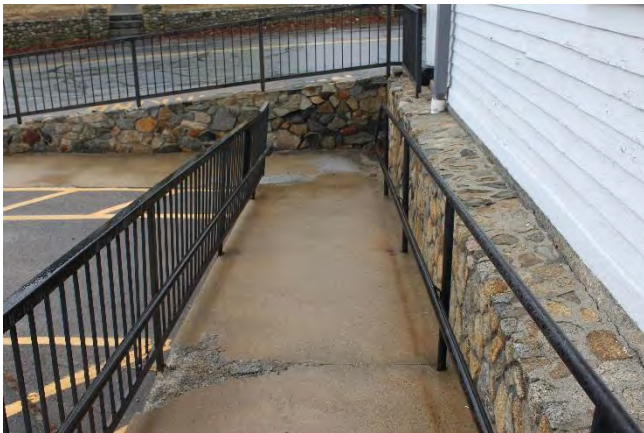
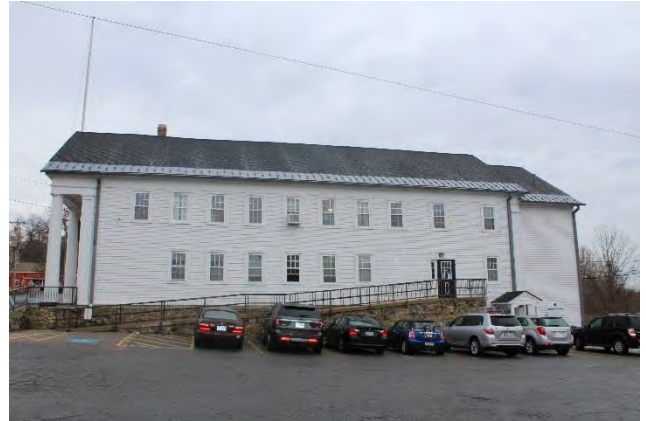
**FIGURE 11 & 12:** East ramp to Town Hall

Upgrades for handicap accessibility may be required. The sidewalks and pedestrian ramps generally do not appear to meet the most recent ADA requirements for slope configuration. The asphalt pavement walkway leading to the Town Hall entrance is cracked and in need of repair. Both handicap accessible ramps are cracked and in need of repair. The hand railings that are part of the east ramp also look to be deteriorating and may need to be replaced. No pedestrian ramp tactile strips were observed at the site. Additional pedestrian crosswalks are needed.
