THE COMMONWEALTH OF MASSACHUSETTS
DEPARTMENT OF LABOR
DIVISION OF OCCUPATIONAL SAFETY
OCCUPATIONAL HYGIENE / INDOOR AIR QUALITY PROGRAM
www.mass.gov/dos/iaq

MA DOS File No. 06S-0155

On Tuesday, December 27, 2005 the Division of Occupational Safety ("DOS") visited the Mendon Fire Department-Headquarters located at 24 Main Street in Mendon, MA as a result of a call received by our office asking for technical assistance on diesel combustion gas issues. Pursuant to Mass. Gen. L. Ch. 149, section 6, DOS is charged with enforcing health standards at all county and municipal workplaces. This report contains a summary of DOS' findings from that visit as well as recommendation and requirements for corrective actions that must be taken. DOS has based the analysis contained in this report on State regulations and other relevant governmental and industry health and safety standards.

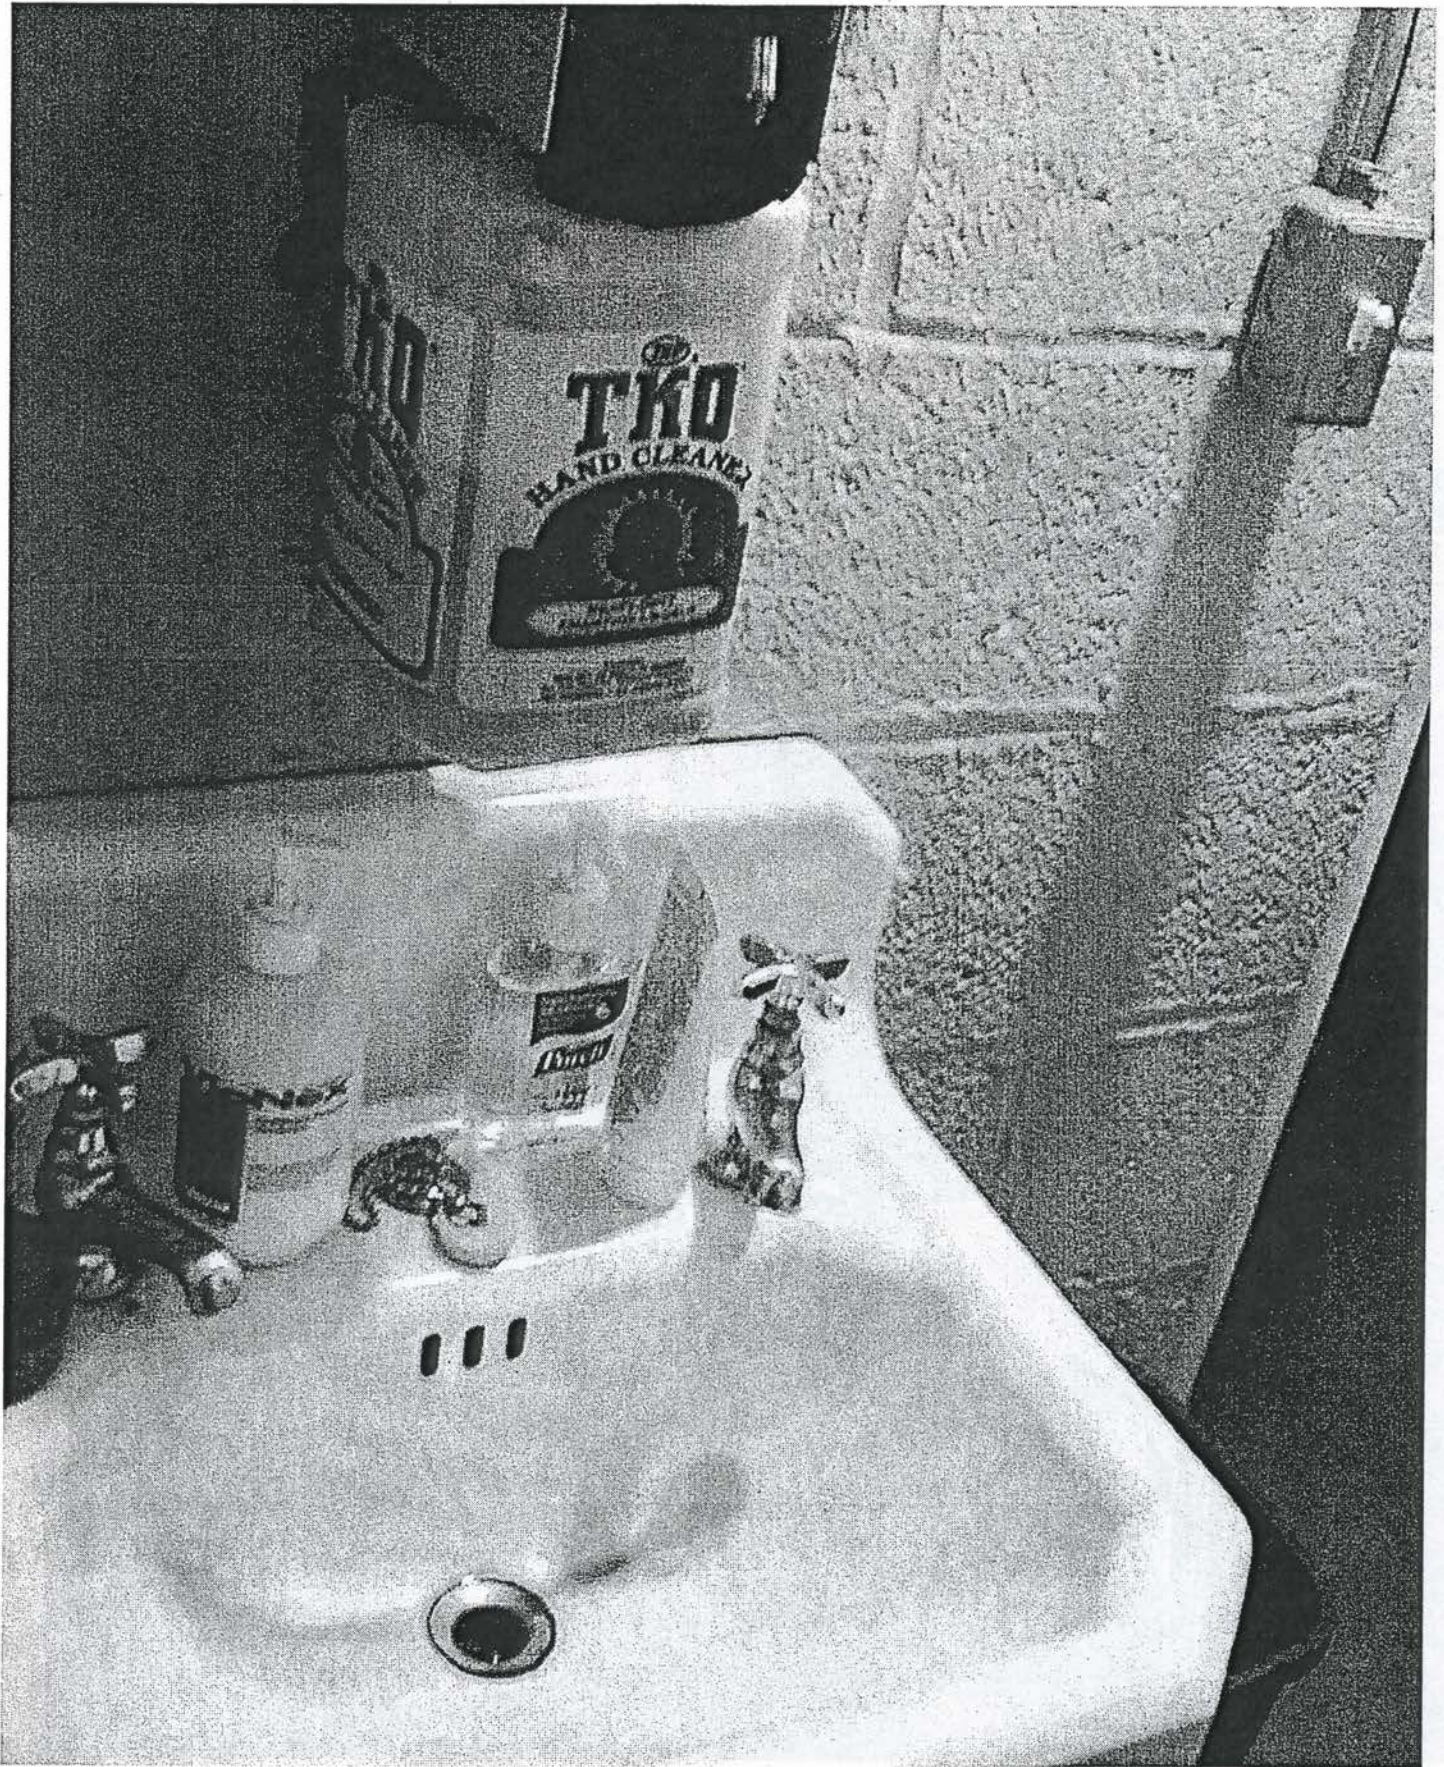
GFCI Protection in Bathroom-I asked the employees on the day of the visit if anyone knew if the electrical service in the bathroom was protected by GFCI protection. No one could provide an answer to this question.

One bathroom sink in one bathroom used by all building occupants. No information if electrical service is GFCI protected.

It is important to investigate whether there is GFCI protection in the bathroom for the building. GFCI's must be used in all wet/damp locations to minimize the potential for electrocution. (item 015)

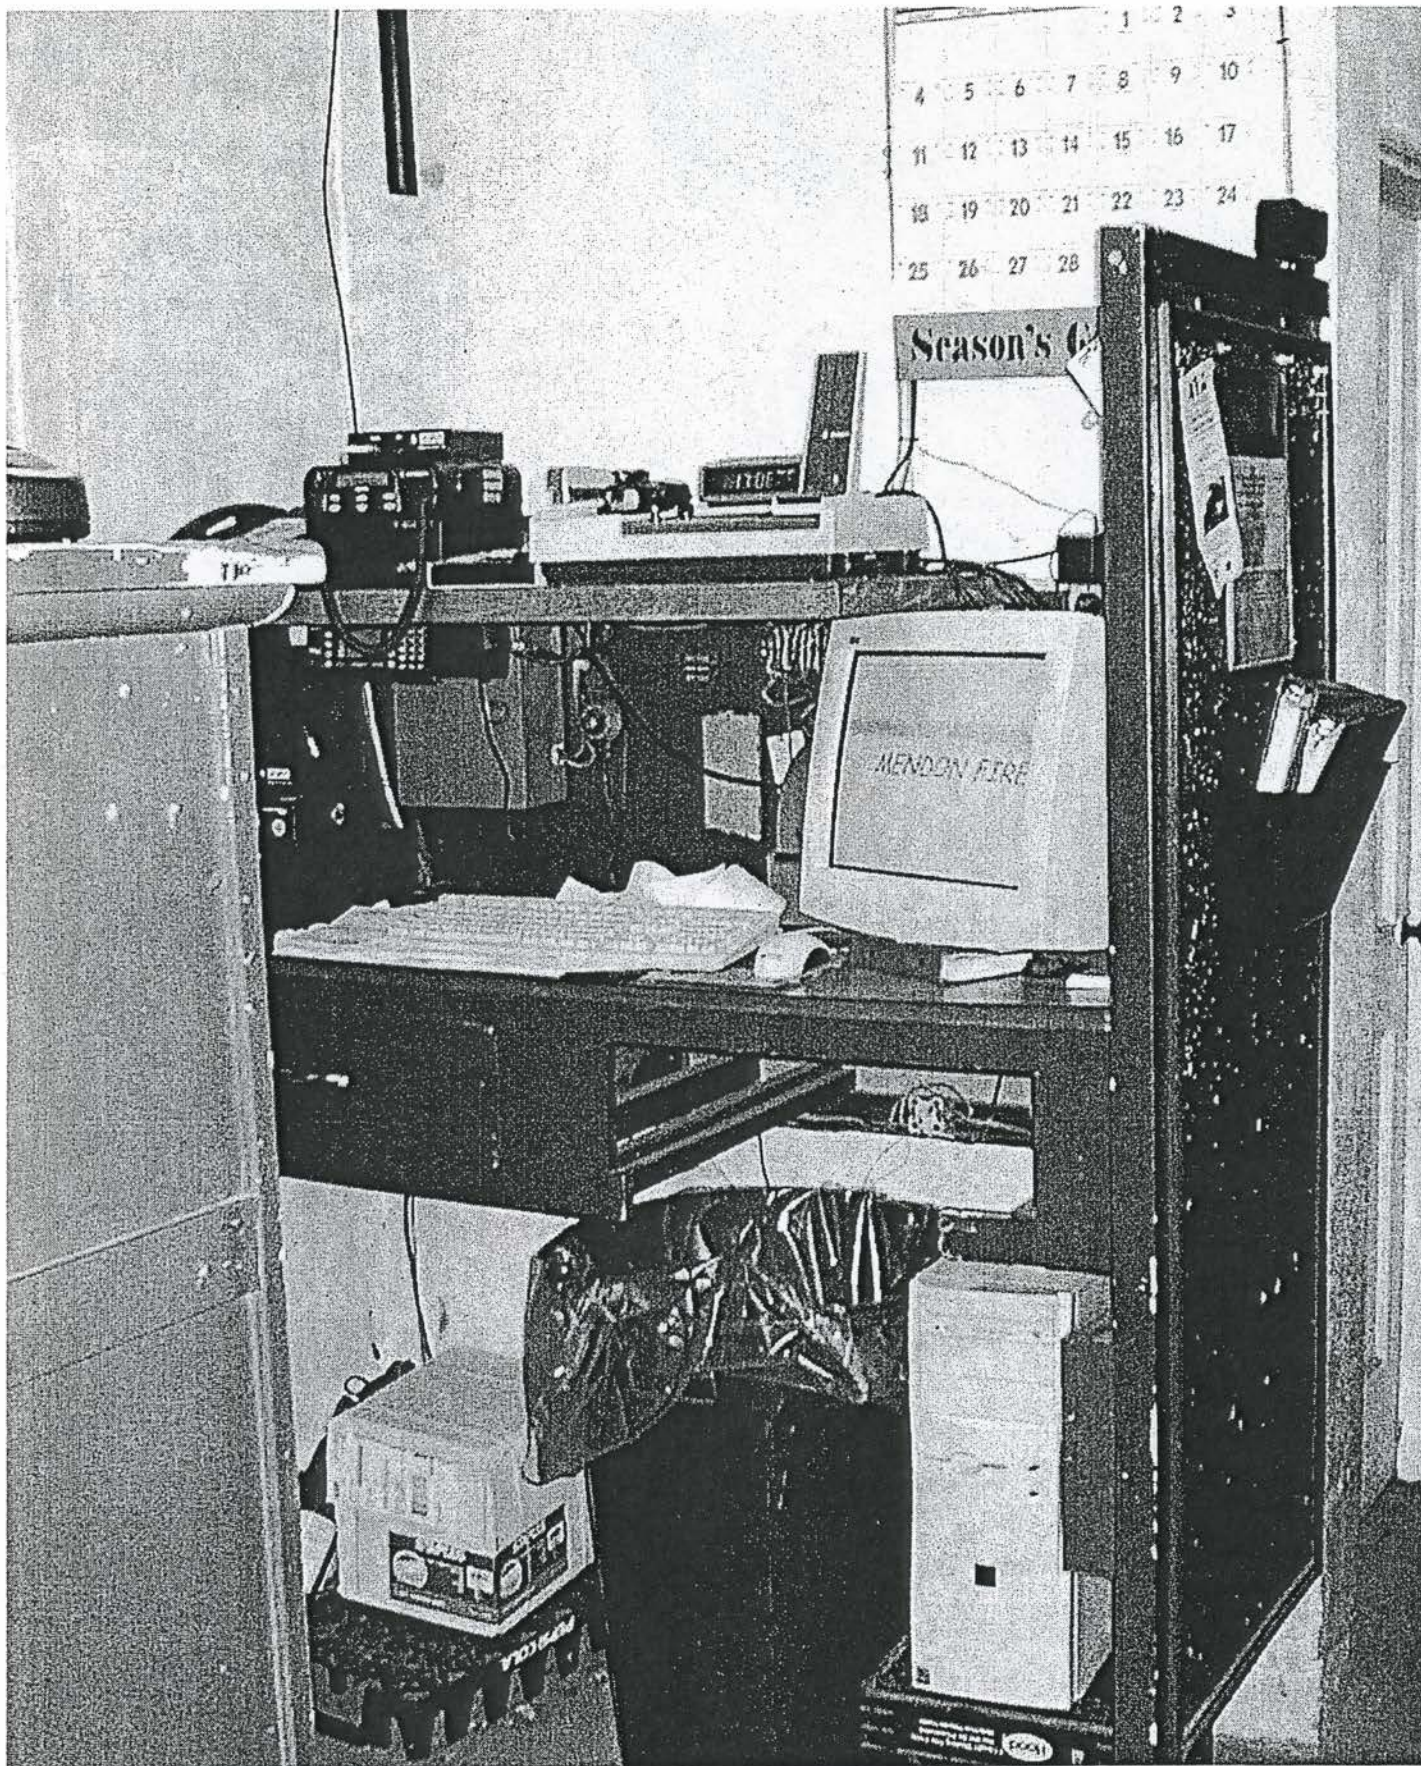
Open desk/computer area for report writing on apparatus floor.

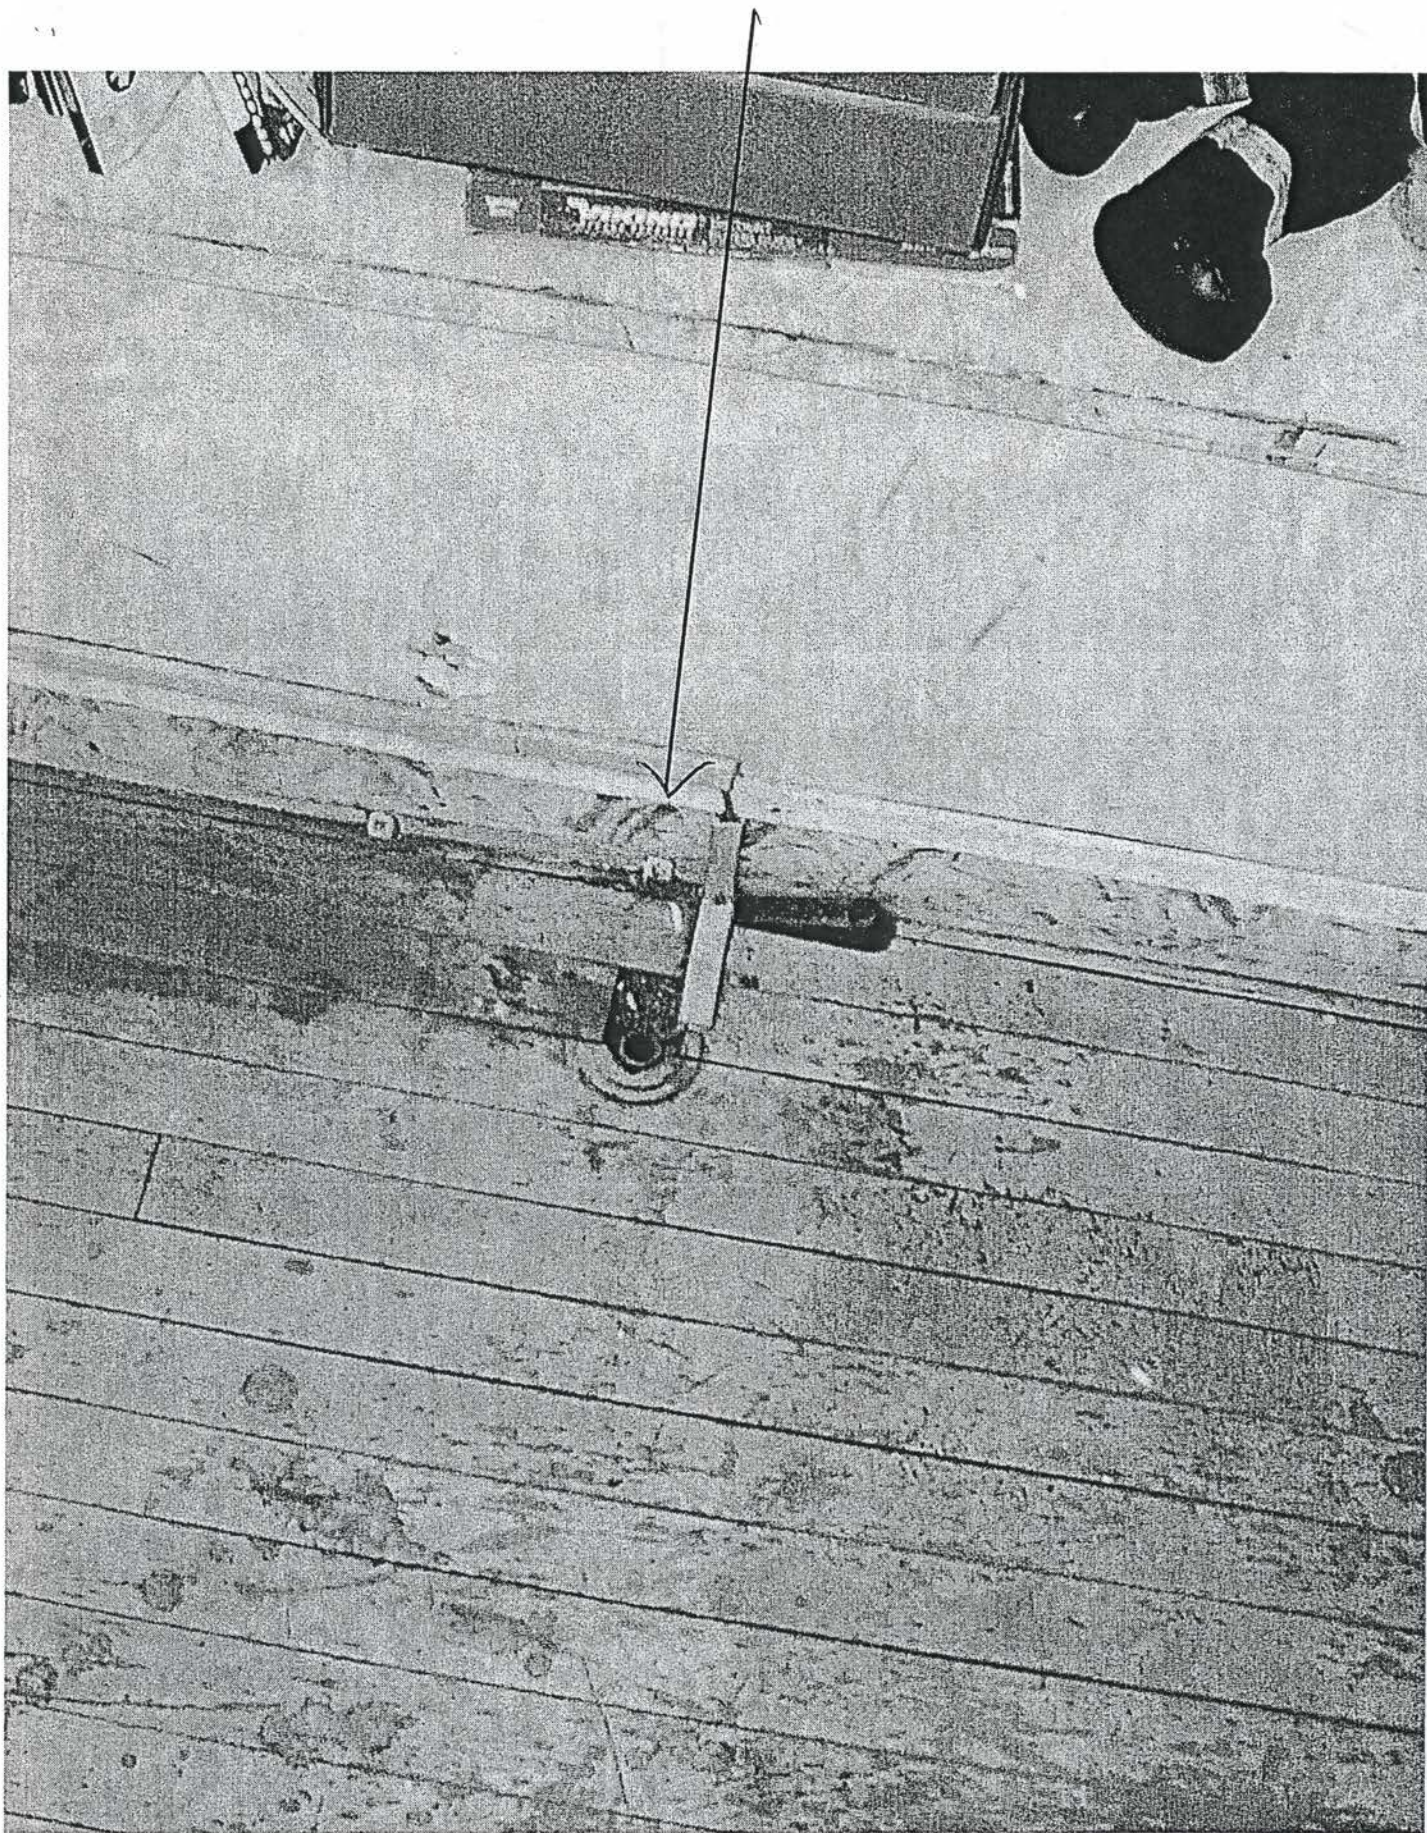
A third modification to the building that is needed is for all of the former heating pipes, that have been sheared off, to be sealed along the floor interface on the second floor level. This will help prevent combustion gases and particles from entering the second floor area. (item 003) Also, this issue has always been addressed in the MA Building Code under the Hazardous Ventilation provisions. Therefore, it is important that this problem be remediated as soon as possible.

Former pipe chase, 2nd floor area of station, appears to be from a steam heat or forced hot water system that had served the building

Corrective Action Needed: Seal the former heating pipes that have been sheared off at the floor level on the second floor of the building. The pipes should be rendered gas tight to prevent exhaust gases from entering the second floor.

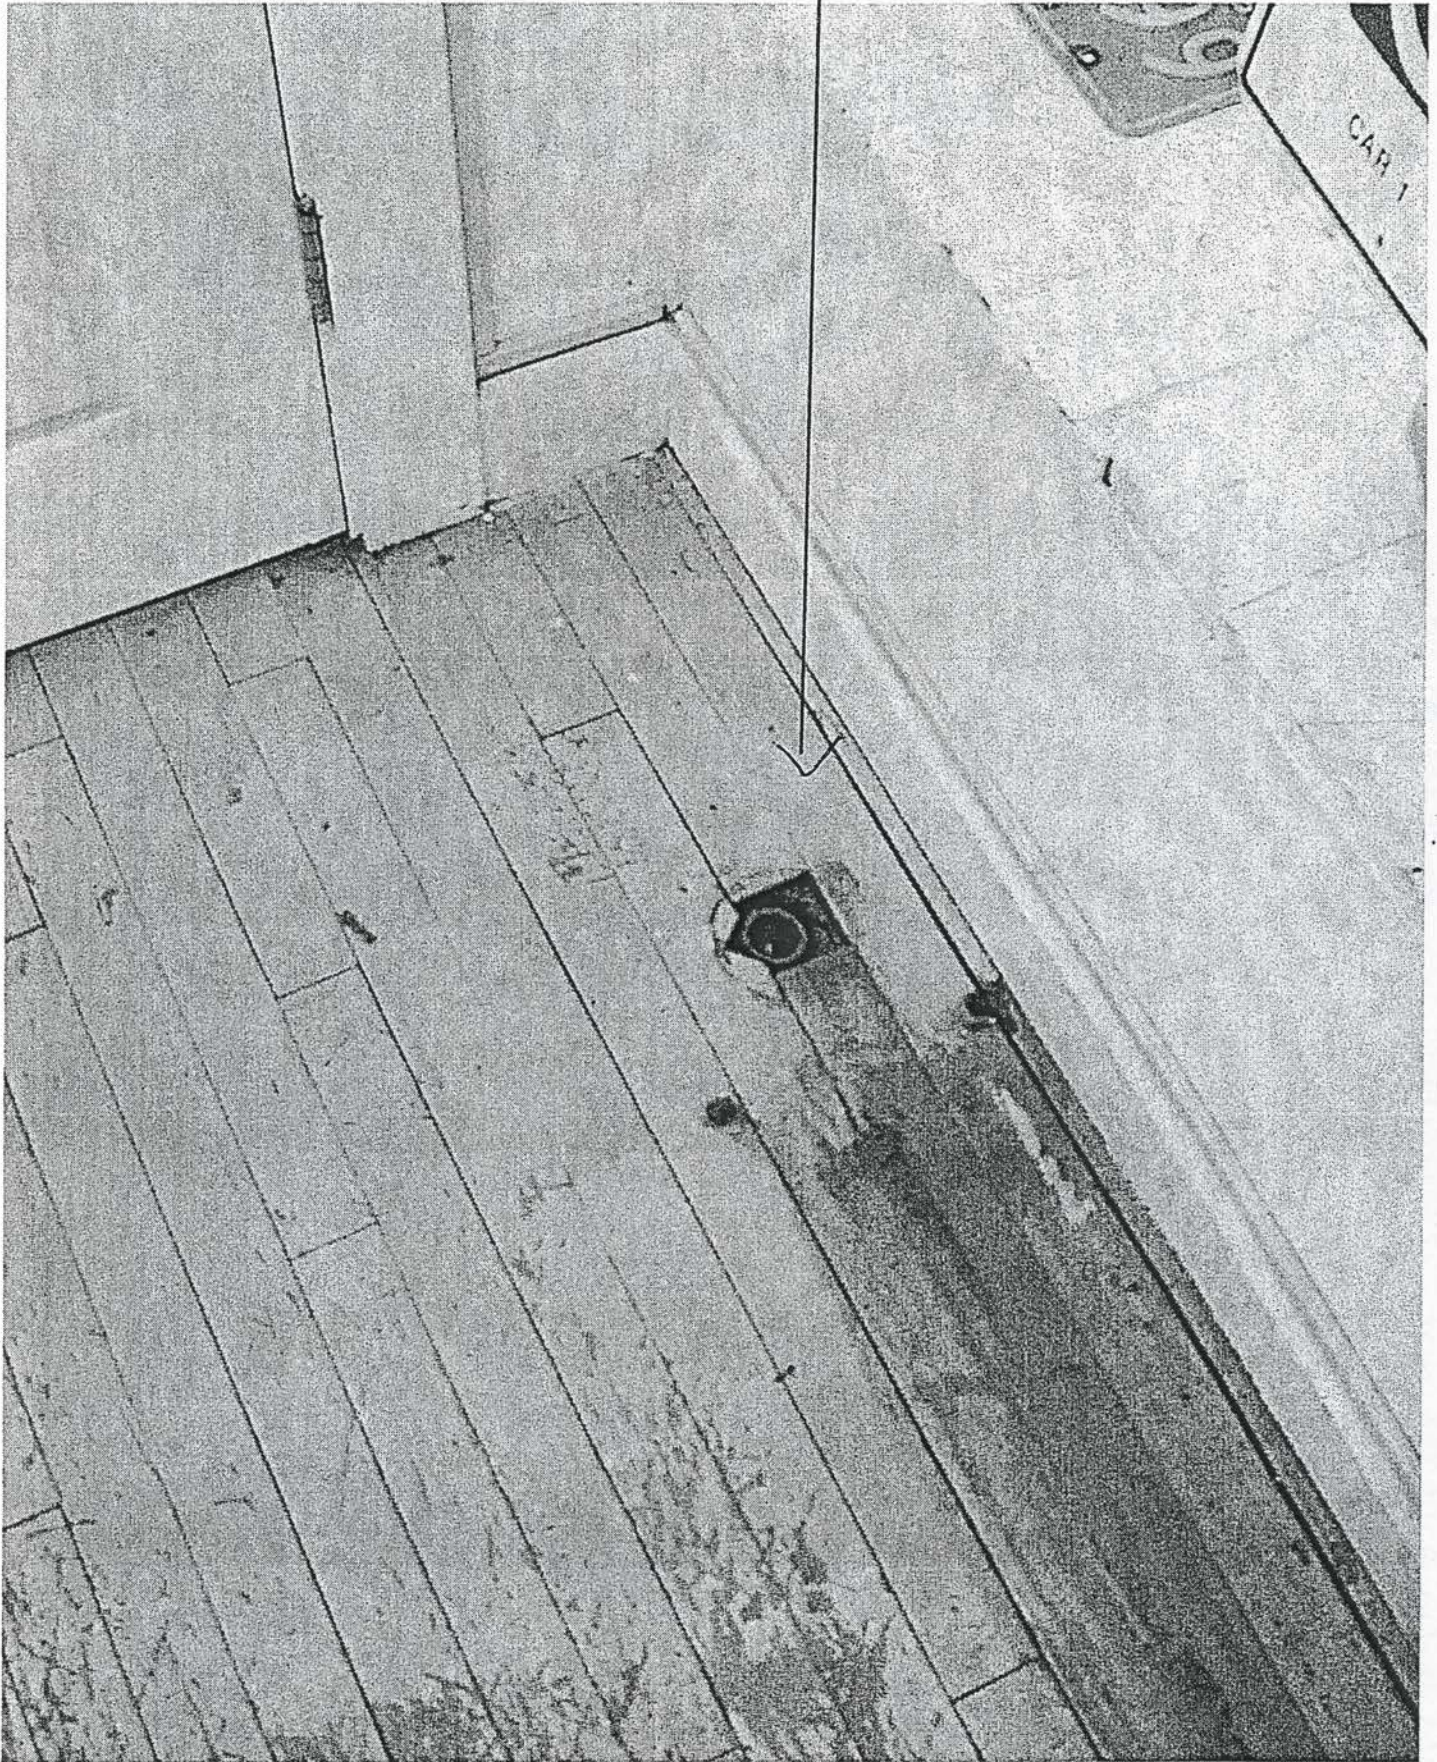
Another open pipe chase on 2nd floor

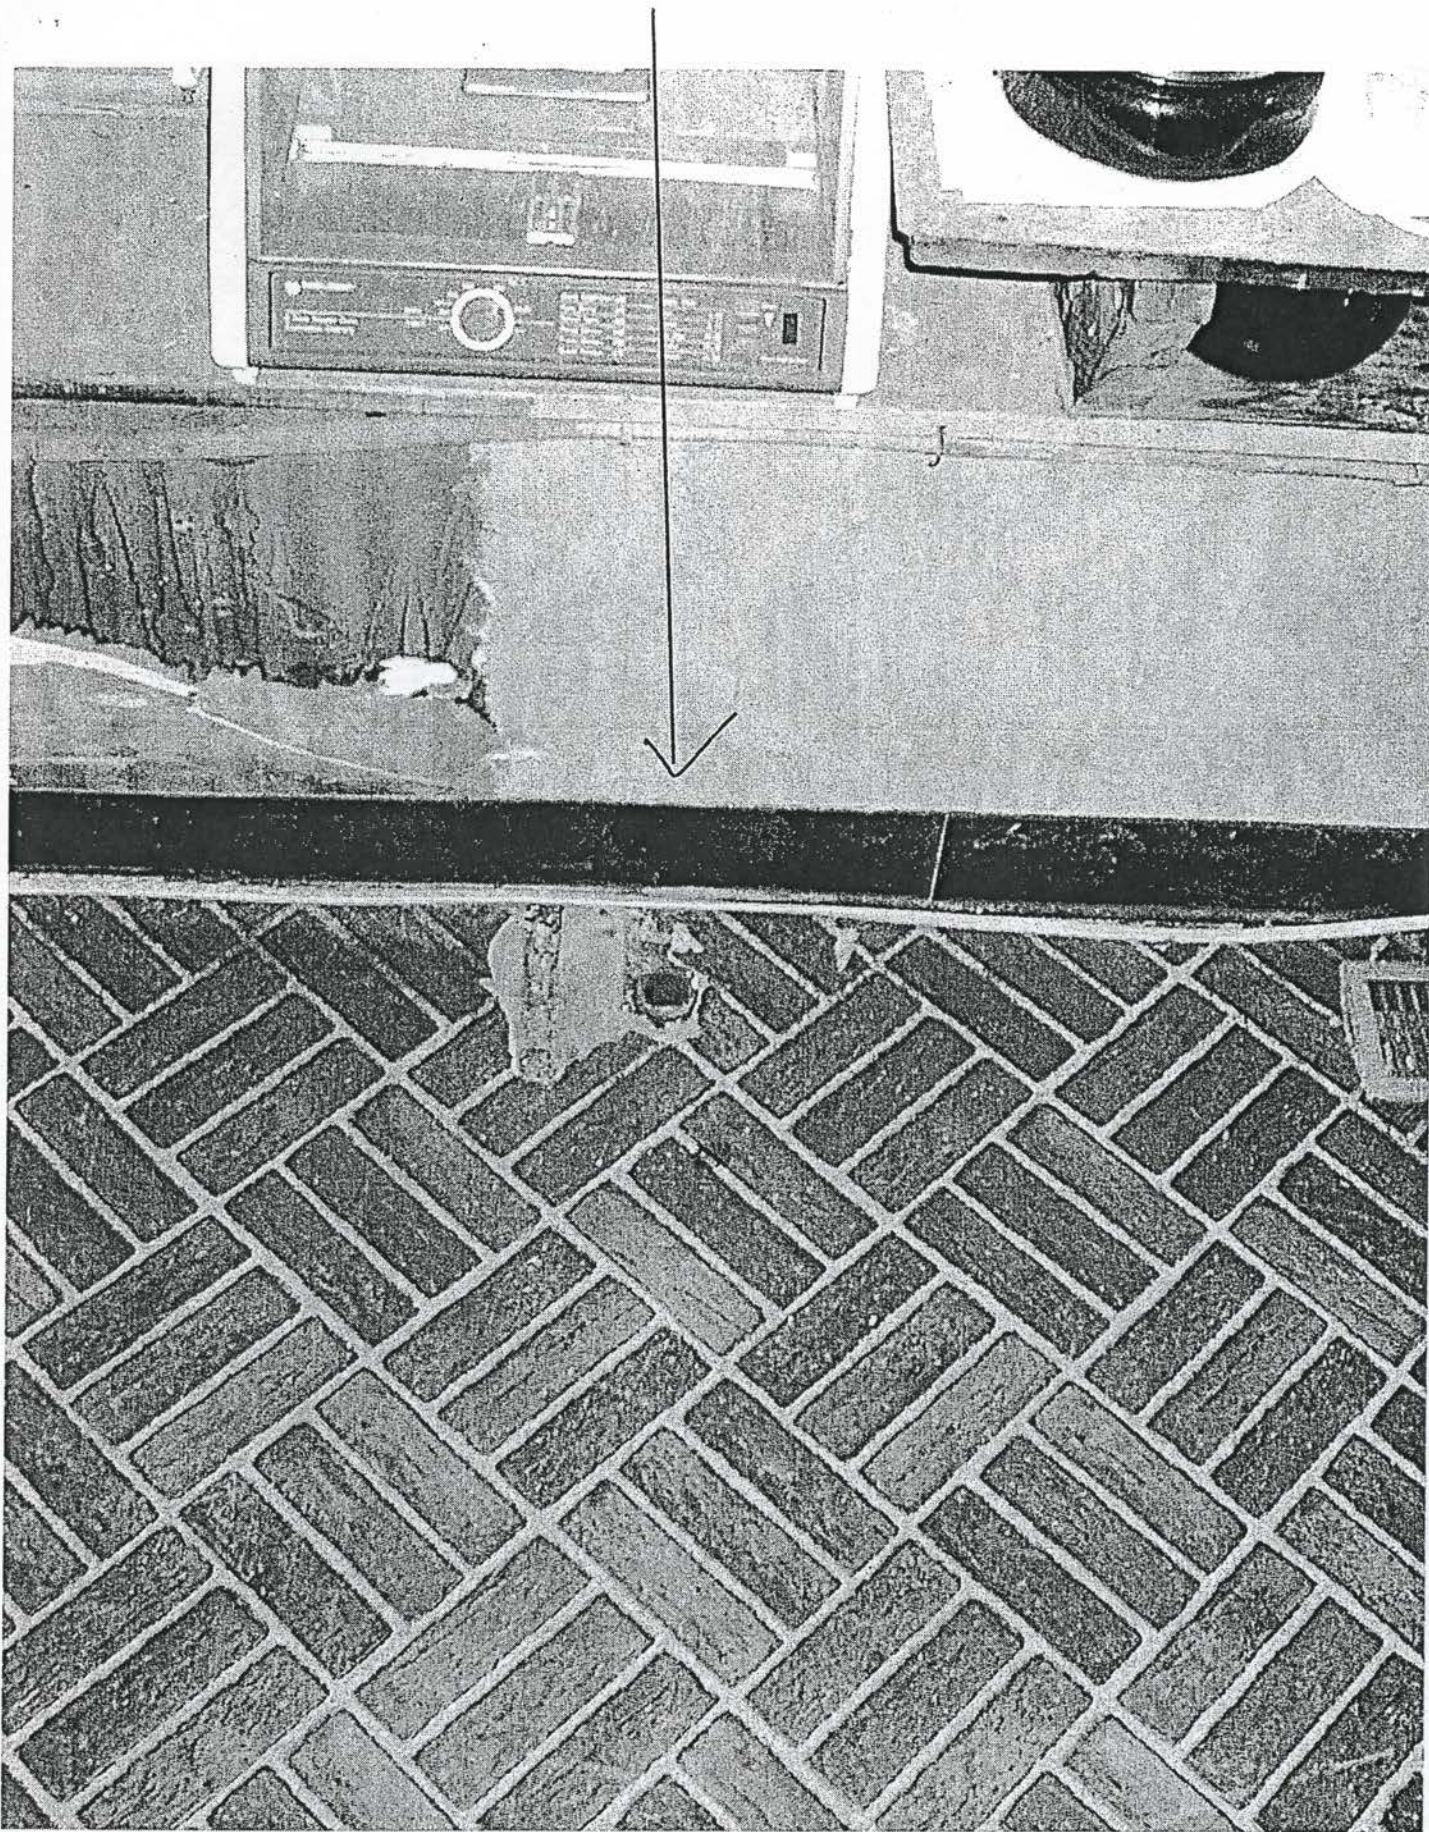
Pipe chase, 2nd floor

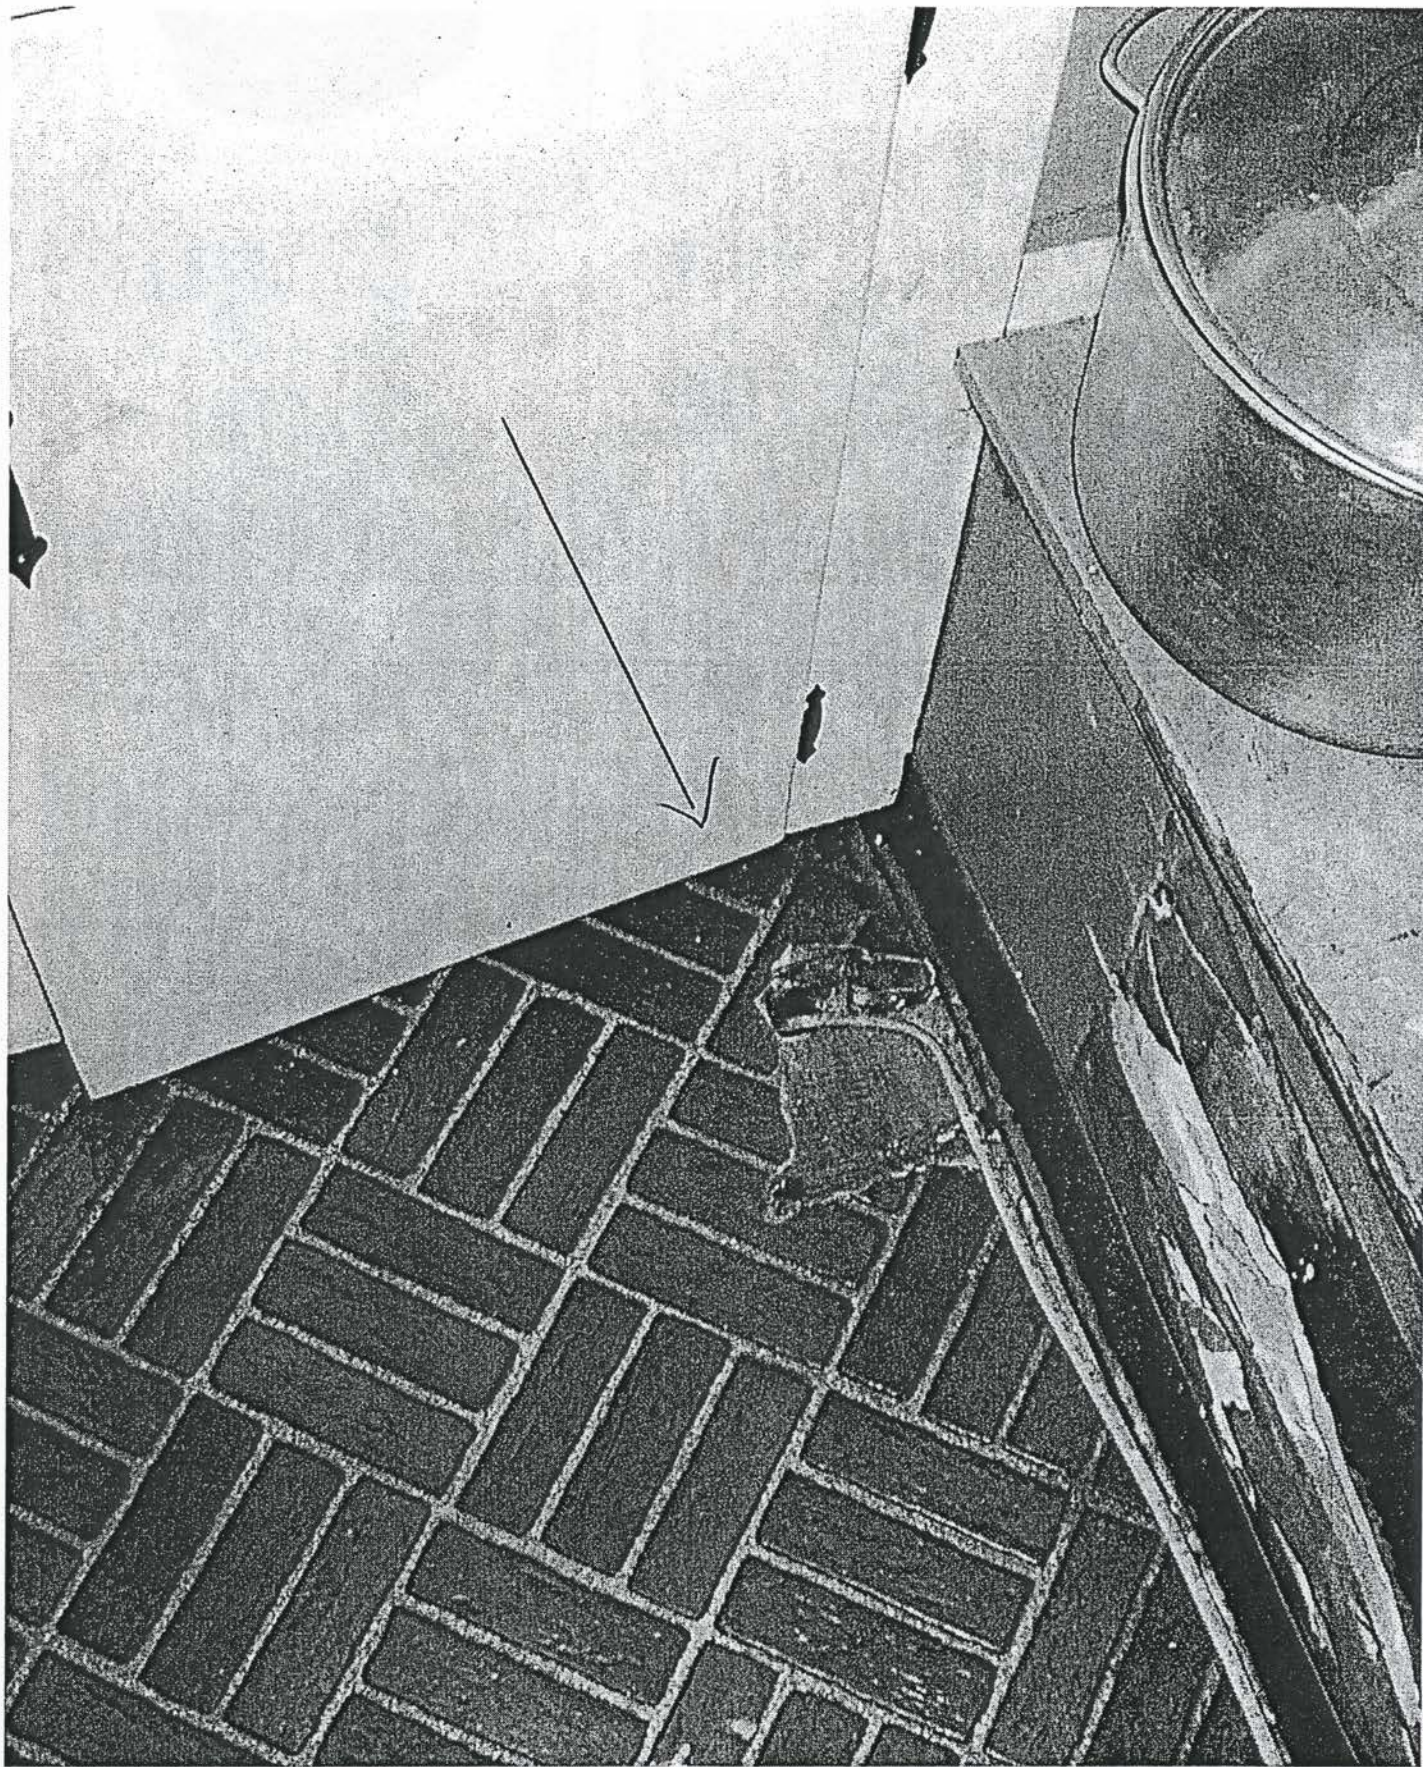
Open pipe chase, 2nd floor

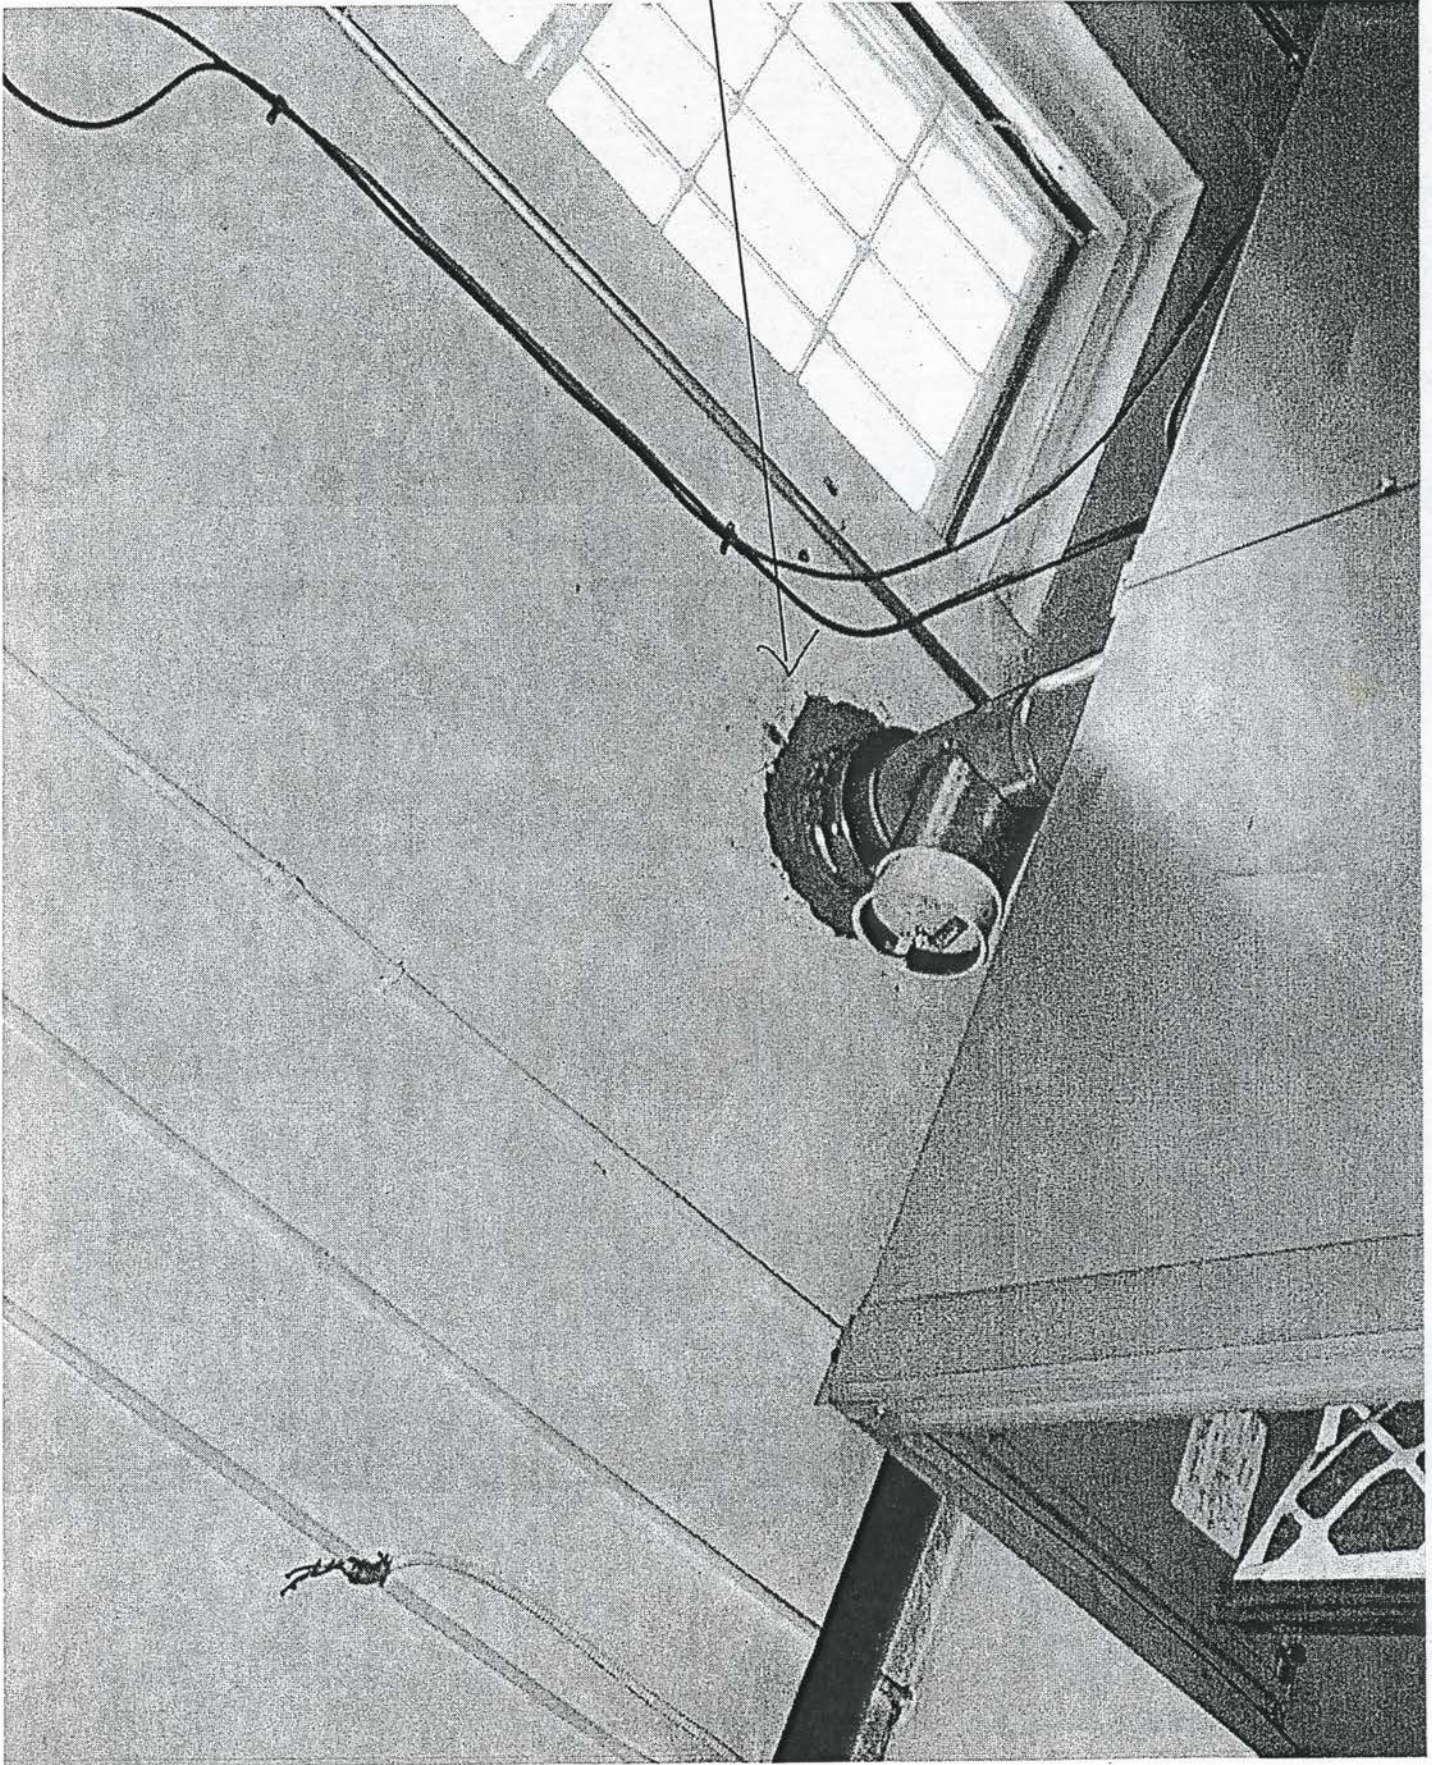
Another issue that should be revisited is the intake for the forced hot air furnace that serves the second floor. At this time, it appears that the furnace is drawing its air from the apparatus floor. This air is then heated and delivered to the second floor, occupied area of the building. I recommend that you consult with a commercial heating contractor and the Mendon Building Inspector to determine if this is problem and whether or not it needs to be remediated. (item 004) Also, the local building inspector for Mendon may determine that this also is another "hazardous ventilation" issue that is referenced in the MA Building Code, 780 CMR.

Intake for forced hot air system, apparatus floor

Corrective Action Needed: Work with a qualified heating contractor to determine if the air being drawn into the furnace can be drawn from the apparatus floor and if the current configuration for make up air is acceptable. Report back to this office with your heating contractor's findings.
