MacLeod Consulting, Inc.

May 13, 2008

Re: Structural Condition Survey
Mendon Town Hall Roof

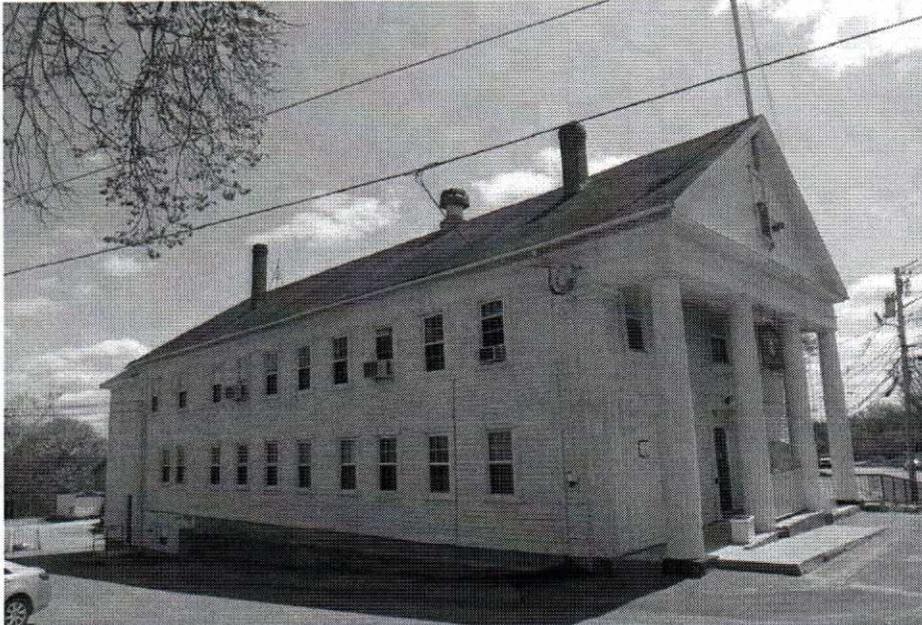
Viewed from the ground, sags between trusses are evident in the c.1840 construction. The c.1900 and c.2000 roofs are not sagging. One large sag at the truss immediately east of the west chimney is readily apparent. See photos 1 and 2.

1. Mendon Town Hall viewed from the northwest. The 20th Century ventilator is abandoned. Sags from trusses and purlin displacements create shadows in the roof.

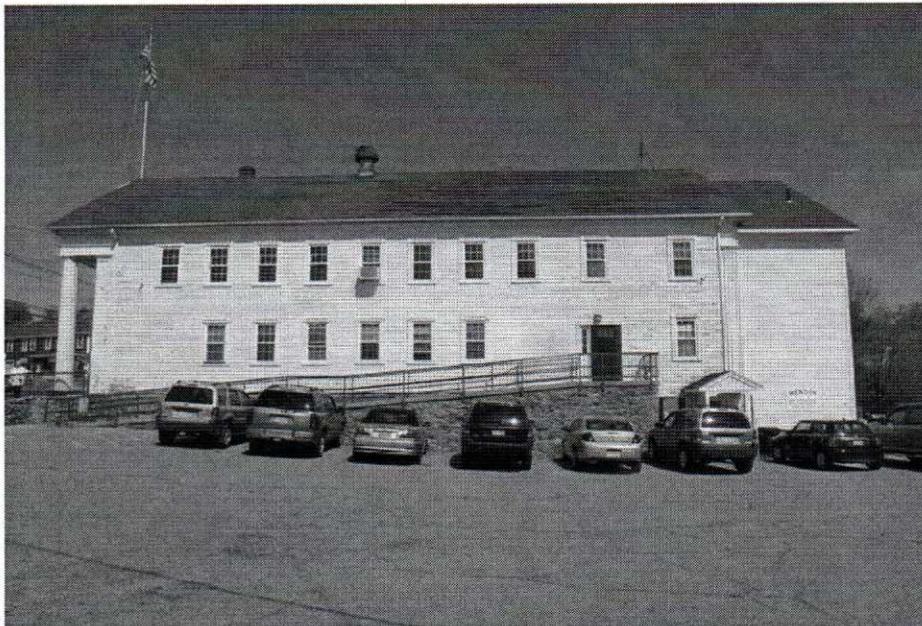
Roofing. The roof shingles are heavily worn. Granules in the asphalt have completely worn off large areas of the south slope.

2. Mendon Town Hall viewed from the south. Sags are evident in roof. Shingles are worn beyond service.

The roofing needs to be stripped and replaced with a new complete roofing system which includes replacing decayed board sheathing, plywood sheathing recovery, ice and water membrane, underlayment felts, and shingles. Include chimney flashing.

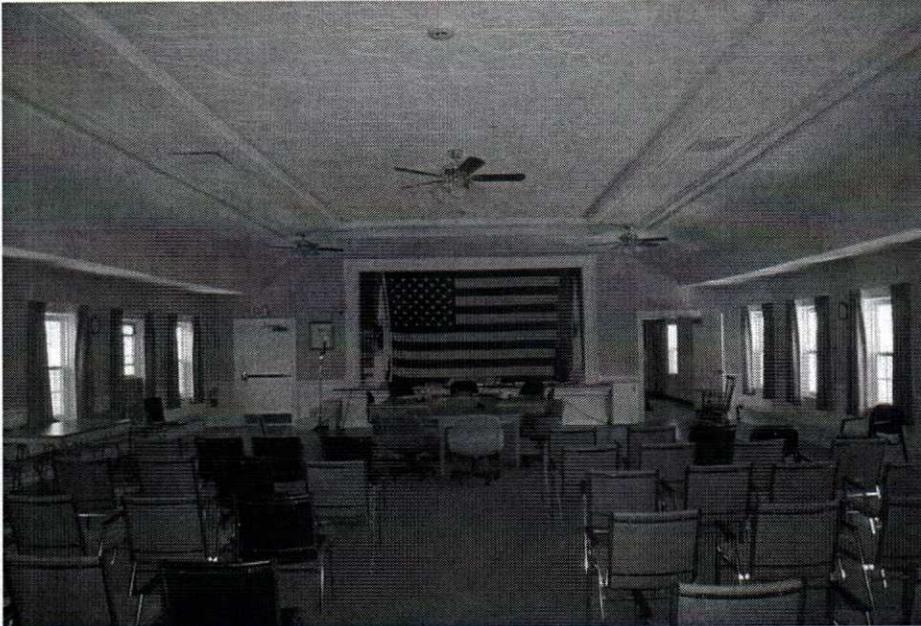
Meeting Hall Ceiling. The ceiling in the second floor Meeting Hall at the northwest corner is displaced several inches. This is directly under the large sag in the roof next to the west chimney. See photos 3 and 4.

3. Second floor Meeting Hall viewed from west (entry). The proscenium marks the joint between the c.1840 and c.1900 construction.

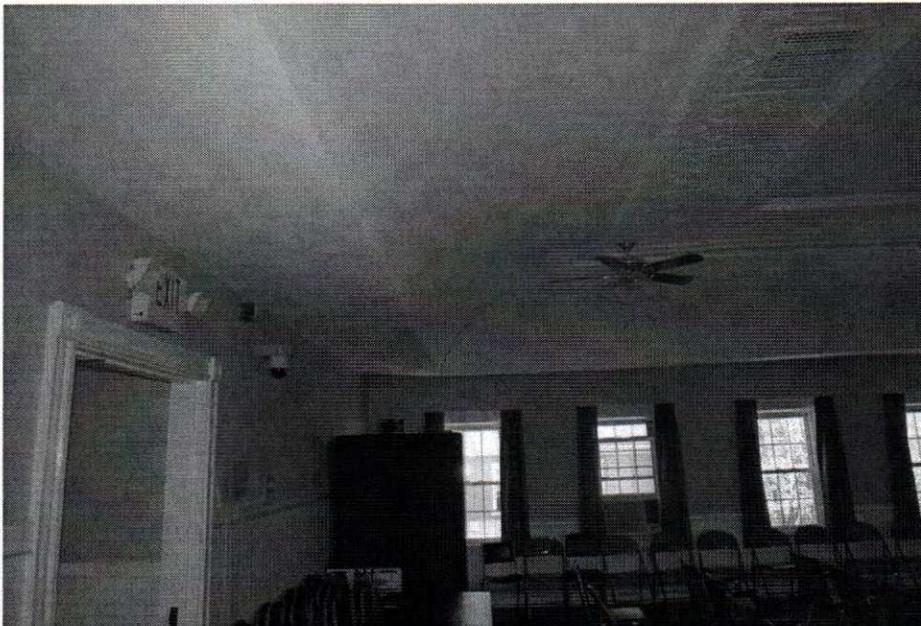
4. The northwest corner of the Meeting Hall viewed from the south. Note the displaced soffit, which is under a failed truss.

Ceiling. The ceilings need resupport possibly hanging directly from the purlins, reconnecting the headers, and checking framing under the catwalks.

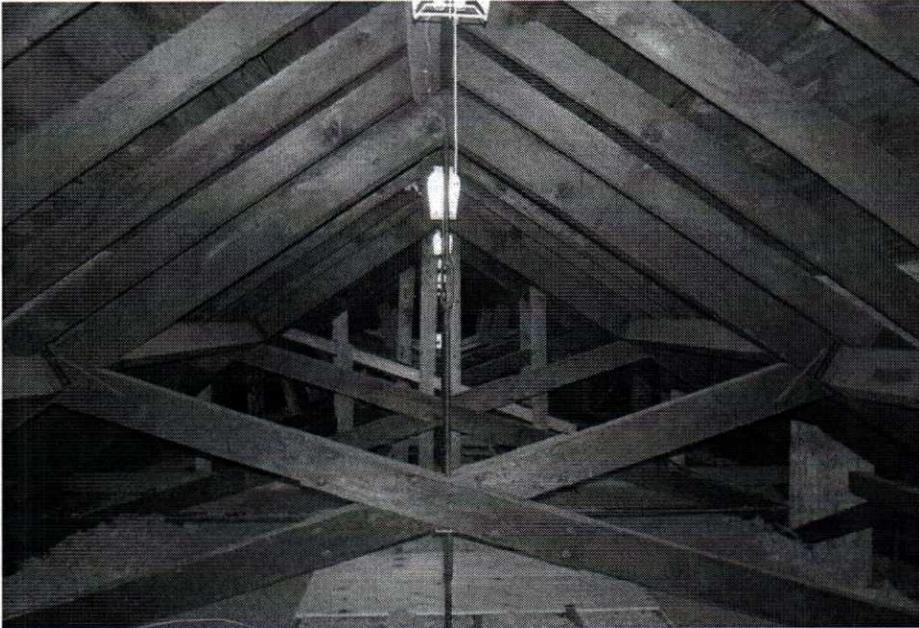
Trusses. Trusses in the c.1900 construction are in good condition. See photos 5, 6, and 7. They show no signs of distress. One tie rod fastener in the westernmost c.1900 trusses is loose on the south end. At the truss immediately east of the west chimney on the north end, a crack is evident in the shear key of the bottom chord. The stair provides a good viewing angle of this condition.

5. Roof trusses viewed from the east end of the attic at the wall separating the c.1900 from the c.2000 construction. The two trusses, purlins, and rafters in the foreground c.1900 are in good condition.

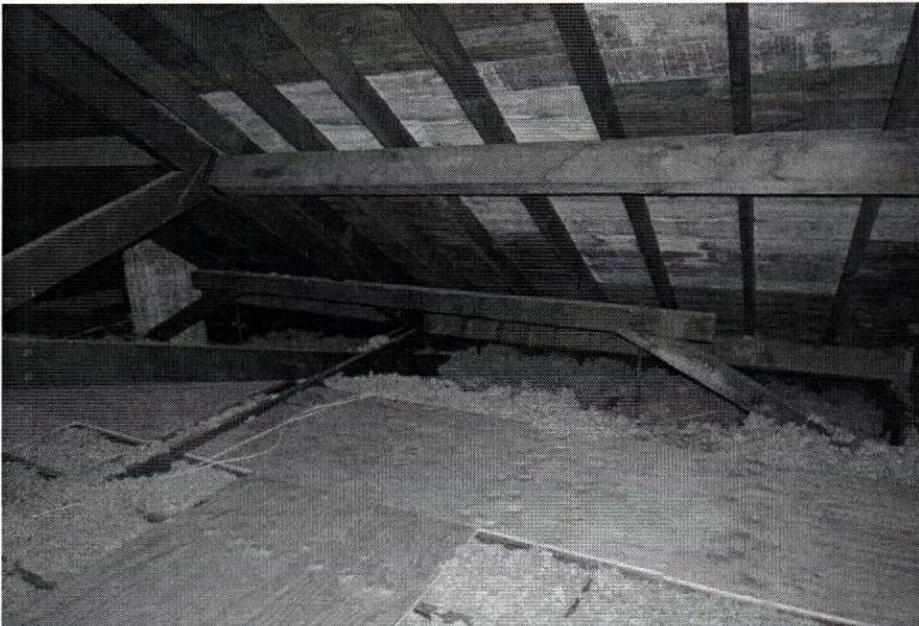
6. Purlin in the c.1900 construction is well supported on steel stirrups. It is oriented in the strong direction. A ceiling truss several feet from the outside wall is on each side of the c.1900 stage. Recent renovations below conceal the purpose of these trusses.

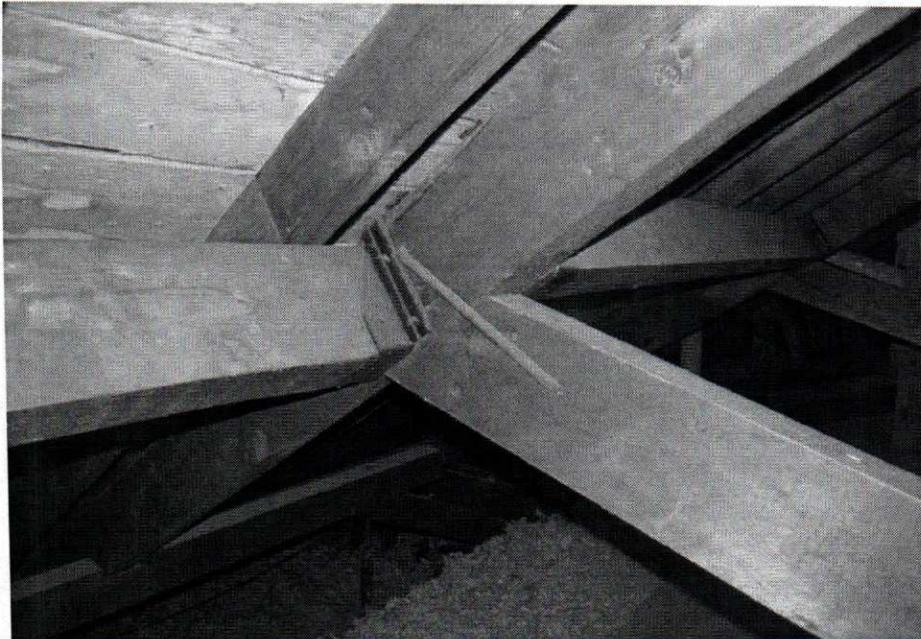
7. Close-up view of c.1900 truss joint showing steel hardware. Joint is tight and shows no signs of distress.

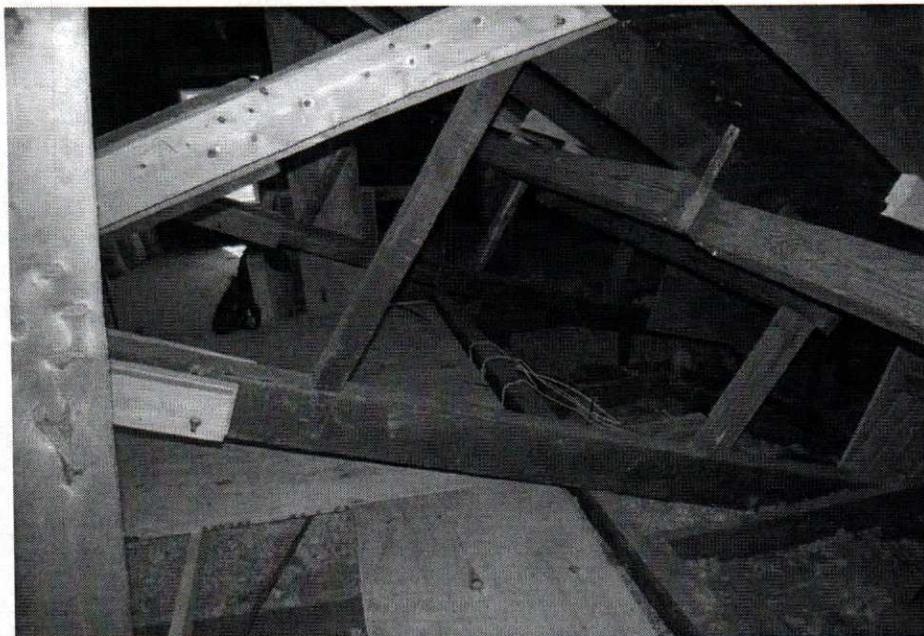
The c.1840 trusses have varied construction. One is a gable truss at the west end of the attic. The remaining five are scissor trusses so as to vault over the Meeting Hall. Within each of these five trusses the member layout varies. Some elements are incomplete. Some are heavily cracked. Some components have been removed and replaced with temporary stabilization repairs. See photos 8, 9, and 10.

Trusses. The shear key in the truss heels are traditional joinery. These are undersized in the c.1840 construction. The joinery for the c.1840 trusses are highly stressed. Analysis indicates they need to be strengthened. Supplementing the members by sistering LVL's will provide the needed strength. Attached to the end of this report is an analysis sheet illustrating a summary of stress index values for the typical strengthened scissor truss. Any value one or less means the member or component is within acceptable stresses at full loading.

8. Circa 1840 trusses at the west end of the attic viewed from the east on the north side. The new wood members are recent repairs made to stabilize the framing.

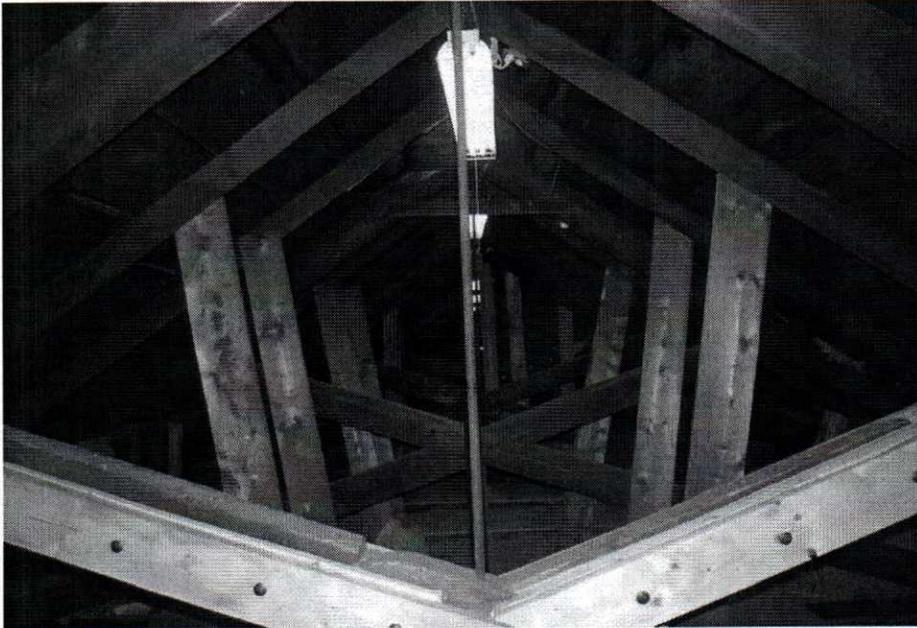
9. Center area of c.1840 trusses viewed from the west. Board hangers fastened to rafters support the Meeting Hall ceiling.

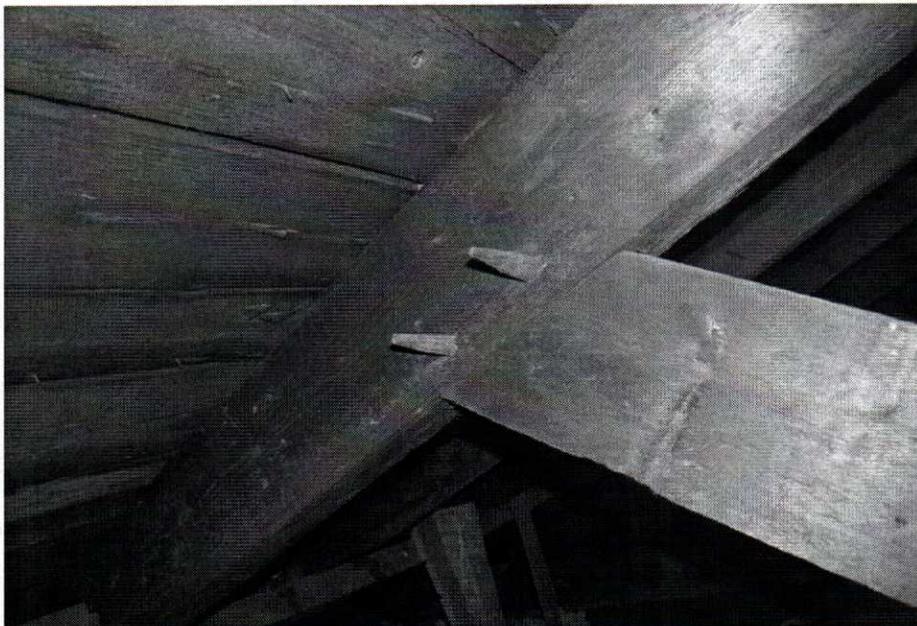
10. Close-up view of c.1840 truss joint showing traditional joinery where treenails fasten tenons to mortises.

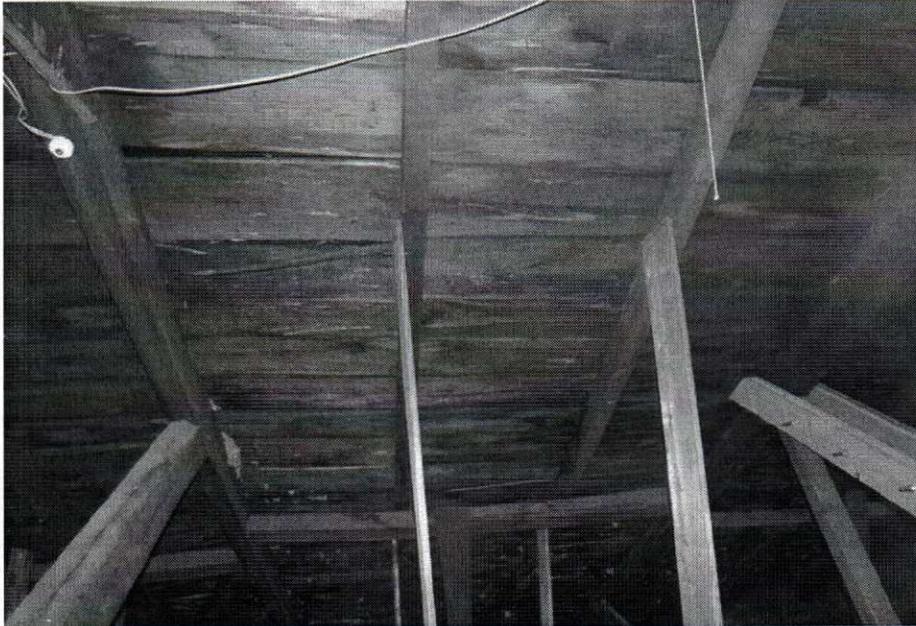
Purlins. Purlins in the c.1900 construction are adequately sized and fastened. In the c.1840 construction most of the purlins are oriented with the wide face upward, the weak direction. Those purlins in the weak orientation are sagging several inches. See photos 11 and 12.

Purlins. Orienting the purlins in their weak direction has cut their strength in half and their stiffness by six. Rotating the purlins 90 degrees will allow them to adequately carry the roof.

11. Rafters and purlins in c.1840 construction viewed from the north. Purlins are oriented in weak direction. Note they are displaced several inches.

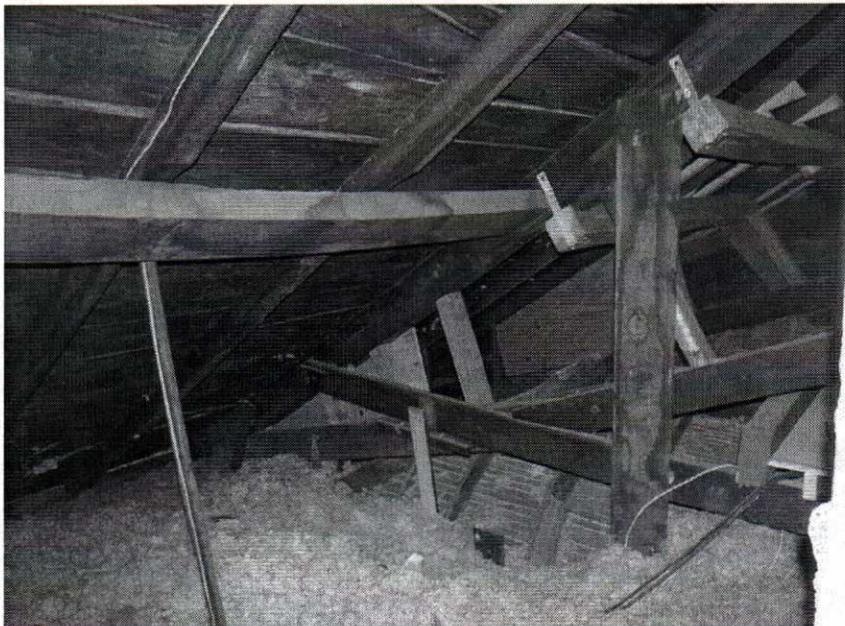
12. Closer view of purlin in c.1840 construction. Two purlins in background replaced a broken purlin.

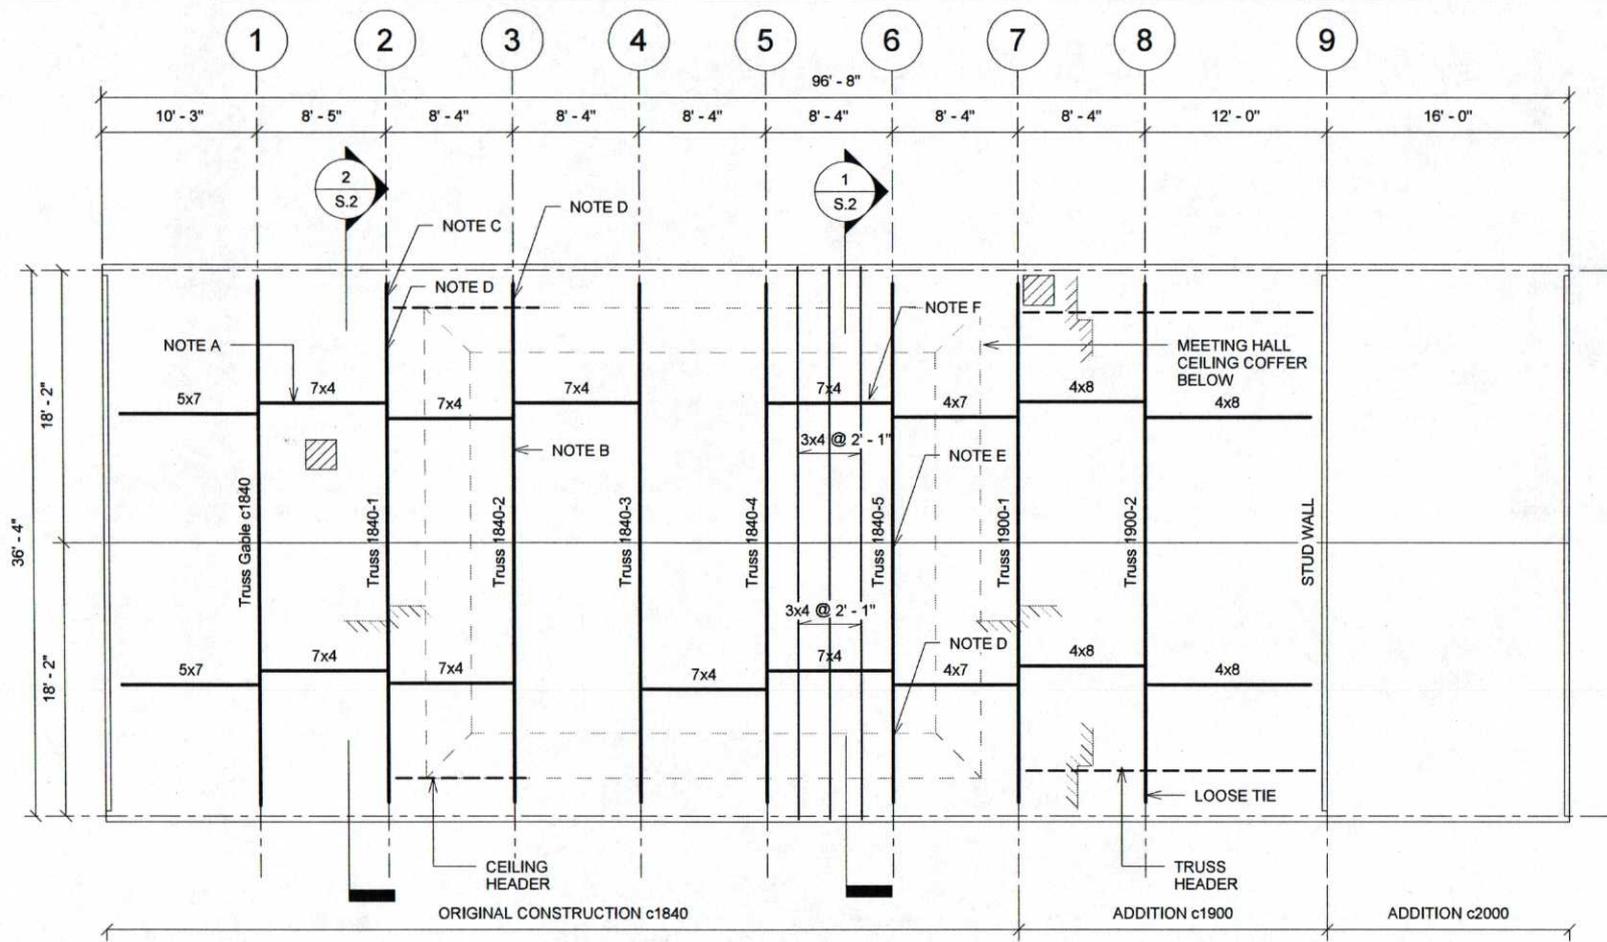
① **Roof Plan Existing Conditions**
1/8" = 1'-0"

NOTE A: PURLINS NOTED 7x4 INDICATE WIDE FACE UP, WEAK POSITION.

NOTE B: TRUSSES ON LINES 2, 3, 4, 5, AND 6 ARE UNDERSIZED AND DO NOT MEET MSBC, 780 CMR CHAPTER 34 REQUIREMENTS FOR SAFE USE.

NOTE C: TRUSS ON 2 LINE HAS DISPLACED ABOUT SIX INCHES DOWN. SETTling IS LIKELY ACTIVE AS CEILING DIRECTLY BELOW IS DISPLACED SEVERAL INCHES.

NOTE D: BROKEN TRUSS CHORD

NOTE E: TRUSS CHORDS ARE SPLIT ALONG THEIR LENGTHS.

NOTE F: RAFTERS SUPPORTED ON WEAK PURLINS (SEE NOTE A) HAVE DISPLACED SEVERAL INCHES. WHERE PURLINS ARE NARROW FACE UP NO SAG IS PRESENT.
