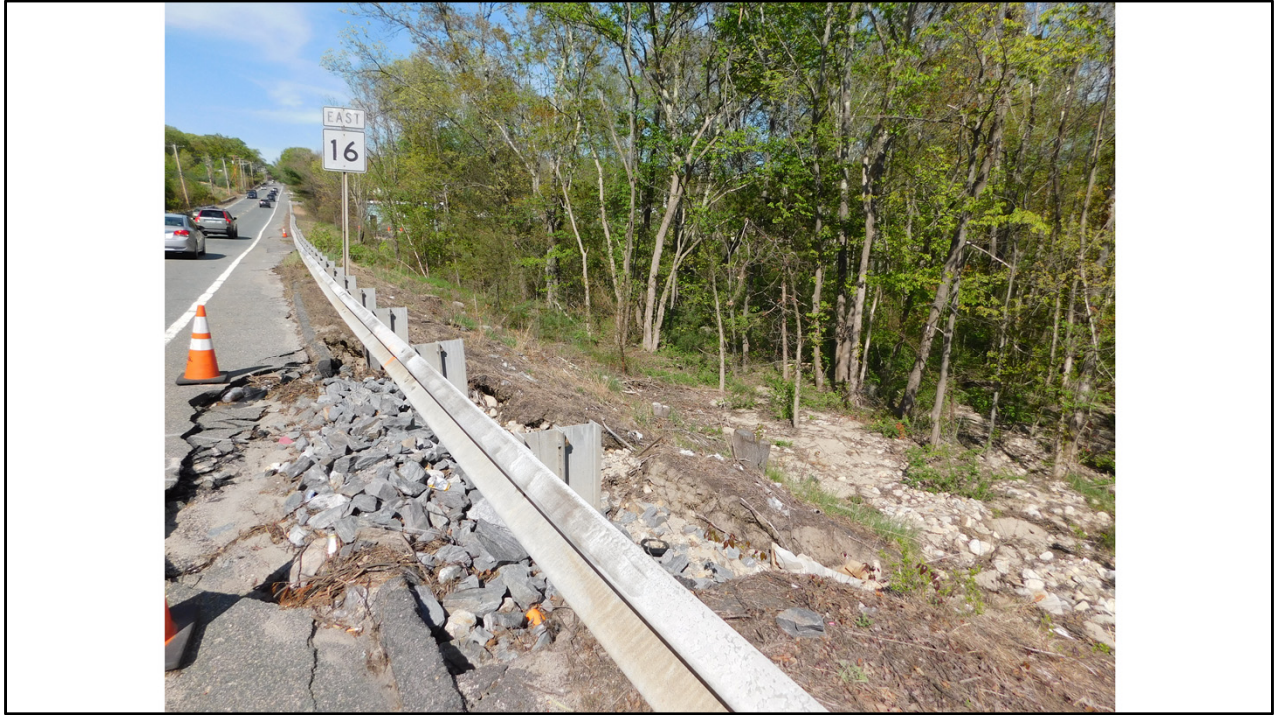
Muddy Brook at Rt 16 (east bound)

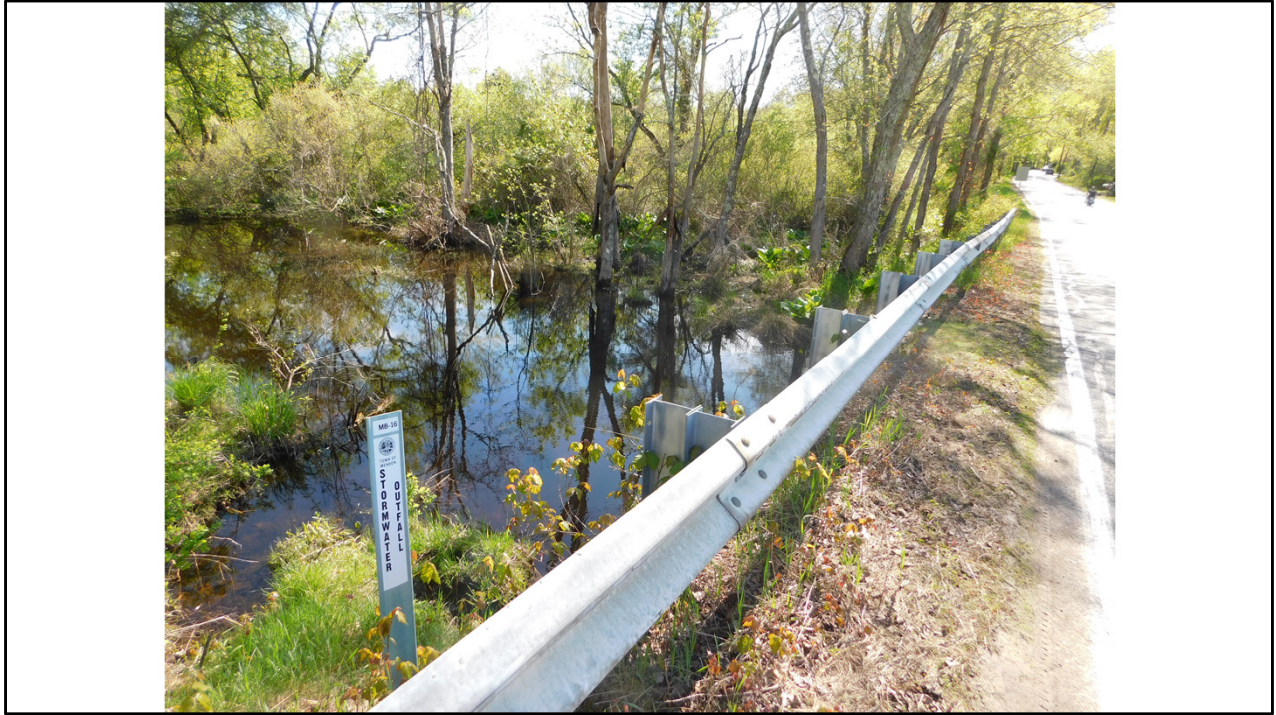
Muddy Brook at George Street, downstream side

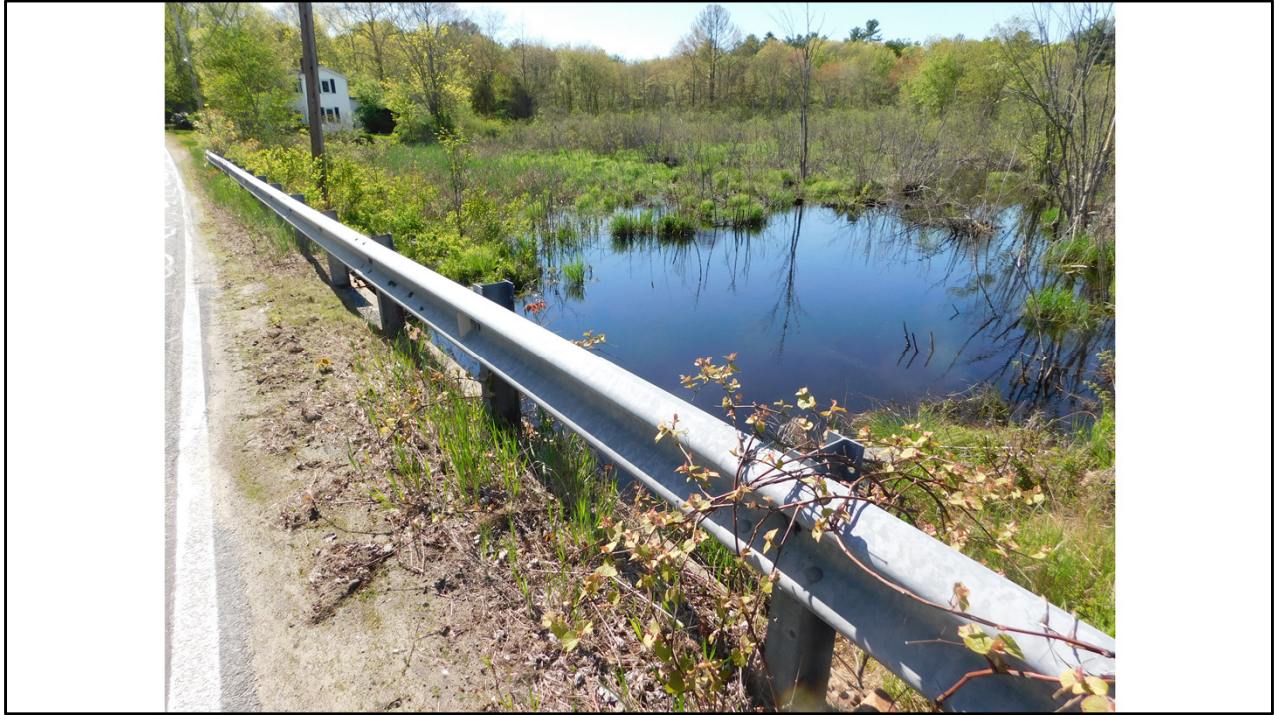
Muddy Brook at George Street, upstream side
