ROAD SAFETY AUDIT

Cape Road/S Main Street (Route 140) at
Hartford Avenue East

Town of Mendon

March 16, 2016

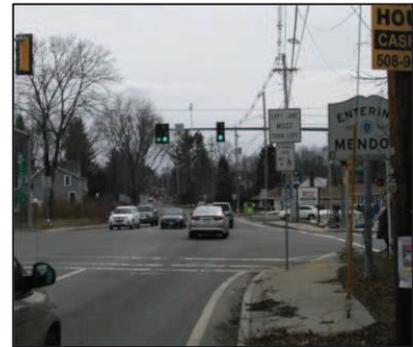
Six of the 47 crashes, involved the collision of southbound left-turning vehicles with northbound vehicles traveling through the intersection. The existing traffic signal phasing provides a protected southbound lead phase then provides permissive phasing for the northbound and southbound approaches. An audit team member noted that it is common for vehicles taking a southbound left-turn from Route 140 to miss the protected movement and get trapped within the intersection, unable to find gaps in the northbound traffic. Further contributing to this issue is that when the Route 140 northbound left-turn lane queues, it obstructs the southbound left-turn lane's sight lines of vehicles traveling northbound through the intersection. One of the crashes involved a northbound left-turning vehicle that collided with a southbound vehicle traveling through the intersection. This crash is also most likely the result of the permissive left-turns.

Protected permissive green arrow signal indication for the Route 140 southbound left-turn lane.

1. Consider changing the Route 140 southbound traffic signal indications to flashing yellow arrow and providing a supplemental “left-turn yield on flashing yellow arrow” sign.
2. Evaluate traffic operations to determine if it is feasible to change the signal phasing to provide a protected-only movement for the southbound left-turn lane.
3. Consider providing protected left-turns along the Hartford Avenue East approaches.
4. Evaluate the signal timings to reduce congestion and driver frustration during the peak hours.
5. Assess and update all clearance intervals to be compliant with current standards.
6. Consider adding reflective borders to the traffic signal back plates to increase signal indication visibility.

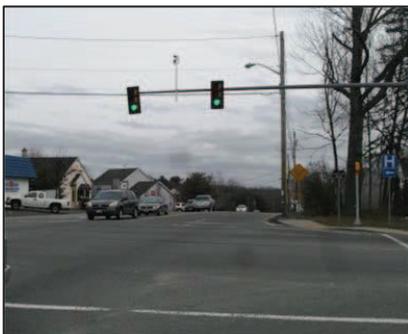
Visibility of westbound vehicles traveling on Hartford Avenue with the steep grade change.

One of the reported crashes involved a left-turning eastbound vehicle that collided with vehicle traveling westbound through the intersection. The Hartford Avenue East approaches have permissive left-turns which increase the potential for conflicts with turning vehicles. In addition, the downward grade along the westbound approach makes it difficult for eastbound vehicles at the intersection to see westbound vehicles approaching the intersection until they have reached the crest of the hill.

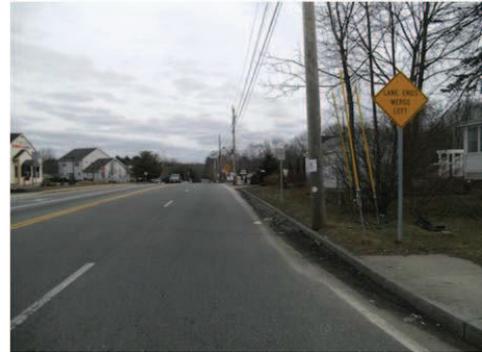
The Hartford Avenue East eastbound approach consists of a shared left-turn/through lane and a shared through/right-turn lane. Two receiving lanes are provided but merge approximately 175 feet east of the intersection. Two sideswipe crashes were reported at the receiving lanes and are most likely the result of vehicles merging at relatively high speeds. It was noted by an audit team member that vehicles traveling eastbound tend to accelerate east of the intersection in order to jockey for position in the merge area.

Merge for Hartford Avenue East eastbound receiving lanes.

1. Consider changing the Hartford Avenue East eastbound lane-use to be an exclusive left-turn lane and a shared through/right-turn lane to eliminate the merge condition along the receiving lanes and provide space for a storage left-turn lane, through lane, and right-turn lane along the westbound approach to reduce congestion and queuing.
2. Evaluate the feasibility of using the additional space created by reducing the number of eastbound lanes to widen the roadway shoulders to accommodate bicycles.

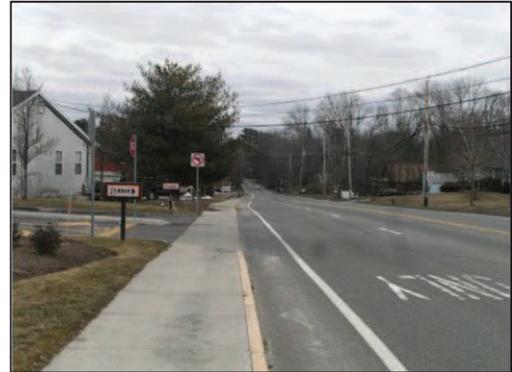
Dunkin' Donuts is located at 144 Hartford Avenue, approximately 200 feet east of the intersection with Route 140. Driveways with access to Dunkin' Donuts are provided on Hartford Avenue and Route 140. Left-turns are prohibited into the driveway on Hartford Avenue by two no left-turn (R3-2) signs. However, an audit member noted that because there are no physical barriers preventing left-turns into the driveway, many people execute the move despite the signs. Turning left from the eastbound travel lane on Hartford Avenue requires vehicles to judge gaps in the two lanes of on-coming traffic. In addition, some of crashes that occurred when turning into the Dunkin' Donuts driveway could be "courtesy" crashes, where one vehicle stops to allow a left turn into the driveway and a second vehicle traveling in the outside travel lane is blocked from view and does not stop.

Dunkin' Donuts driveway on Hartford Avenue

Seven of the 47 crashes involved vehicles turning left into the Dunkin' Donuts driveway and getting hit by vehicles traveling westbound along Hartford Avenue. In addition to the lack of physical prohibition, the Hartford Avenue address of the Dunkin' Donuts may mislead people to believe that the only entrance is along Hartford Avenue. The storefront is visible along Hartford Avenue but not along Route 140 and no signage is provided to guide people to the second driveway on Route 140.

1. Consider providing guide signs to direct people to the driveway on Route 140.
2. Consider making the Dunkin' Donuts driveway on Hartford Avenue an exit only.
3. If providing left-turns into the driveway is desirable, consider providing a left-turn lane for vehicles to turn left into the driveway to get vehicles out of the eastbound through lanes.
4. If the left-turn prohibition is to remain, consider changing the geometry of the channelized island at the driveway or making geometric changes along Hartford Avenue to provide room for a short median to physically prevent people from turning left into the driveway on Hartford Avenue and only allow right-turns in and out of the driveway.
