ROAD SAFETY AUDIT

Route 16 at Washington St./Emerson St./Maple St. &
Route 16 at North Ave./Main St.

Mendon, Massachusetts

9/11/2018

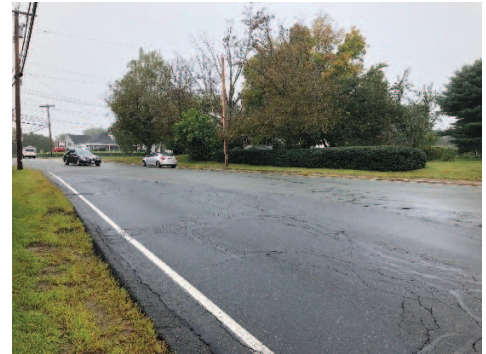
Route 16 consists of one travel lane in each direction and no separated turn lanes. During the day, vehicles looking to make a left turn from Route 16 to Washington Street or Emerson Street have been observed to back up traffic and cause queuing. Other vehicles use the wide lanes to bypass the vehicles waiting to turn. This behavior increases the risk of sideswipe and rear-end collisions. Nine rear-end crashes involving vehicles waiting to turn left or waiting for other vehicles to turn left occurred during the analysis period of 2011 – 2015.

Photo 1: Travel lanes on Route 16

1. Evaluate the need for left turn lanes on Route 16 to allow through vehicles to safely pass those waiting to turn left.
2. Evaluate if a traffic signal is warranted to help improve traffic flow and allow easier turning movements.

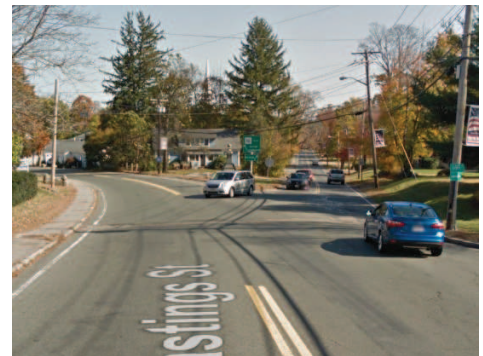
Audit members noted that there is heavy traffic on Route 16 throughout the day. Due to high traffic volumes on Route 16, vehicles entering Route 16 from Washington Street, Emerson Street, or Maple Street must quickly accelerate onto Route 16 to fit into a gap between traffic. This creates the risk of both angled crashes and rear-end crashes. 17 crashes involving vehicles entering from Washington, Emerson, or Maple Streets and colliding with vehicles on Route 16 were reported. These crashes include 14 angled crashes, 2 sideswipes, and one head-on collision with 4 crashes resulting in injury.

Photo 2: Vehicle turning from Maple St onto Route 16

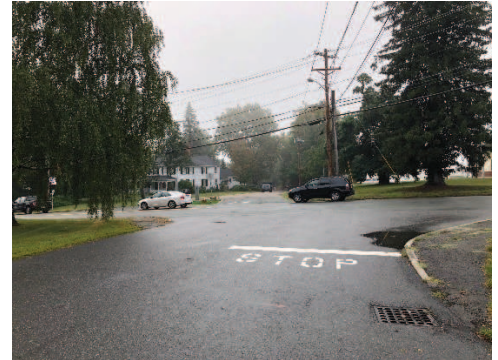
The stop bar on Washington Street is offset from Route 16. As a result, vehicles have an obstructed view of the approaching traffic in both directions. This causes stopped vehicles on Washington Street to encroach into the intersection in order to look for oncoming traffic.

Photo 4: Stop bar on Washington Street

1. Relocate the stop bar and stop sign on Washington Street to improve sightlines.
2. Better align Washington Street and Emerson Street to allow for safer crossing with improved sightlines and potentially reduce solar glare.
3. Evaluate the feasibility of a roundabout to provide traffic calming and allow for safer entering and exiting from Route 16.
4. Consider realigning Maple Street to meet Route 16 closer to a 90-degree angle to improve sightlines and simplify turning movements.

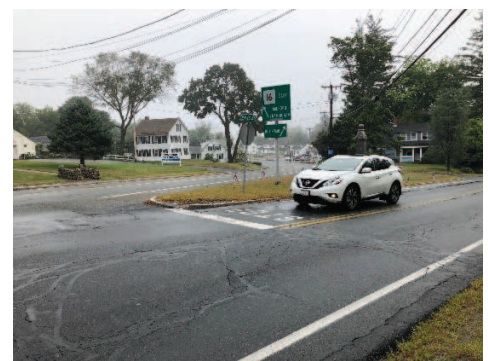
Maple Street meets Route 16 at a skewed angle. Drivers must turn their heads over 90-degrees to look for approaching vehicles. This harsh angle makes it difficult for vehicles on Maple Street to see cars approaching on Route 16 westbound and judge gaps in traffic. 12 crashes involved vehicles exiting Maple Street and entering Route 16 westbound. Deficient sightlines may have contributed to these crashes.

Photo 5: Geometry of Maple Street

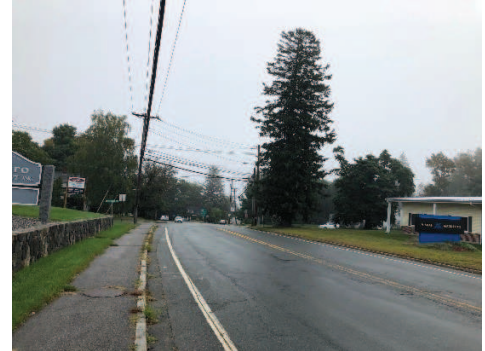
None of the intersection approaches have a designated bike lane or a bike path. Audit team members stated most cyclists ride in the traffic lanes rather than the shoulder. There were two crashes involving cyclists traveling east on Route 16 being hit by vehicles entering from Washington and Emerson Streets. It was noted that this is likely due to vehicles having to look for gaps and oncoming traffic and not paying attention to cyclists.

Photo 6: Sidewalk on north side of Route 16 & lack of bicycle accommodations.

1. Consider providing bike accommodations on Route 16 such as a wider shoulder, designated bike lanes, or a shared-use path.
2. Consider providing pedestrian accommodations on the south side of the Route 16 including sidewalks to offer a safe and protected walkway from vehicles.
3. Evaluate pedestrian desire lines and consider adding crosswalks with pedestrian warning measures to the intersection to allow for safe crossing.

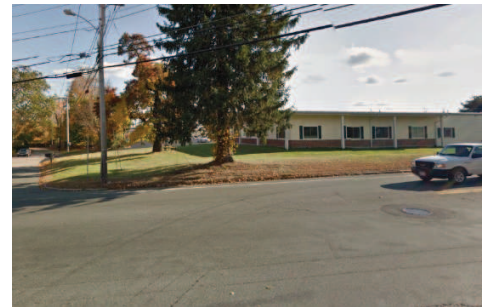
Pedestrians on the south side of Route 16 are unable to safely cross Route 16 to reach the sidewalk, as there are no crosswalks at this intersection. Audit team members noted that if there were crosswalks, pedestrians would utilize them, but they have not seen any unsafe crossing by pedestrians.

Photo 7: Strip of grass where pedestrians walk

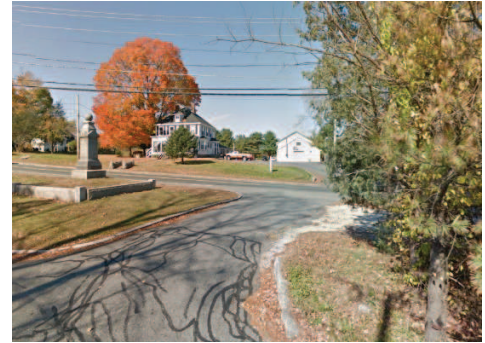
The cut through on Maple Street is not marked with any signage dictating that it is a private driveway, if it is one-way, and if you can turn both directions out of it. Audit team members noted that vehicles frequently use the cut-through improperly. There was one reported crash involving the cut-through where a driver was listening to their GPS and took a fast left onto the cut through.

Photo 8: Lack of signage on Maple Street cut-through

1. Update the signage at the intersection to meet MUTCD and retroreflectivity standards.
2. Trim back trees along the Route 16 westbound approach to Washington Street in order to improve visibility of oncoming traffic.
3. Add signage to the private driveway to clearly dictate usage whether for one-way use or private driveway-use only.
4. Consider using signage to increase safety on Maple Street, such as “Oncoming vehicles do not stop” to warn drivers before they enter Route 16.

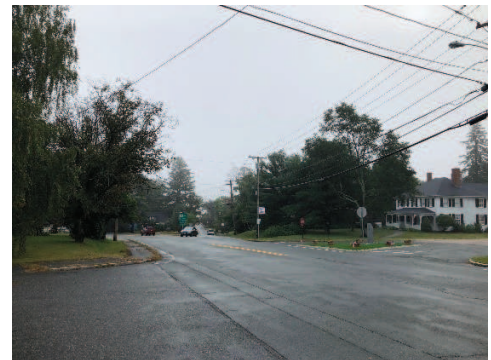
The signage at the study area is outdated. An audit team member noted that the stop sign on Washington Street is old and needs to be refreshed as it may have lost some of its reflectivity. In addition to the location of the stop bar on Washington Street, it was also noted that visibility of westbound Route 16 vehicles was difficult due to overgrown trees.

Photo 9: Trees blocking sightlines from Washington Street

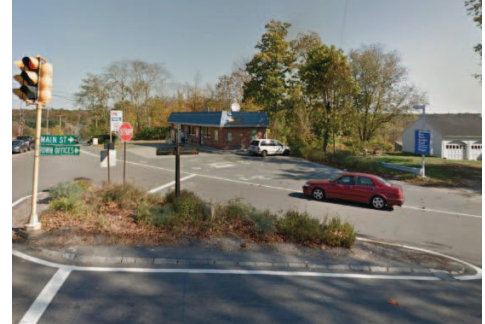
Route 16, Main Street, and North Avenue each consist of one travel lane in each direction and no separated turn lanes. The approach lanes are quite wide and vary between 14 and 18 feet. During the day, vehicles turning left at any of the approaches have been observed to back up traffic and cause queuing. Vehicles use the wide lanes to queue in two lanes at each approach, most notably from the Main Street northbound approach. A portion of the island on Main Street between the through/left lane and channelized right lane was paved to allow two lanes and bypassing. Including the paved portion, this approach is approximately 20 feet wide. 10 of the 77 total crashes were conflicts between vehicles turning left and oncoming vehicles traveling straight.

Photo 10: Paved portion of the island on Main Street

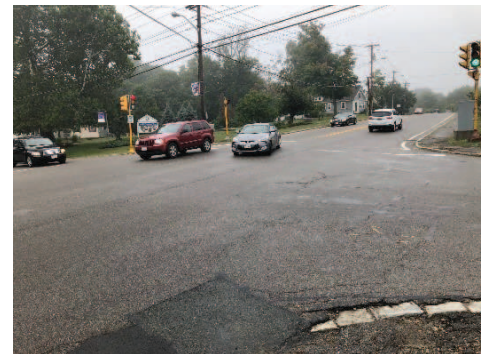
Audit team members also noted that during peak hours vehicles wait several light cycles before an opportunity arises to turn left during peak hours. The congestion causes vehicles to pull into the intersection and wait for the signal to become red before turning. Audit team members also noted that many drivers get frustrated sitting in congestion, which can lead to vehicles running red lights to get through the traffic. Ten of the 77 crashes were a result of drivers failing to yield the right-of-way. There were also seven crashes that were reported with a driver operating a vehicle in an erratic, reckless, careless negligent, or aggressive manner.

Photo 11: Vehicles passing in two lanes on Route 16

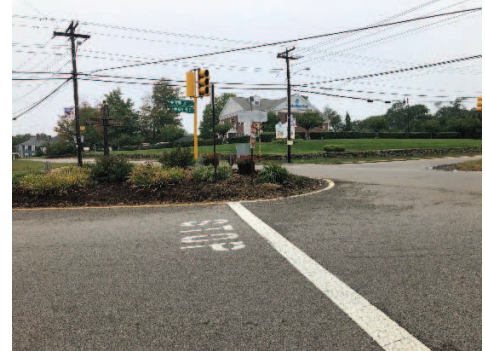
The stop bar on the channelized right lane on Main Street is offset from the intersection. As a result, vehicles have an obstructed view of the approaching traffic. This causes vehicles to roll through the stop. Two rear-end collisions were reported between 2011-2015 at this stop sign.

Photo 12: Offset stop bar on Main Street

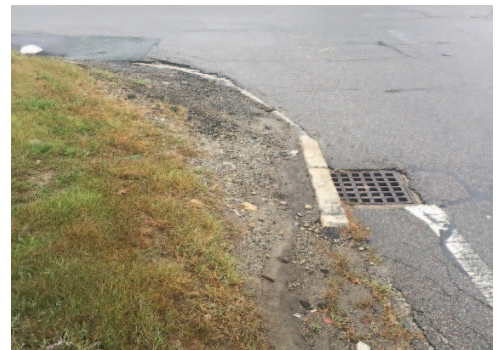
There are heavy vehicles and school buses passing through the intersection on a daily basis. The geometry of the intersection makes it difficult for heavy vehicles to make right turns and even some left turns. Trucks frequently drive over the curb on the corner of Route 16 and North Avenue when taking a right-turn from Route 16 westbound to North Avenue. Audit team members noted that the signal post has been hit several times. Audit team members also noted that the stop bars on Main Street and Route 16 headed east are close to the intersection making it difficult for tractor-trailers to make turns.

Photo 13: Curb at the eastern corner of North Avenue and Route 16

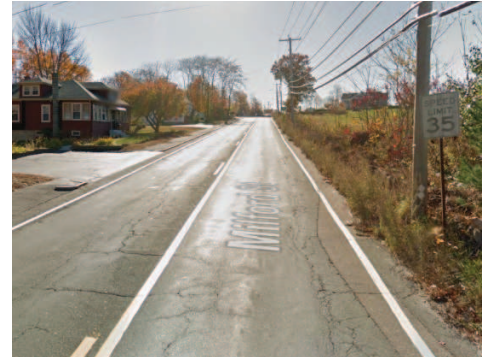
According to the state speed regulation record, no part of Route 16 in Mendon has a speed limit above 45 miles per hour. The current posted speed limit on Route 16 eastbound is 50 miles per hour, which appears to be signed incorrectly. The speed drops to 35 miles per hour (mph) just after the downward hill on Route 16 eastbound (Milford Street). An audit team member noted that most drivers do not obey the speed change and approach the intersection traveling over the 35-mph speed limit. One of the 77 recorded crashes was due to the driver driving too fast for the conditions.

Photo 14: Speed limit on westbound approach

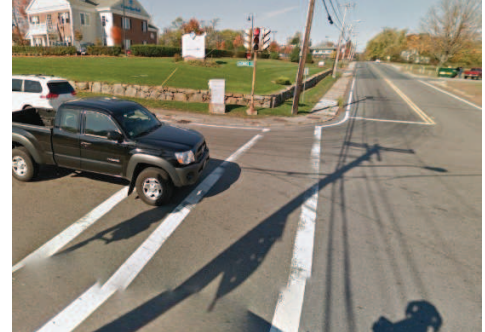
There is one crosswalk connecting the northwest corner of the intersection and the southwest corner. An audit team member noted that the pedestrian signal is not always functional.

Photo 15: Existing crosswalks and pedestrian pushbutton and indication

1. Add bike accommodations such as a wider shoulder, designated bike lanes, or a shared-use path.
2. Add sidewalks along all approaches to the intersection on both sides of the roadway to provide a safe and protected walkway from vehicles.
3. Update wheelchair ramps to meet ADA guidelines.
4. Add crosswalks to all sides of the intersection to provide access from all directions.
5. Repair the existing pedestrian signal
6. Upgrade the existing pedestrian signal to provide accessible pushbuttons and countdown signals.

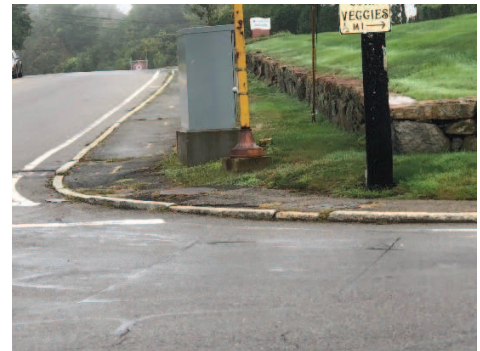
The sidewalks at the intersection are in poor condition and the wheelchair ramps at the crosswalks are ADA compliant. The audit team noted that students do not use the sidewalks or crosswalks to get to or from school due to their narrow width, poor condition and heavy adjacent vehicle traffic. There is only heavy pedestrian activity during events. An audit team member noted that there is discussion of a new development within the northwest quadrant of the intersection. This area has been discussed for an affordable housing unit and a set of sports fields. The team member emphasized this development will likely be built in the next ten years. If this area was built upon, it would increase pedestrian foot traffic in the area. From 2011-2015 there were no collisions involving pedestrians in the study area.

Photo 16: Non ADA-compliant wheelchair ramp and sidewalk

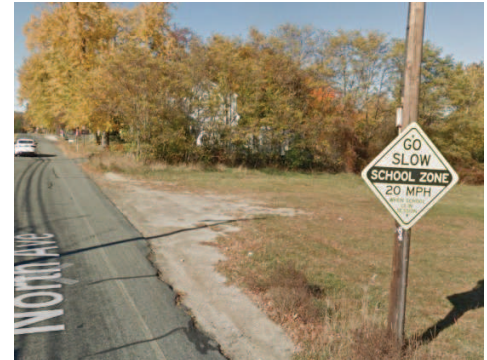
Photo 17: Outdated school zone sign

1. Update the signage including the signal warning signs, add lane use signage on each approach, and update the signage to be MUTCD compliant to improve safety for vehicles and reduce driver confusion.
2. Relocate street name signs to improve visibility, reduce driver confusion, and avoid vehicle strikes.
3. Ensure the visors on the traffic signal heads of the eastbound and westbound approaches are maintained and correctly aligned to improve visibility to drivers.

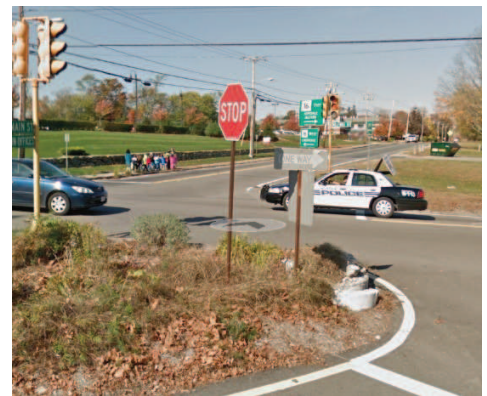
Photo 18: Faded one-way sign
