RE: RDA - 29 Hartford Avenue West
Map: 10, Lot: 29

Goddard Consulting, LLC is pleased to submit this Request for Determination of Applicability (RDA) under the MA Wetlands Protection Act (the WPA) and the Mendon Wetlands Protection Bylaw (the Bylaw) on behalf of the applicant, Rte. 85 Realty Corporation. The applicant seeks after-the-fact approval from the Mendon Conservation Commission (the Commission) and request a negative determination for the completed driveway repairs within the Buffer Zone to Bordering Vegetated Wetlands (BVW) at 29 Hartford Avenue West.

- RDA (WPA Form 1) Application Form
- Wetland Border Report: *29 Hartford Ave, Mendon, Goddard Consulting, LLC, 2/4/2020*
- Site Plans: *29 Hartford Avenue West, Driveway Maintenance & Resource Area Plan of Land in Mendon, MA, Guerriere & Halnon, Inc. 9/23/2020*

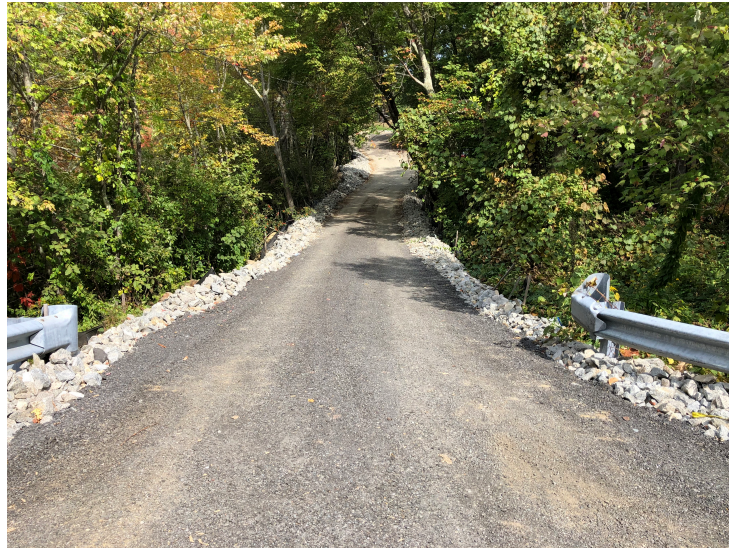
Photo 1: A view of the improved gravel driveway from Hartford Avenue West.

within the silt fence to reduce erosion even further. About 8 - 12 inches of unsuitable gravel was removed from the driveway, replaced with 8 - 12 inches of processed gravel, and topped with 4 inches of reprocessed asphalt. The gravel driveway is now packed flat, has no pockets for puddling, and is well drained. The surrounding BVW is unchanged; the BVW is void of any sediment, trash, or debris for the recent driveway improvements.

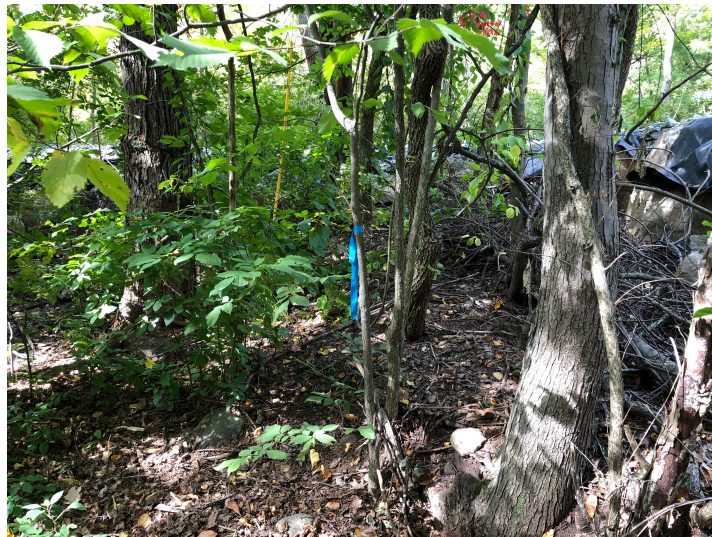
Photo 2: A blue wetland flag is seen in the center of the photo. To its left is forested BVW and to its right is the gravel driveway. The BVW remained undisturbed from the completed work.

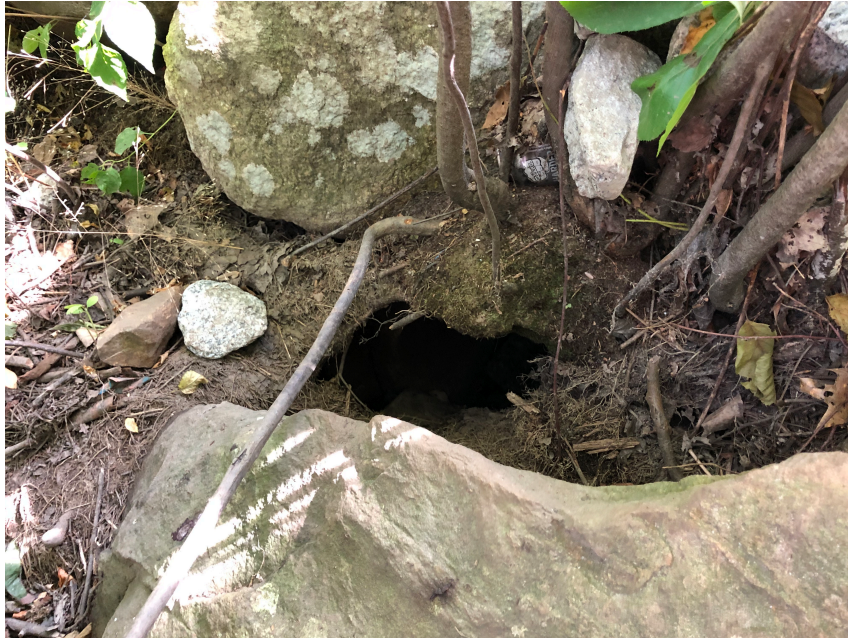
Photo 3: The inlet to the culvert can be seen behind a large rock. The culvert is $\frac{1}{2}$ filled with years of sediment buildup from the surrounding BVW.

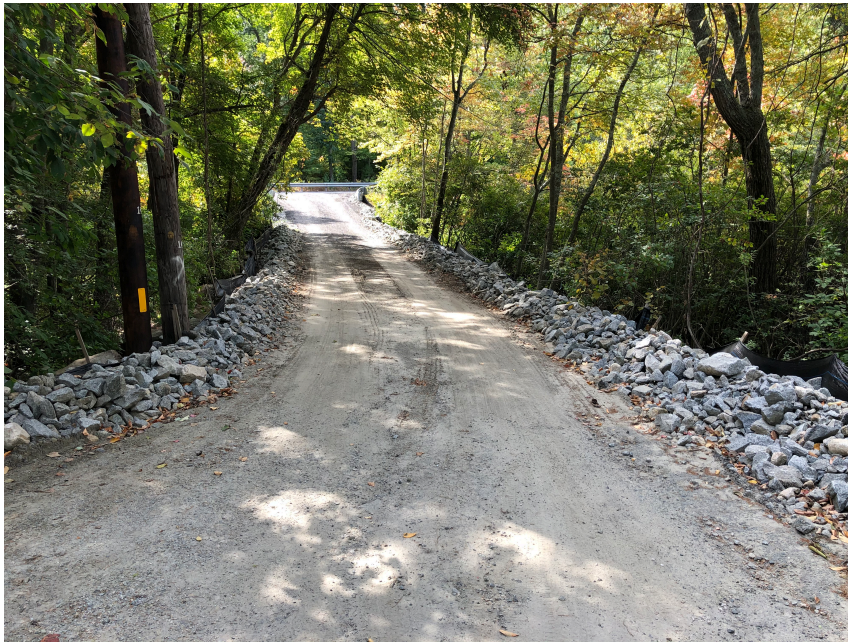
Photo 4: A view of the improved gravel driveway and Hartford Avenue West in the distance. Rip rap and silt fence can be seen at the edges of the driveway, preventing sediment from reaching the BVW.

Improvements to the existing gravel driveway were recently completed to make the driveway safer and more suitable for car traffic. Silt fence and straw waddles were installed along the edge of the gravel driveway to minimize impacts to the downgradient BVW. Rip rap was added
