FIELD NOTES SUMMARY

Customer: Town of Mendon
Pond Name: Lake Nipmuc
Site Location: Mendon, MA
Date: 6/22/23

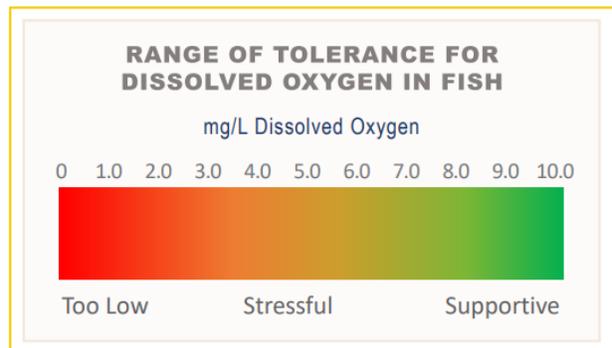
While on-site, dissolved oxygen (DO) and temperature readings were collected using a calibrated YSI meter with optical sensor. Dissolved oxygen is the amount of oxygen in water that is available to aquatic organisms. DO is necessary to support fish spawning, growth, and activity. Tolerance varies by species, but the figure below provides a general range of fish tolerance (Source: epa.gov). Dissolved oxygen can be affected by many

outside factors, such as: temperature, time of day, and pollution. Dissolved oxygen levels are typically lowest early in the morning. Healthy water should generally have concentrations of about 6.5-8+ mg/L.
