Re: Lake Nipmuc, Mendon, MA – 2023 Year End Report – DEP File #218-0725

Summary Of 2023 Management Activities

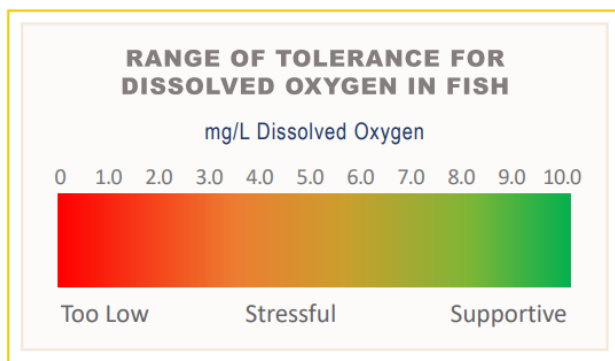
Figure 2: Dissolved Oxygen Table

sensor. Dissolved oxygen is the amount of oxygen in water that is available to aquatic organisms. DO is necessary to support fish spawning, growth, and activity. Tolerance varies by species, but the figure shown provides a general range of fish tolerance (Source: epa.gov). Dissolved oxygen can be affected by many outside factors, such as: temperature, time of day, and pollution. Dissolved oxygen levels are typically lowest early in the morning. Healthy water should generally have concentrations of about 6.5-8+ mg/L. All readings are included in the tables throughout this report.

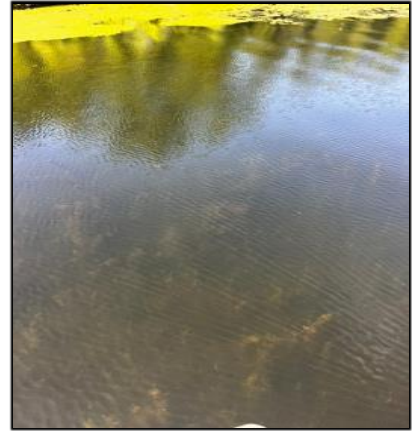
Figure 3: Visibility at Lake Nipmuc

Throughout the entire lake, there was a microscopic algae bloom, which had negative impacts on water clarity/visibility. In addition to the microscopic bloom, there were also patches of benthic filamentous algae. The north cove that was treated contained scattered patches of variable milfoil, as well as native bladderwort. The second cove, by Alicante Restaurant contained dense densities of both variable milfoil and bladderwort. The final two coves treated both contained moderate densities of variable milfoil. Along the shoreline and scattered in the middle of the lake were patches of water lilies and watershield. We recommend that the current algae bloom be monitored and potentially sampled to ensure the safety of Lake users.

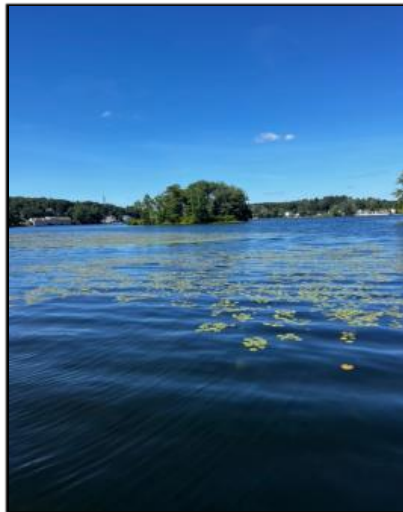
Figure 4: Invasive species in Lake Nipmuc

Bob Sweet, Mendon Conservation Commission/Lake Nipmuc Association accompanied Water & Wetland during the survey. Conditions were rainy, but visibility was sufficient to complete the survey without issue. A small amount of variable milfoil regrowth was found near the outlet and in the cove near Alicante. This is not uncommon when treatment utilizes diquat, a contact herbicide. Small patches of bushy pondweed were also observed in low, non-nuisance densities.

One other option for treatment of milfoil is Procellacor (florpyrauxifen-benzyl) herbicide which was heavily considered but ultimately ruled out. ProcellaCOR is a highly selective systemic herbicide used for the management of freshwater aquatic vegetation. ProcellaCOR is highly selective and impacts milfoil with minimal impact to native pondweeds. While ProcellaCOR provides multiple year systemic control of milfoil, it also acts much like a contact herbicide in that it makes spot-treatment possible, yet also has a very short half-life in water (roughly 9 hours). Usage of ProcellaCOR allows for less product in the water. Due to its selective formulation, ProcellaCOR can be applied at very low concentrations. The cost of Procellacor is considerably higher than that of diquat but would provide multiple years of nuisance level milfoil control. The rationale for ruling out this specific product is due to its' selectivity. Particularly near Nipmuc Marina, bushy pondweed has become the most nuisance target plant. Procellacor will have very minimal impacts to this species, vs. diquat which is effective on both milfoil and bushy pondweed. All treatments should be accompanied by pre- and post-treatment monitoring.
