Lake Nipmuc Baseline Assessment

Mendon, Massachusetts

Project No. M410-000
November 30, 2021

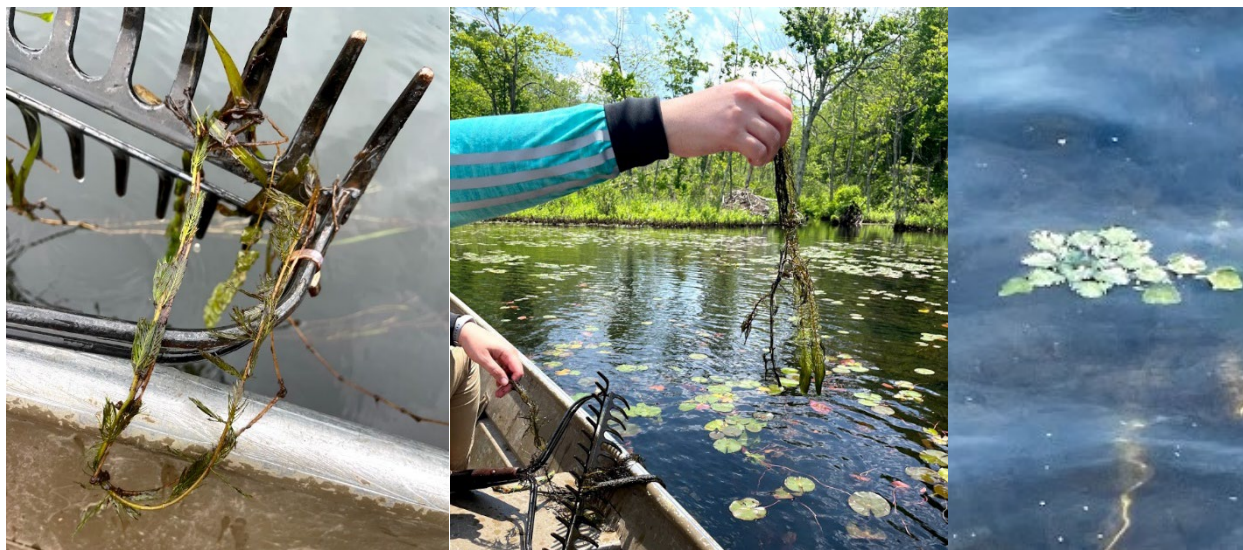
Eurasian milfoil (left), variable-leaf milfoil (center), and water chestnut (right) were each present in Lake Nipmuc.

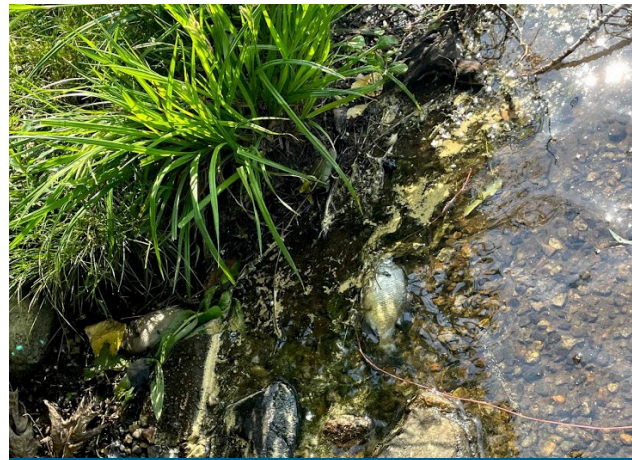
Two of the dead fish observed along the eastern shoreline of Lake Nipmuc on June 8, 2021.

ESS observed a fish kill event at Lake Nipmuc on June 8, 2021. Fewer than 10 dead fish were found washed up along the shoreline to the north of Site 1 (Town Beach). All of the fish observed by ESS appeared to be bluegill (*Lepomis macrochirus*). Later in the day, ESS was informed that local residents had also observed at least 40 additional dead fish of multiple species in the northernmost cove. The cause of this fish kill has not been established.

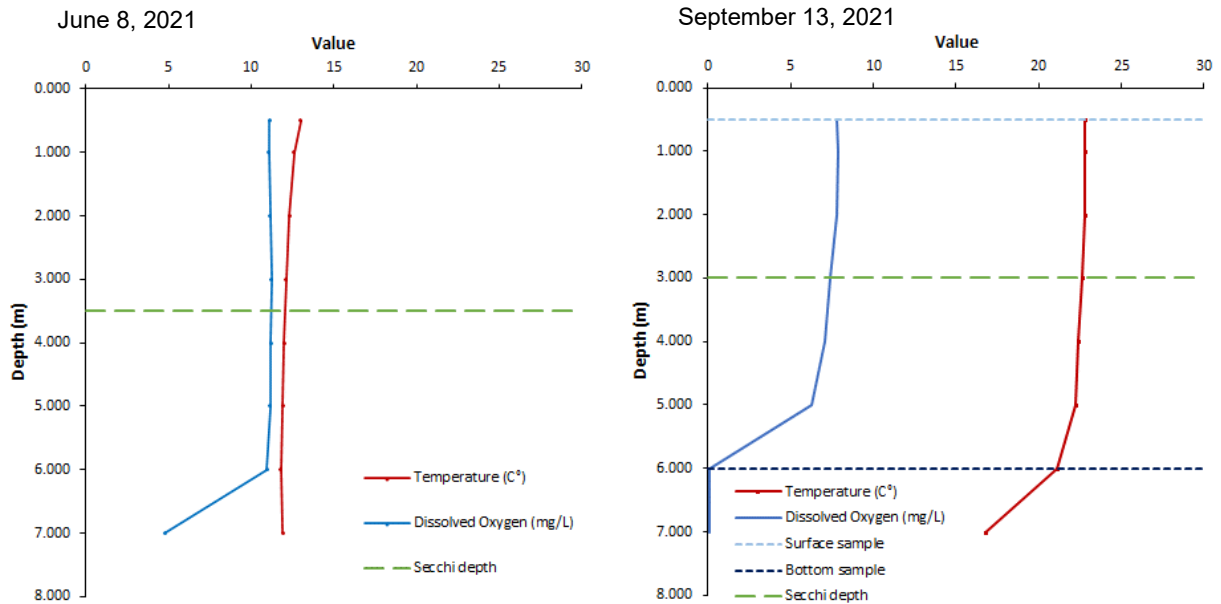
Figure 7. Temperature and Dissolved Oxygen in Lake Nipmuc

At Lake Nipmuc, the observed dissolved oxygen concentrations met the warmwater standard at the surface during each of the three in-lake water quality sampling events but did not meet the state standard at the bottom of the water column during the September sampling event (Figure 7, Table D).

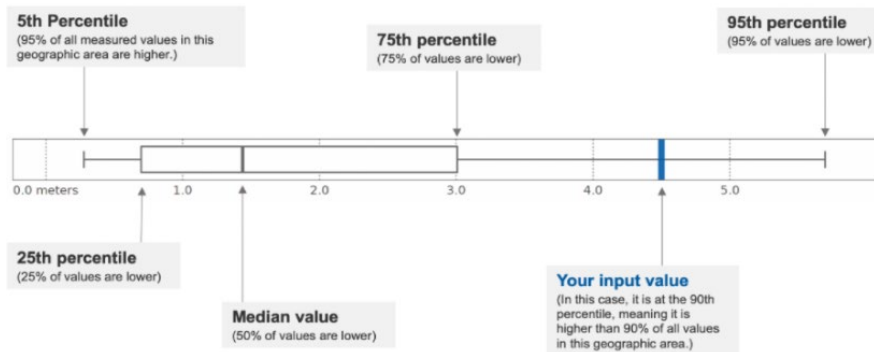
The data graphics are called **box-and-whisker plots**. The box indicates the boundaries for the middle 50% of all observations. The horizontal lines extending to the left and the right of the box are called the whiskers and indicate where the top and bottom 5% of values fall.

You reported that Lake Nipmuc in Massachusetts (MA) had an observed value of **3.3 meters** for Secchi Depth in 2021. The graphs below show how your lake ranks at the state, regional and national levels compared to representative data collected by the U.S. National Lakes Assessment in **2017**. For Secchi Depth, an upper percentile ranking is generally preferable.

Transparency at Lake Nipmuc ranged between 3.0 (10 feet) and 3.5 meters (11.5 feet) (Table D). US EPA recently introduced a new lake context tool that allows users to compare their water quality values to those observed by the National Lakes Assessment program, which is conducted nationwide every five years. The last assessment was completed in 2017. Using this tool, the Secchi disk depth at Lake Nipmuc falls in the highest quartile for Massachusetts lakes, falling in the 85th percentile, although the margin of error is high. Therefore, Region 1 (which includes Massachusetts and the other New England states) may provide a more useful comparison. According to this, Lake Nipmuc is closer to the median value (the 65th percentile).
