## **Conditions Assessment, Historical Analysis, and Adaptive Reuse**

### **Town Hall Campus Study Mendon Center Historic District Town of Mendon, Massachusetts**

PROJ.: Mendon Town Hall Campus Study  
RE: Building Conditions Assessment, Historical Analysis, and Adaptive Reuse

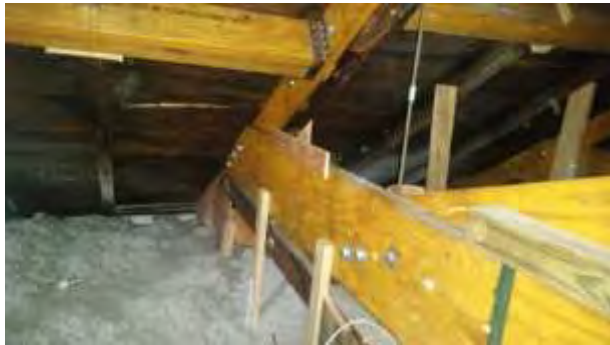
Supplemental roof framing installed following 2008 report.
3

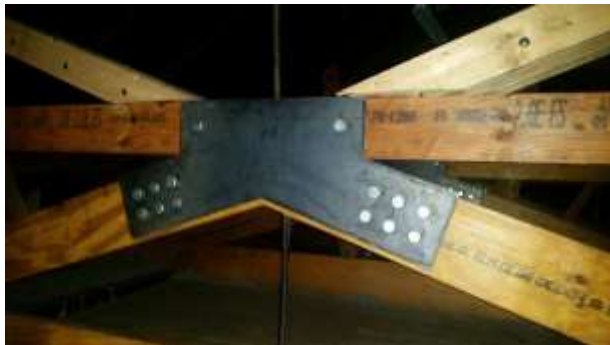
Supplemental roof framing installed following 2008 report.

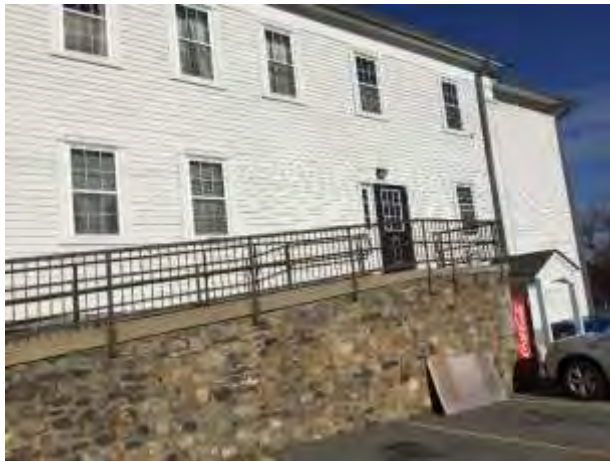
7

- Historical Integrity: Fieldstone may be local. Ramp was installed in 1980's or 1990's
- Material: Fieldstone walls and concrete surface with steel railings and posts.
- Condition: Poor, with open / failing joints and loose stones at walls, damaged and rusting railing components, and spalled areas of concrete.
- Recommendations:

Exterior ramp constructed adjacent to the original building.
8

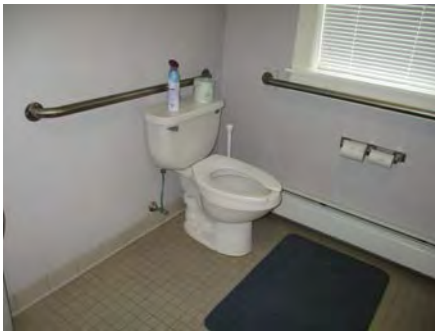
Lavatories are wall hung vitreous china with hot and cold water handles. Lavatories do not have mixing valves.

*Upper Level toilet fixtures*

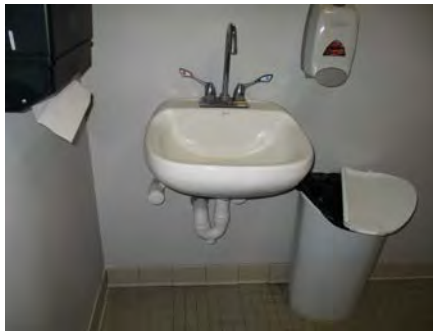
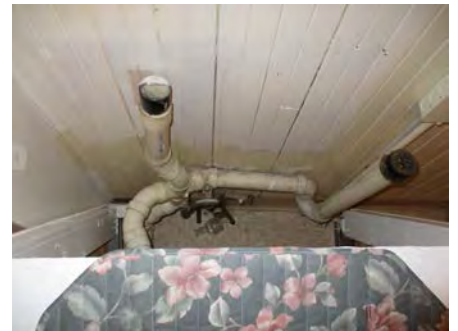
There appears to have been a drinking fountain on the First Floor. Roughing is capped at wall.

*Capped piping for drinking fountain*

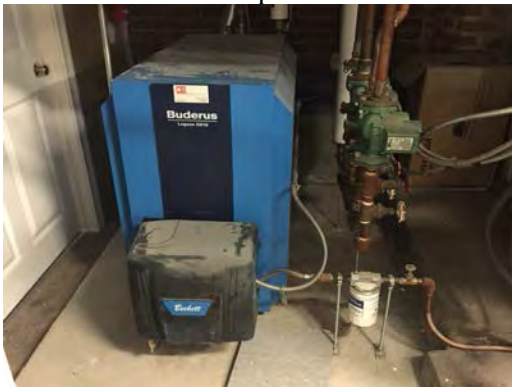
The original heating plant has been modified and replaced with two Buderus cast iron sectional boilers with Beckett burners. The system generates heating hot water and supplies heat to the entire building through wall mounted fin tube radiation and cast iron radiators. The boiler plant operates on No.2 fuel oil, the site does not have any natural gas. Fuel oil is stored on site within the boiler room, there are two 275 gallon residential style fuel oil tanks utilized. The vent and fill lines travel from the tanks to the exterior utilizing schedule 40 black steel. Both these boilers and associated pumps and zone valves were installed approximately three years ago and all appear to be in good condition. The piping system utilized throughout the building is copper and is insulated with fiberglass insulation. The piping system appears to be in good condition however, several section of piping should be removed and reviewed to determine the internal condition of the piping. There were several sections of piping where insulation was missing, these locations should be identified and insulation provided. Combustion gases generated from the boilers exhaust to an existing masonry chimney through a galvanized sheet metal breeching system. The hot water system circulates water throughout the building through the use of inline Taco pumps. There are approximately five system pumps and two boiler circulator pumps. All these pumps were recently installed and in good condition. Each pump appears to serve several zones, each zone is provided with a zone Taco valve. Each one of these zone valves are associated with an individual space and is controlled through the space's wall mounted thermostat. Therefore each space is provided with individual temperature control. The hot water system utilizes a floor mounted vertical expansion tank which is used to eliminate any air within the system. Combustion air for both boilers is provided through a wall mounted energy recovery unit, the manufacture is Fantech. This unit is provided with insulated flexible ductwork which travels from the unit to the outdoors and is equipped with an energy recovery section. Return air for the unit is being drawn from the adjacent corridor therefore providing outside air to the boilers for their combustion process. Both boilers are provided with all operating and safety controls.

*Existing Boiler*

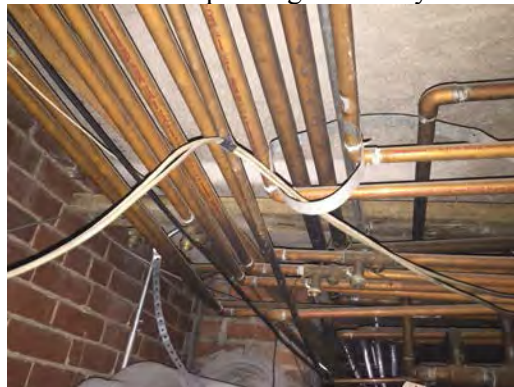
*Non-Insulated Piping*

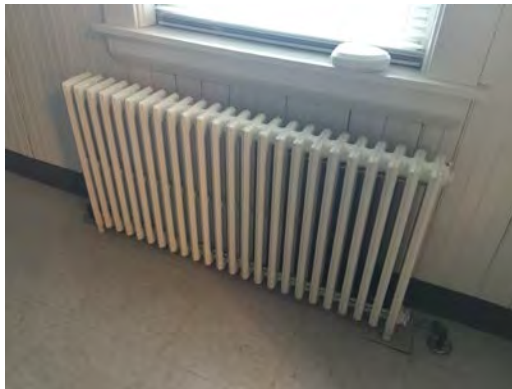
The hot water that is generated from the main boiler plant is distributed throughout the building which feeds the entire building. The basement level consists of the original cast iron radiators and supplemental electric heaters. These radiators and spaces are not provided with individual temperature control. The first

*Typical Cast Iron Radiator*

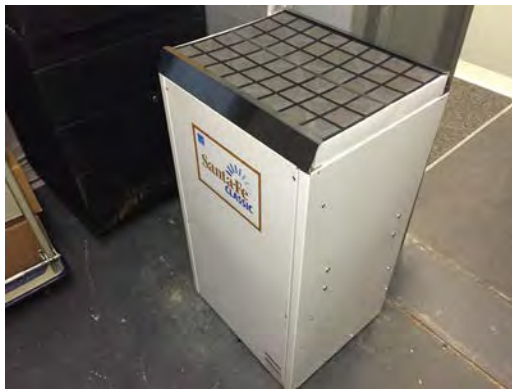
and second floors are provided with fin tube radiation. The fin tube is typically located within each office space. Control of the fin tube are wall mounted thermostats which are connected to the zone valves within the boiler room. There is a records room located on the first floor which consist of a vertical floor mounted cooling unit which has no distribution system and basically freely blows air into the space. This unit prevents the room from overheating however the unit is inadequate and does not provide any controllability of the spaces humidity levels. We would recommend a new critical applications unit for this space which would provide temperature and humidity control.

*Vertical Cooling Unit*

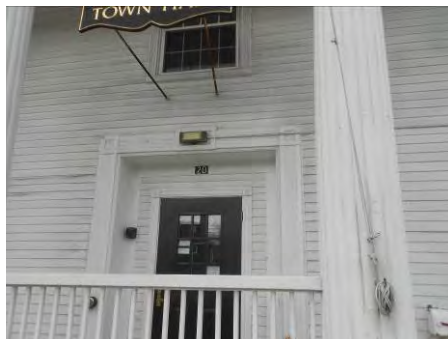
Exterior lighting consists of HID wall packs located above the doors. These fixtures are not the cut-off type.

*Wall Pack*

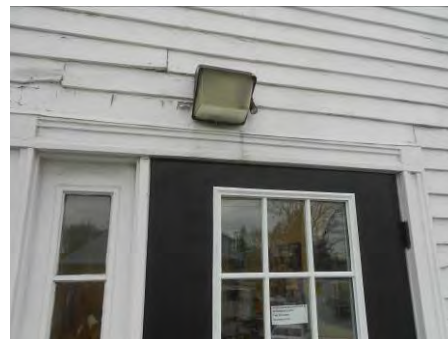
*Wall Pack*

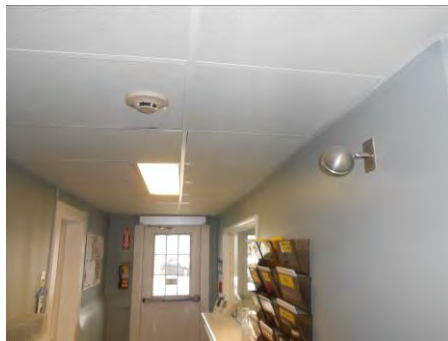
The fire alarm system consists of a Fire-Lite, Fire Alarm Control Panel (FACP) located in the first floor entry lobby. Horn/strobes are not of the ADA type. There is inadequate coverage of horn/strobes and smoke detectors.

*Smoke Detector*

- Fire alarm system should be replaced with a new addressable, ADA, code compliant system.
  - Cost: \$30,000.00

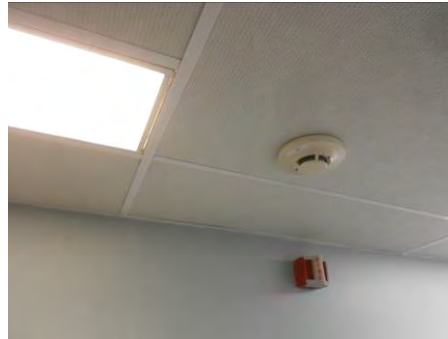
*Horn/Strobe*

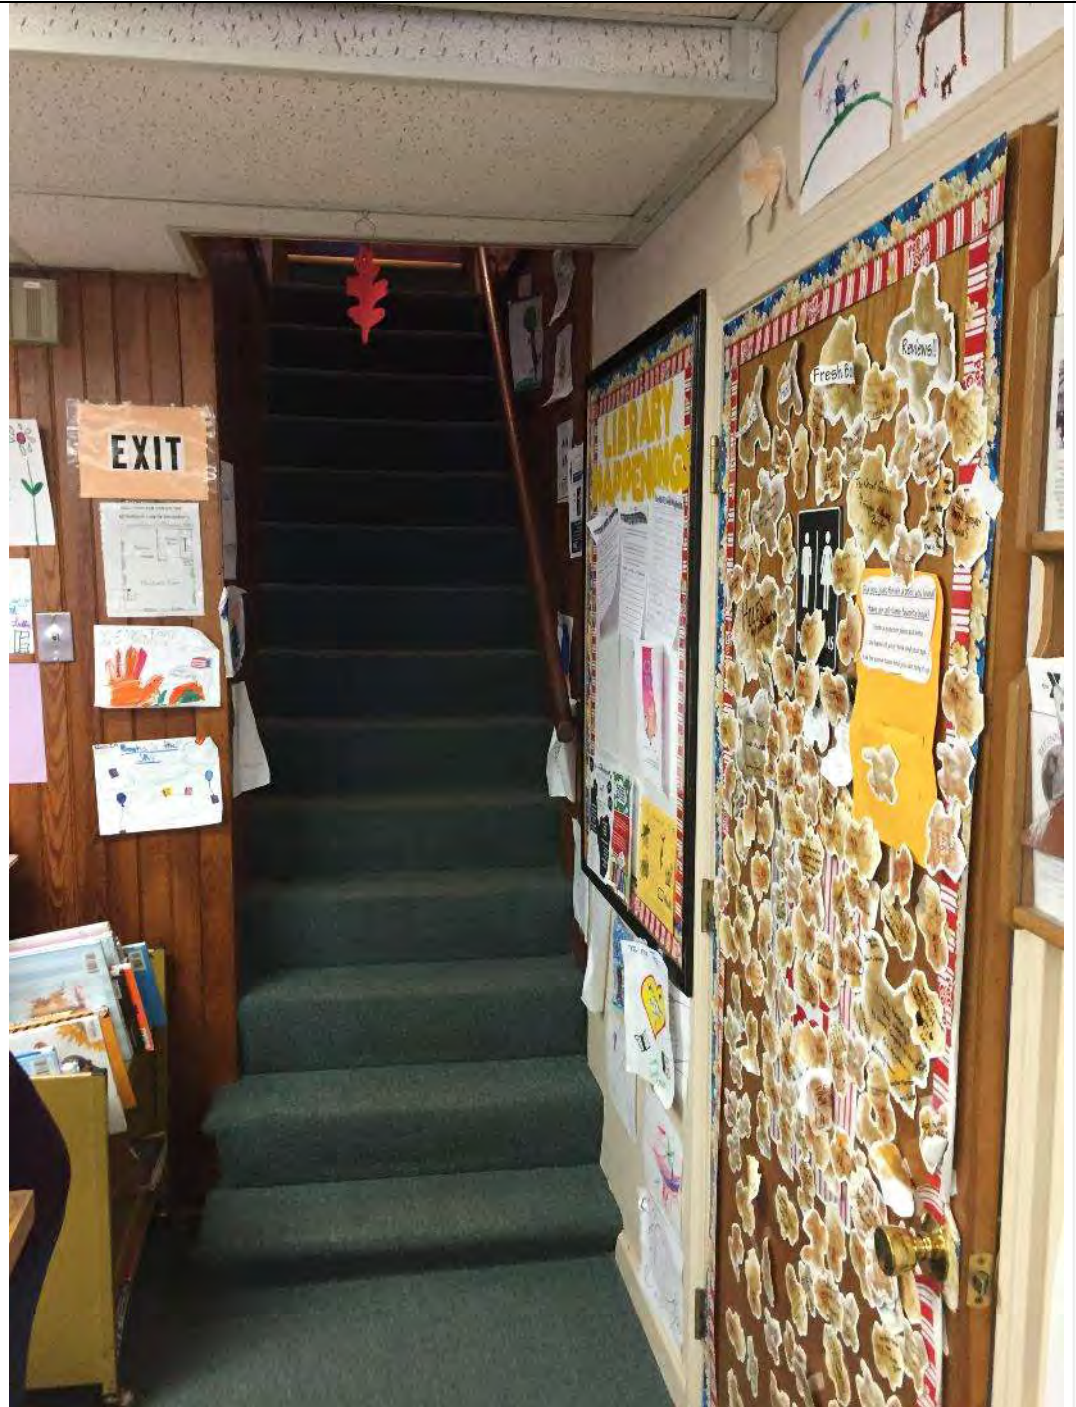
16

The stair connecting the two levels is not code-compliant. Also, because of its proximity to the Main Entry above, the Upper Level doesn't have two remote exits.

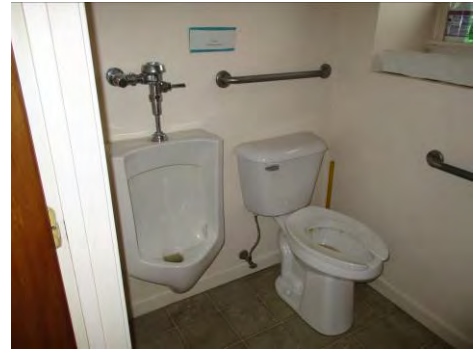
There is one bathroom located on the lower floor. Water closet is floor mounted, tank type, vitreous china. Urinal is wall hung vitreous china with manual flush valve. Lavatory is wall hung vitreous china with hot and cold water handles. Lavatories do not have mixing valves.

*Lower level plumbing fixtures*

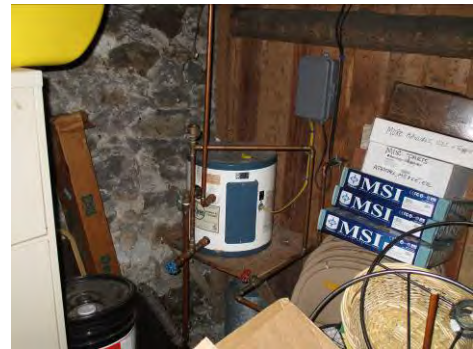
The domestic water heater is generated through a tank type electric water heater. There is no mixing valve or expansion tank.

*Electric water heater*

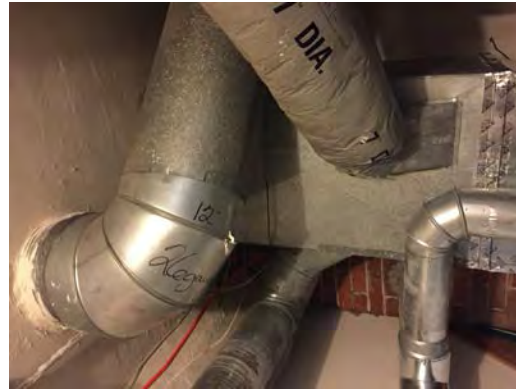
*Un-Insulated Duct*

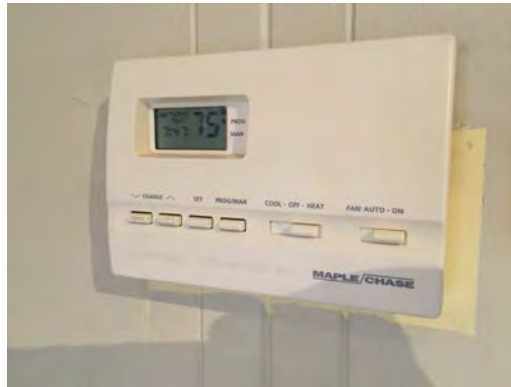
The automatic temperature control system is a standalone electronic system. It utilizes a Maple Chase thermostat which is connected directly to the unit and is located on the wall near the return air system. There is only one thermostat for the building, this provides uneven temperatures between downstairs and upstairs. The thermostat is a programmable thermostat therefore it offers a scheduling feature for each day of the week. The overall control system is functioning however, a new complete direct digital control system would offer much better temperature control and allow for troubleshooting and web access to all the building components.

*Thermostat*

- Provide individual zone control for the first and second floor with interconnecting control wiring from the zone dampers to the existing unit. This should be provided if the existing unit remains.
  - Cost \$5,000
- Provide two new heating, ventilation and air conditioning system with energy recovery, heating and cooling sections and MERV 13 filters. This system would be associated with a new galvanized sheet metal duct distribution system and would serve the first and second floors.
  - Cost \$80,000
- Provide a new direct digital control system and connect to a town wide building management system with web access and alarm notifications.
  - Cost \$20,000
- Provide general exhaust systems for storage and toilet rooms for improved indoor air quality.
  - Cost \$4,000

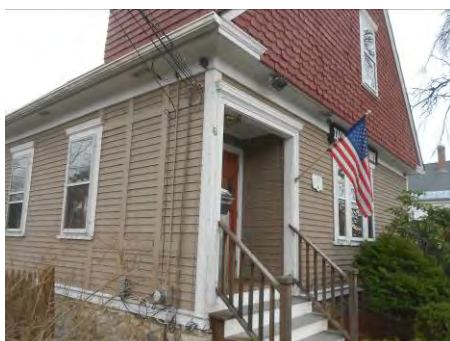
The secondary service originates on a utility company pole where it runs overhead to a utility meter mounted on the exterior of the building. A 100 ampere, 2 pole main breaker load center exists in the Storage Room. The voltage is 120/240 volts, single phase, 3 wire. The load center was manufactured by Westinghouse and is in good condition.

*Overhead Service*

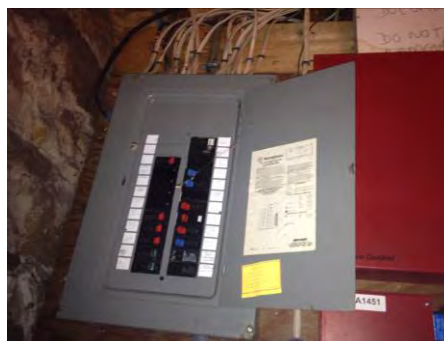
*Main Breaker Panel*

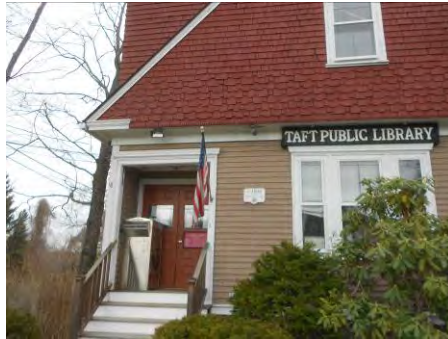
The exterior lighting consists of building mounted flood lights, wall packs, and surface mounted fixtures with an incandescent lamp at the front entrance. Lighting is switch controlled from the vestibule.

*Exterior Lighting*

- Replace all exterior building mounted lighting, with LED and cut-off type automatically controlled with photocell on, time clock off. Egress lighting to be provided with emergency backup power.
  - Cost: \$2,500.00
- Replace existing interior lighting with energy efficient historic LED type fixtures.
  - Cost: \$10,000.00
- Provide occupancy sensor to toilet, offices, etc.
  - Cost: \$2,000.00

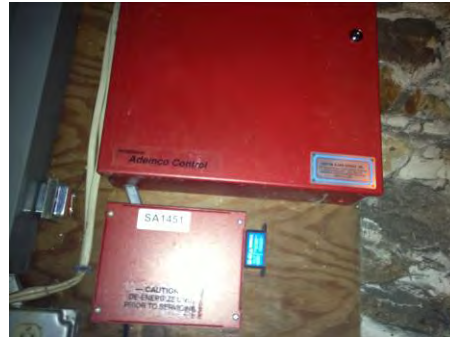
*Fire/Security Panel*

Smoke detectors are provided throughout the building. No horn/strobes were noted in the facility. Fire alarm system does not meet current code requirements.

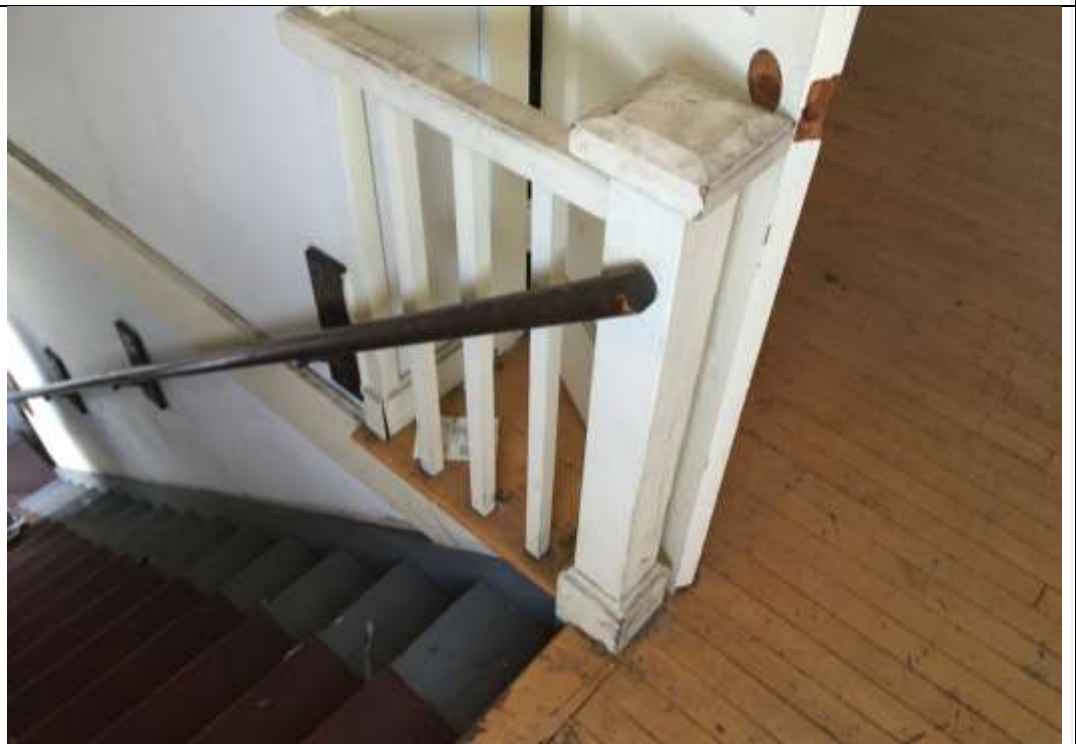
12

The only stairwell is steep. It is open to the Second Floor Corridor.

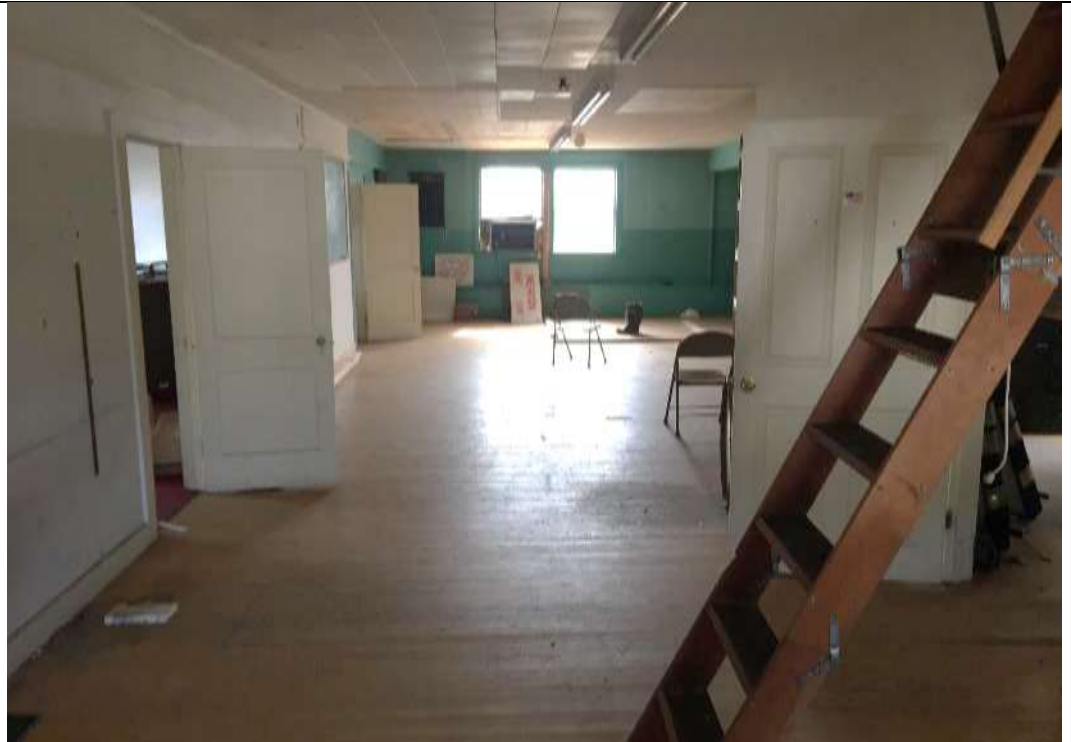
13

The Second Floor had been the Living Quarters. It is not rated for Storage, and currently unused.

- Recommendation: Seal off the 2<sup>nd</sup> floor. Refer to Code Red Report.

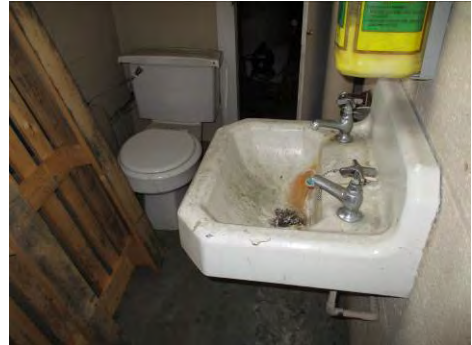
There is one bathroom located on the first floor. Water closet is floor mounted, tank type, vitreous china. Lavatory is wall hung vitreous china with hot and cold water handles. Lavatories do not have mixing valves.

*Abandoned bathroom fixtures*

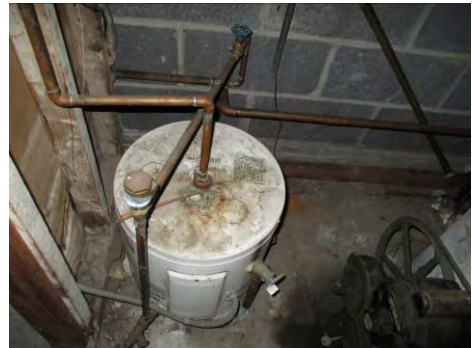
The domestic water heater was generated through a tank type electric water heater. There is no mixing valve or expansion tank. Unit is in poor condition.

*Abandoned water heater*

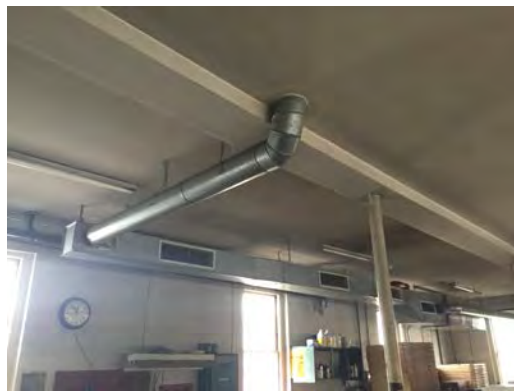
The heating system for the second floor quarters consists of an indoor oil fired air handling unit which is located within the apparatus bay on the first floor. The unit does not appear to have any cooling components nor does it have any ventilation air associated with its ductwork. The system is associated with a galvanized sheet metal duct distribution system which travels to floor mounted diffusers on the second floor and duct mounted diffusers for the apparatus bay. None of the ductwork is insulated which decreases the units efficiency. The air handling unit is equipped with a burner which utilizes No.2 fuel oil which is stored within a residential style 275 gallon storage tank located outside. The unit creates combustion gases that are forced to exit the building with the help of a fan inducer located on the unit. These gases exit the building through the use of a galvanized sheet metal flue which exits through the masonry wall.

*Typical Un-Insulated Ductwork*

- Provide one new heating, ventilation and air conditioning system with energy recovery, heating and cooling sections and MERV 13 filters. This system would be associated with a new galvanized sheet metal duct distribution system and would serve the second floor only.
  - Cost \$60,000
- Provide propeller style unit heaters within the apparatus bay for heating purposes only.
  - Cost \$4,500
- Provide a new direct digital control system and connect to a town wide building management system with web access and alarm notifications.
  - Cost \$30,000
- Provide general exhaust systems for storage and toilet rooms for improved indoor air quality.
  - Cost \$5,000

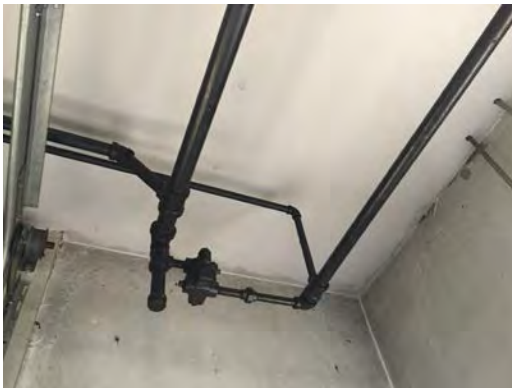
*Existing Abandoned Steam Piping*

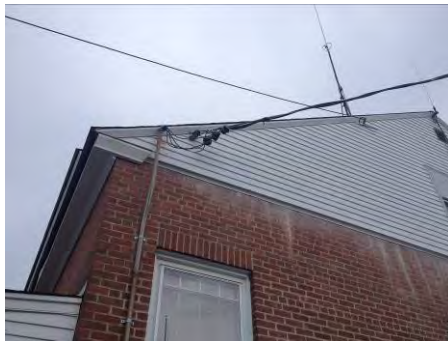
There are sub-panels in the basement that serve most loads, as well as, various sub-panels mounted exposed in the Fire Station. These sub-panels are full with little to no room for expansion. The service is undersized. The electrical distribution is in poor condition and should be replaced.

*Overhead Service*

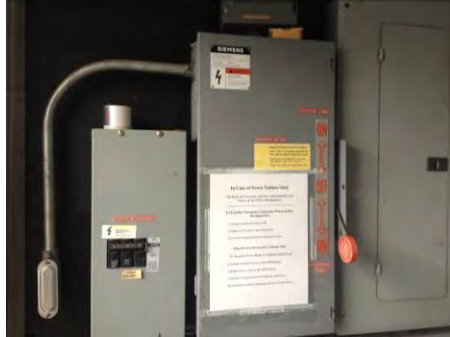
*Service Main Breaker*

- A new electrical service and distribution system will need to be provided to accommodate the new loads.
  - Cost: \$20,000.00
- The generator should be replaced with a larger exterior unit to provide the required emergency system needs. (approx. 60kW)
  - Cost: \$60,000.00

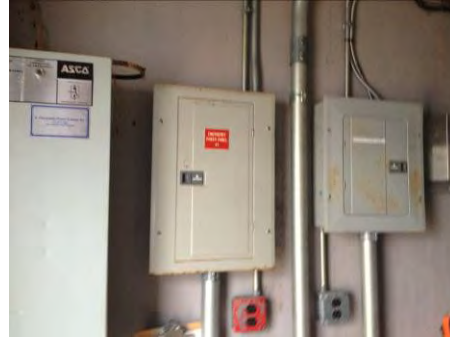
*Sub-Panel*

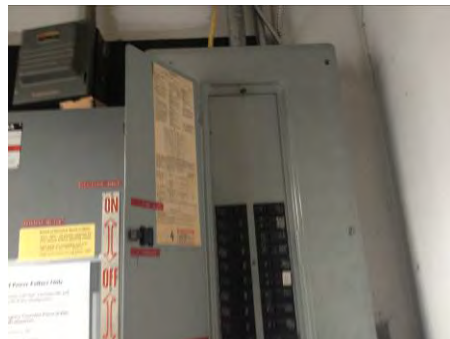
*Main Distribution Panel*

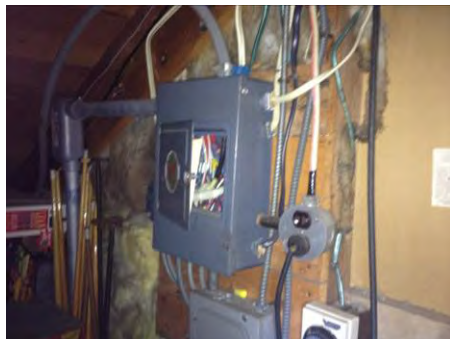
*Attic Sub-Panel*

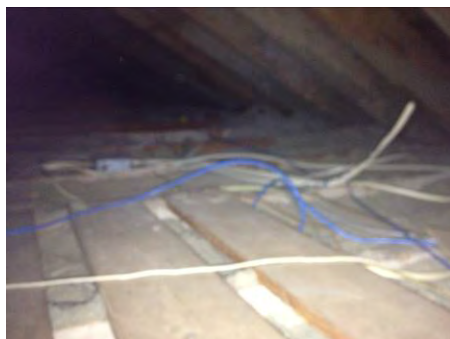
Branch circuit wiring has been added on over the years. The installation varies in quality and type. Both MC cable and NM sheathed cable “Romex” have been used. Romex is not code compliant in commercial installations. Lack of receptacles results in the use of extension cords and plug strips. Most wiring has been installed exposed and some MC and Romex are subject to physical damage.

*Wiring*

- Replace all existing non-sheathed cable throughout the building.
  - Cost: \$5,000.00

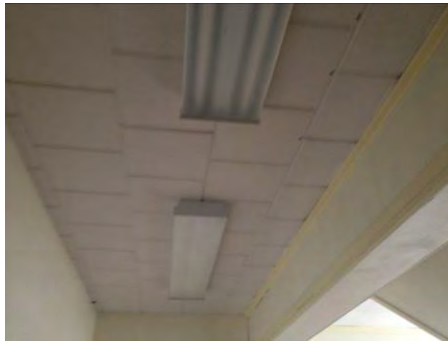
The lighting consists of 1'x4' wraparound fluorescent fixtures with acrylic lenses in the corridors. In general, the lighting is in poor condition and many spaces within the Fire Station are under-lit and still utilize incandescent fixtures which are very inefficient.

*Corridor Fixtures*

- All interior and exterior lighting fixtures should be replaced with new energy efficient LED type fixtures.
  - Cost: \$30,000.00

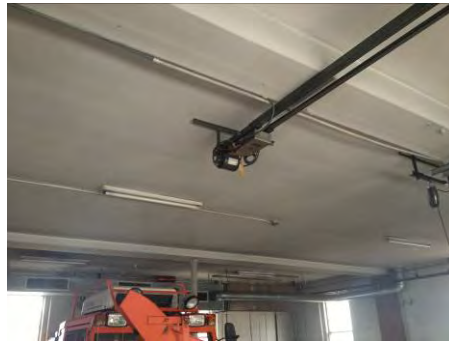
The apparatus bay lighting is in poor condition and consists of a one lamp cross section, fluorescent strip fixtures. Lighting control is via local line voltage, there was no automatic lighting control system noted. Current energy code requires either an automatic lighting control system or the use of occupancy sensors.

*Apparatus Bay Fixtures*

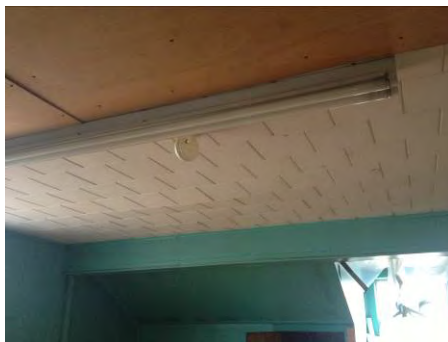
*Strip Fixtures*

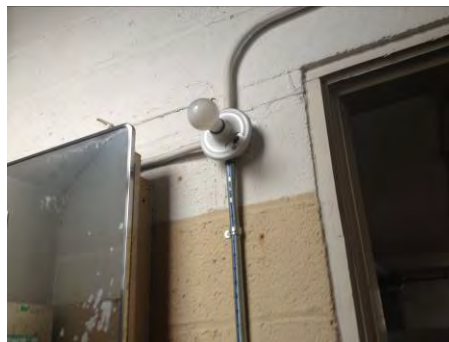
*Porcelain Socket*

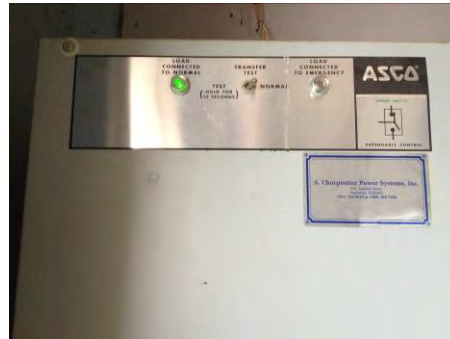
The facility is equipped with a Katolight natural gas fired interior pad mounted generator. The generator is in poor condition, and is undersized. It feeds an ASCO automatic transfer switch that serves an emergency panel. No exterior emergency egress lighting was noted during the field visit.

*Automatic Transfer Switch*

The emergency lighting and optional loads are not separated. The emergency system does not comply with today's codes. No exit signs were found in the building.

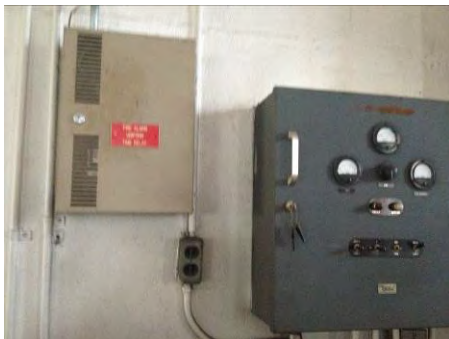
There is no fire alarm system in the building. The fire alarm consists of panel and an exterior master box. There are no pull stations, detectors, or horn/strobe units. A new addressable fire alarm system needs to be provided.

*Fire Alarm Panel*

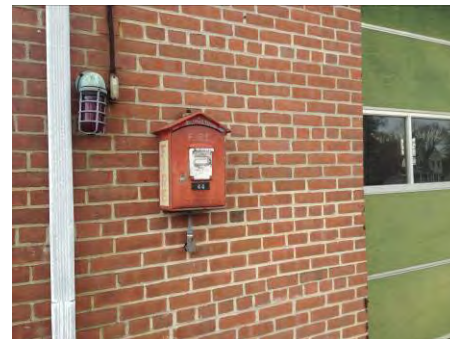
*Master Box*

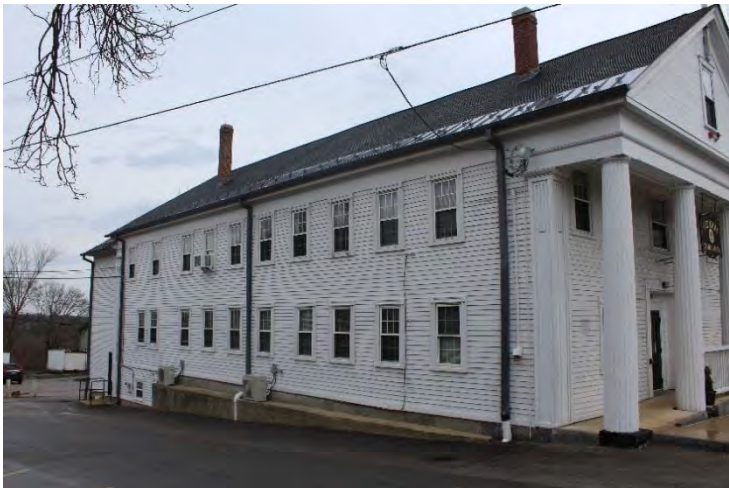
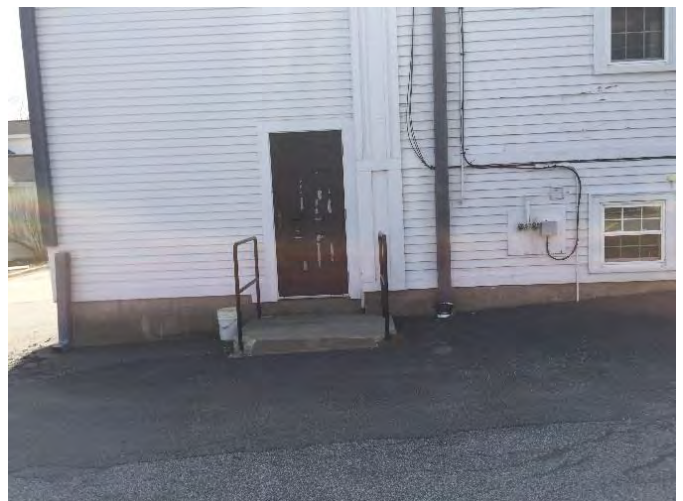
There does not appear to be any site drainage based on the existing information available. The overall site is moderately sloped where storm water is directed to the east perimeter of the site where it is discharged onto a grass area of an adjacent property. The roof drainage of the existing town hall is collected by seven (7) downspouts. On the north face of the building, there are three (3) downspouts that appear to be connected to an underground system, and one (1) downspout located at the back corner of the building that discharges to grade. This downspout appears to be damaged. On the south face of the building, three (3) downspouts spill to grade and drain off of the site from west to east.

**FIGURES 1 and 2:** North face (side) building downspouts

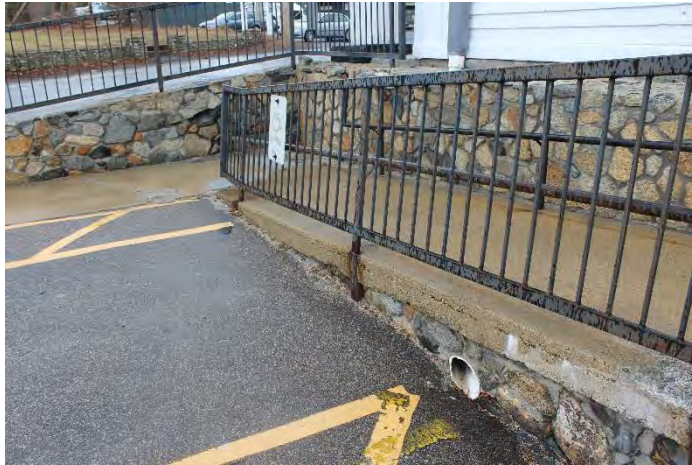
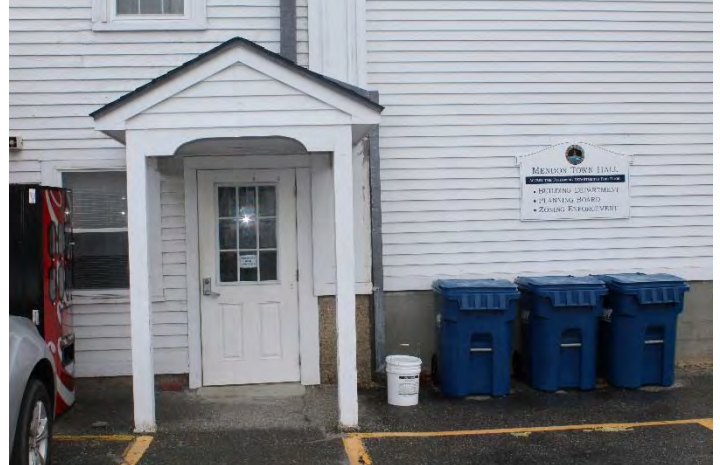
**FIGURES 3 and 4:** South face (side) building downspout

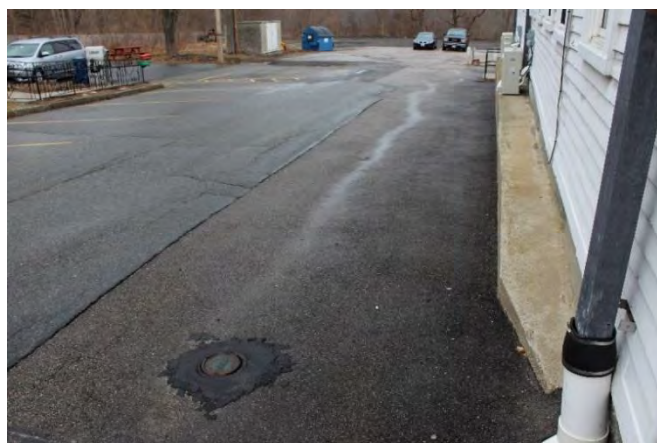
Based on available utility information, there is a well located in the existing Town Hall that appears to service the surrounding buildings as well. The domestic water service exits the Town Hall at the rear and enters the Police Station at the west corner of the building. The Police Station also appears to have a water connection to the Fire Station on site. There is an additional water line that exits the west face of the Town Hall that appears to connect to the Library. There are no known pipe sizes or pipe materials based on available information. On the west face of the building two water valves were observed approximately 10-feet from the building. There is no record information of a municipal water main in Main Street.

**FIGURE 5:** Water Valves observed at Town Hall

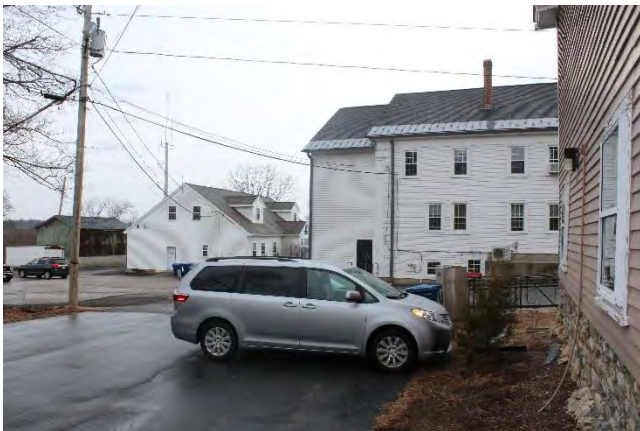
Record drawings and site photos indicate an electrical service to the Town Hall through overhead wires from a utility pole located in Main Street. The record drawing information also indicates overhead wires connecting the Town Hall to the Library. An existing fiber-optic cable line is also shown on the record drawings connecting the Town Hall and the Library. The electric meter and alarm panel were also observed along the north face of the building. A second observed overhead electric connection was observed at the western (front) corner of the Town Hall.

**FIGURE 6:** Electric utility service onsite

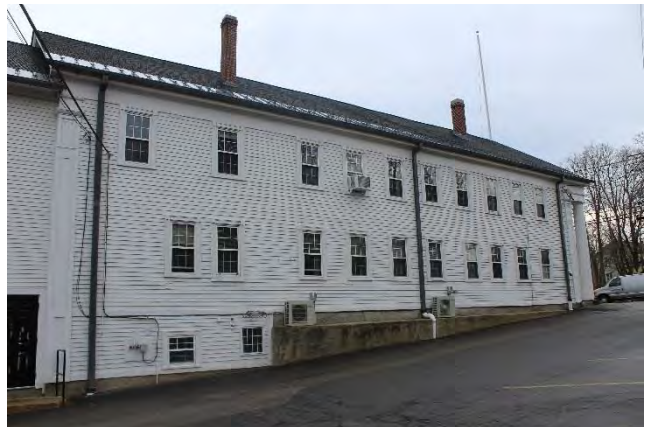
**FIGURE 7:** Electric connections to Town Hall

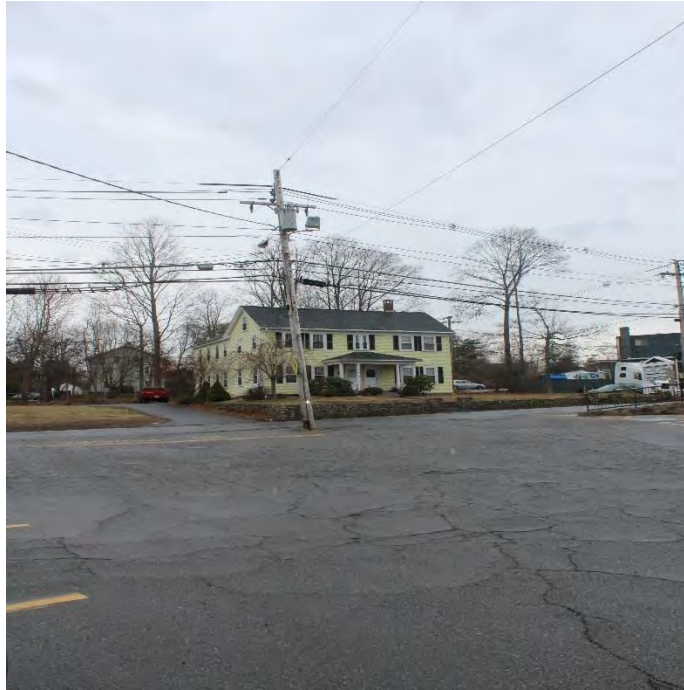
Asphalt pavement in the entrance to the Town Hall as well as additional parking areas that serve the surrounding buildings was observed to be in poor condition with some heaving, cracking and degradation. Granite curbing was not observed onsite.

**FIGURE 8:** Parking lot looking towards Main Street

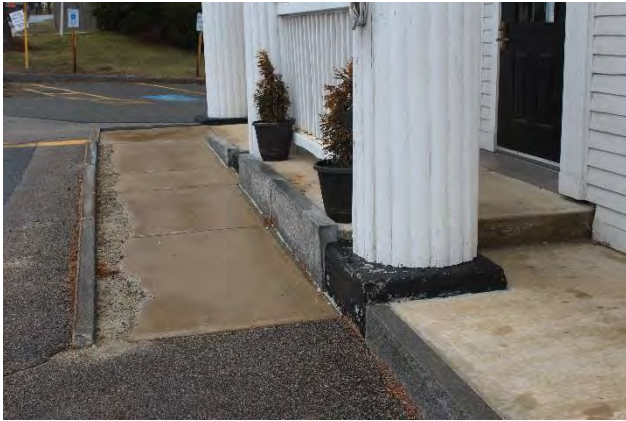
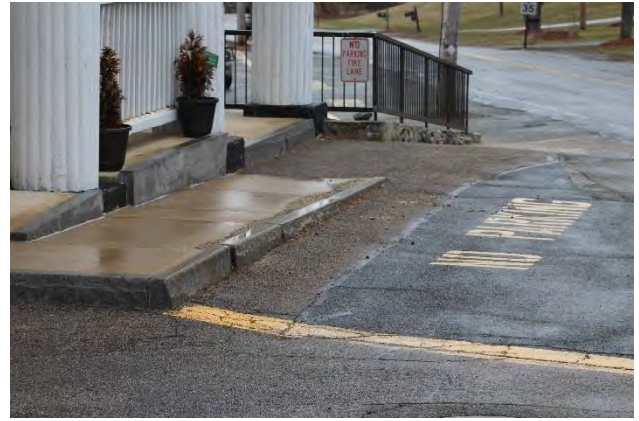
**FIGURE 9 & 10:** Front Entrance ramp to Town Hall

Upgrades for handicap accessibility may be required. The sidewalks and pedestrian ramps generally do not appear to meet the most recent ADA requirements for slope configuration. The asphalt pavement walkway leading to the Town Hall entrance is cracked and in need of repair. Both handicap accessible ramps are cracked and in need of repair. The hand railings that are part of the east ramp also look to be deteriorating and may need to be replaced. No pedestrian ramp tactile strips were observed at the site. Additional pedestrian crosswalks are needed.
