December 20, 2022

Re: Lake Nipmuc, Mendon, MA – 2022 Year End Report

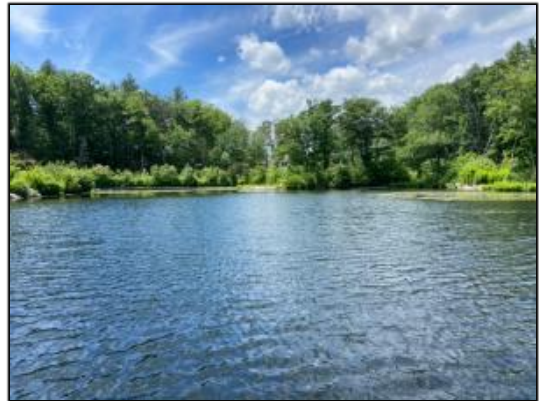
Figure 2: Overview of Lake Nipmuc

Upon arrival, a survey was conducted using visual observation. The eastern portion of the pond had trace densities of milfoil, while the coves had moderate to dense densities of milfoil. Native species observed were cattails, waterlilies, watershield, and ribbon leaf pondweed in trace to dense densities.

As planned, and based on the survey, a treatment was conducted for the control of milfoil. The liquid herbicide, diquat, was applied using a treatment boat equipped with a calibrated sub-surface injection system. This application methodology allows for even coverage within the treatment areas. Prior to treatment, signs noting the treatment and affiliated water use restrictions were posted by Mendon Parks & Recreation Department.

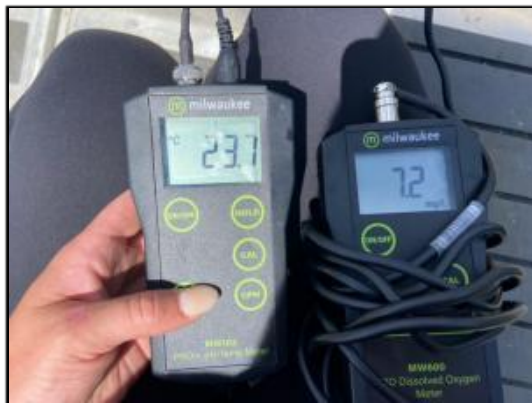
Figure 3: Measurements at Lake Nipmuc

While on-site, basic water quality was collected using calibrated meters. The water temperature was consistent with other similar waterbodies we manage in the area, and the dissolved oxygen was sufficient to support fish and wildlife. Water clarity was also assessed using a Secchi disk. A Secchi disk is a disk with alternating black and white quadrants. It is lowered into the water of a pond or lake until it can no longer be seen by the observer. This depth of disappearance, called the Secchi depth, is a measurement of the transparency of the water. The Secchi reading, in one of the deeper portions of the pond was 20 feet 10 inches, which is indicative of excellent water clarity.

Surface Temp (°C)	Surface Dissolved Oxygen (mg/l)
23.7	7.2
